Report No: 04-009 FE FBC

Testing : Polycarbonate Hurricane Shutter Panels

Transparent Protection Systems, Inc.

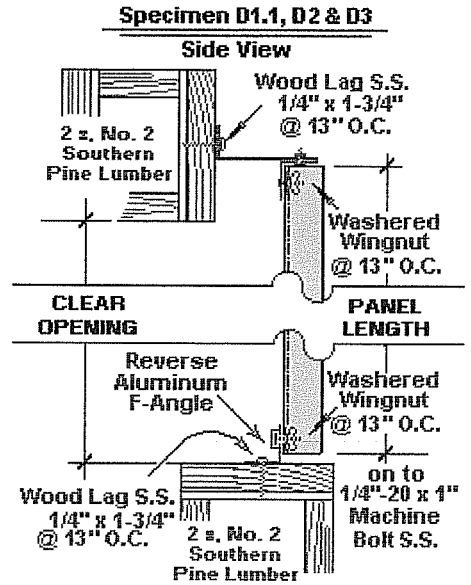
Wind Load Data : Specimen D1.1

Shear Failure at ~20-1/4" H2O, at head, 2nd & 3rd panel overlap torn from fastener.

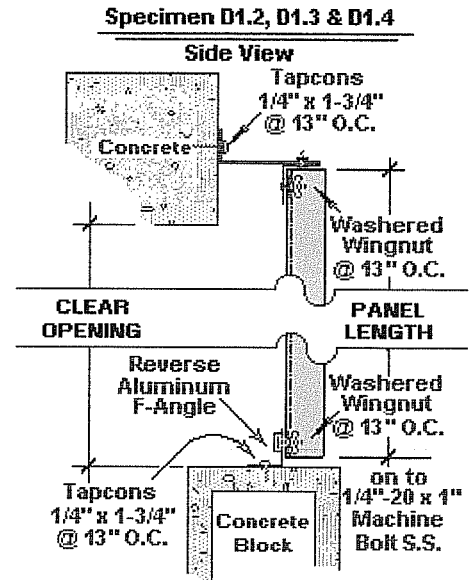
Wind Load Data : Specimen D1.2

Shear Failure at ~19-1/2" H2O, at sill, 1st & 2nd panel overlap torn from fastener.

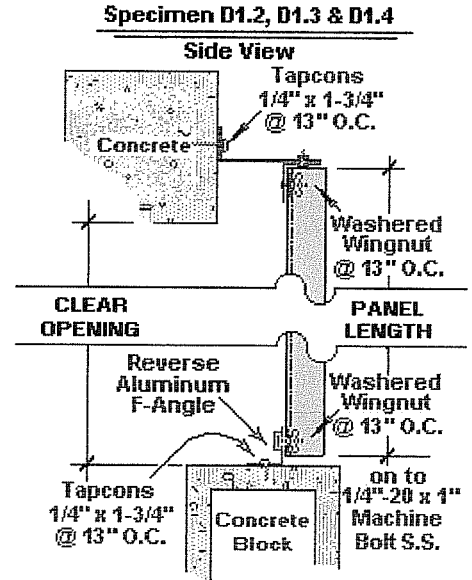
Wind Load Data : Specimen D1.3

Test discontinued when sample D1.2 Failed.

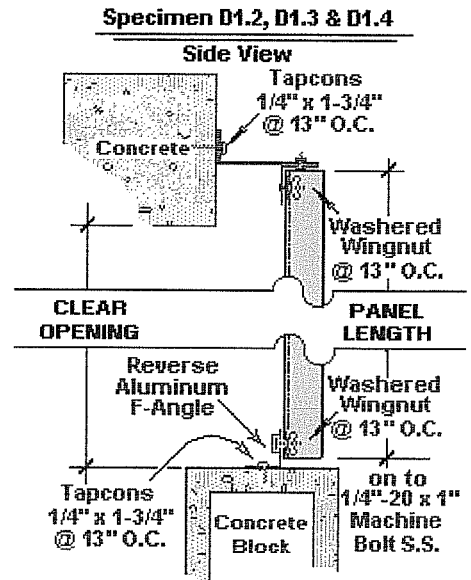
Wind Load Data : Specimen D1.4

Test dis continued when sample D1.2 Failed.

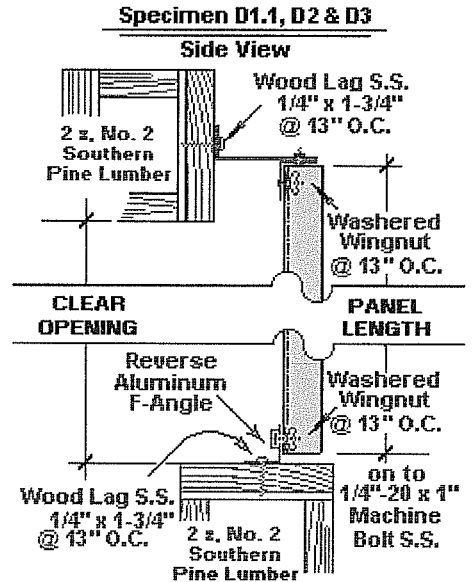
Wind Load Data : Specimen D2

Shear Failure at ~11-1/2" H2O, at sill, 2nd panel of three torn from fasteners.

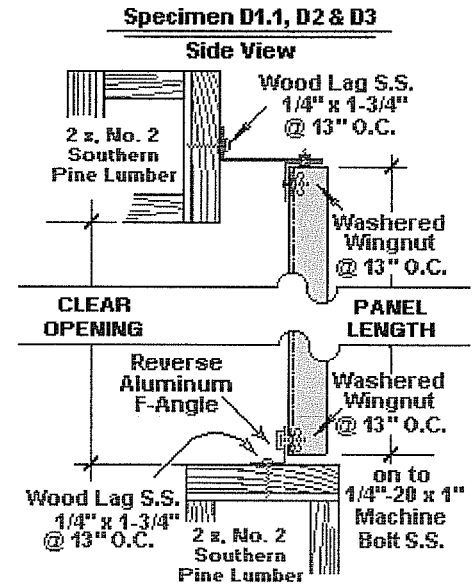
Wind Load Data : Specimen D3

Shear Failure at ~27-1/2" H2O, at sill, 1st & 2nd panel overlap, torn from fastener.
