**Study of Mitigative Techniques In Existing Houses
to Control Indoor Radon Exposure In Alachua
and Marion Counties In Florida**

Technical Publication # 71

M.E. RINKER, Sr.
SCHOOL OF BUILDING CONSTRUCTION
UNIVERSITY OF FLORIDA

July 12, 1990

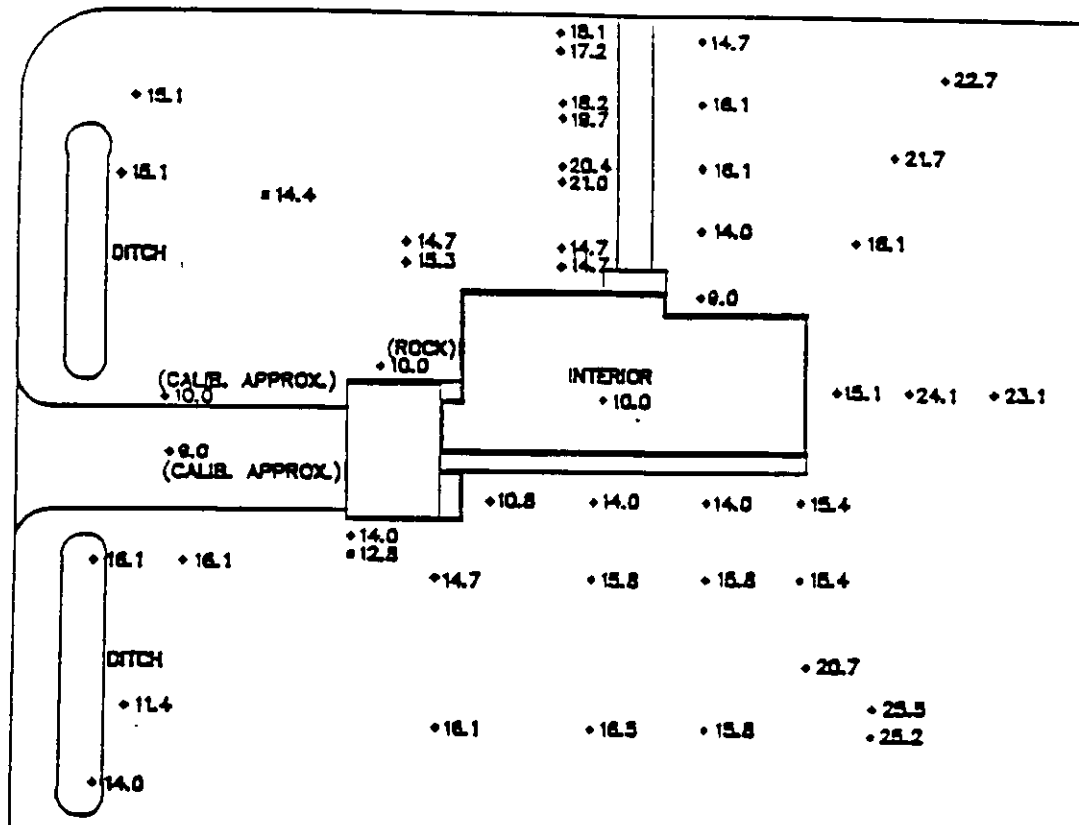
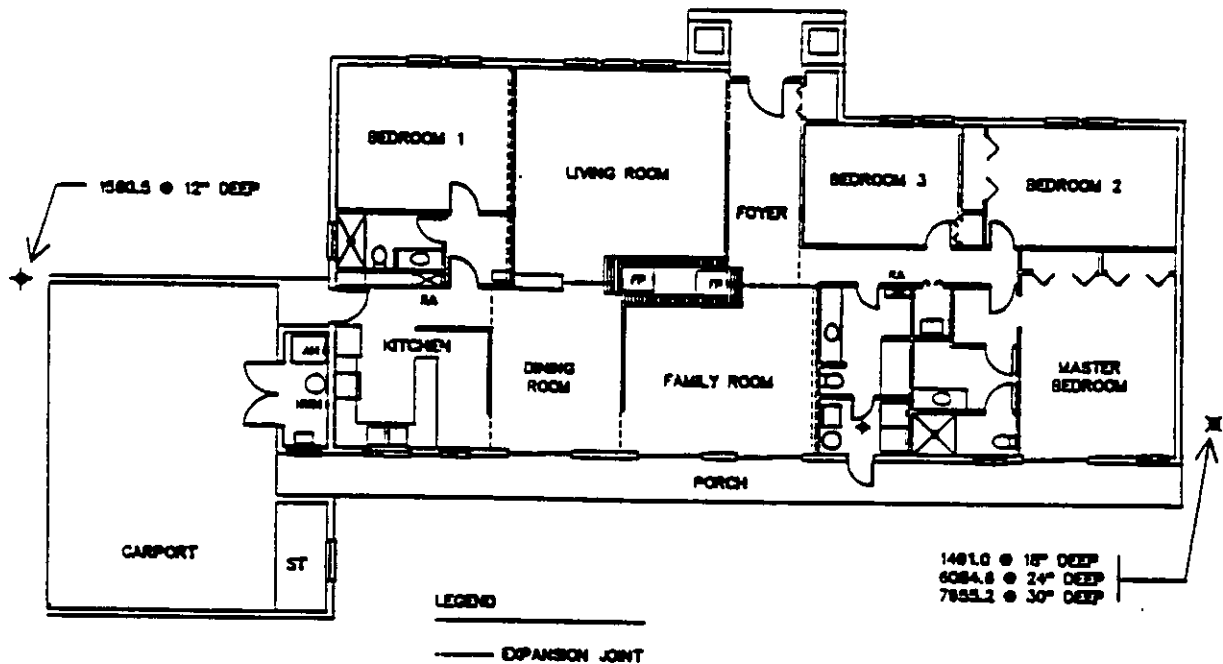
The first test conducted upon arrival at the site was the outdoor gamma radiation test. The results of this test, illustrated in Figure 16-A, show moderate to very high soil radiation levels. The native soil on this site was found to be emitting higher levels of gamma radiation than most of the soils found around reclaimed phosphate mines in Southcentral Florida. Gamma emissions in the range measured on this site predict a very high radon source potential. Subsequent soil gas measurements for radon confirmed the presence of high levels of radon in

GAMMA RADIATION AND SOIL GAS RADON MEASUREMENTS

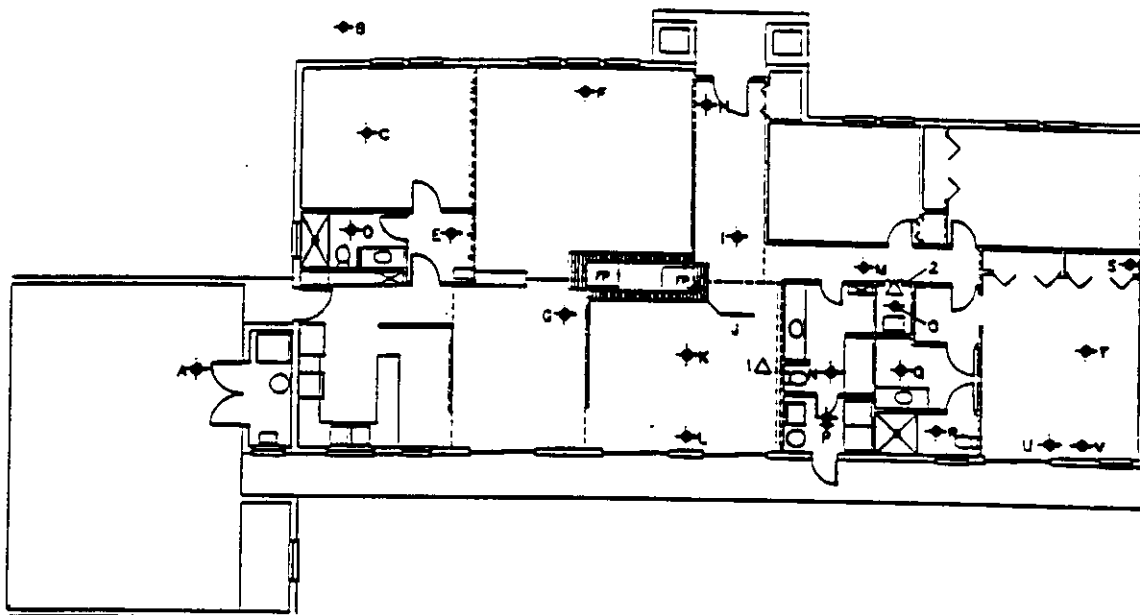
Grab and sniffer sampling was then conducted to determine radon levels outdoors, inside the house and under the floor slab. See Figure 17 for the results of this testing. Sub-slab grab and sniffer measurements confirmed a very high radon source with levels exceeding 9000 pCi/L just four inches below the floor. With concentrations in this range, very little soil gas must enter the occupied space to make significant changes in the indoor radon level. Sniffer measurements confirmed that most of the suspected entry conditions were active radon pathways. The sub-slab return-air duct system was determined to be the primary entry route. Radon levels were monitored inside the return-air ducting while the air handler was cycled on and off. Elevated radon levels inside the masonry wall cavities, were confirmed as were radon levels at many of the slab penetrations. Small tents of plastic film were taped in place over the slab cracks and the air pumped through the radon monitor. This procedure for all practical purposes isolated the air inside the crack from the rest of the room air. The resulting radon levels were therefore representative of the gas migrating up through the crack from below the slab. Small holes were punched through the wall board just above the baseboard so that a small length of tubing could be inserted into the cavity for radon levels to be measured. This technique was especially useful for confirming suspected entry conditions associated with plumbing. In this house, no evidence was found that radon was entering through any openings under the bathtubs or shower stalls.

MARK	SAMPLE LOCATION	RADON LEVEL (pCi/l)
A	HVAC - RETURN AIR PLENUM - AMBIENT	103.1
	HVAC - RETURN AIR PLENUM - FAN ON	93.1
B	BEDROOM #1 - WALL RECEPTACLE	81.8
C	BEDROOM #1 - ROOM AIR	63.0
D	BEDROOM #1 BATH - TOILET BASE	132.7

• - SHOWER HEAD/WALL PENETRATION	146.1
	• - TOILET WATER SUPPLY PENETRATION	120.6
E	BEDROOM #1 CLOSET - SUB-SLAB	9015.5
F	LIVING ROOM - ROOM AIR	165.4
	• - CABLE BOX	185.6

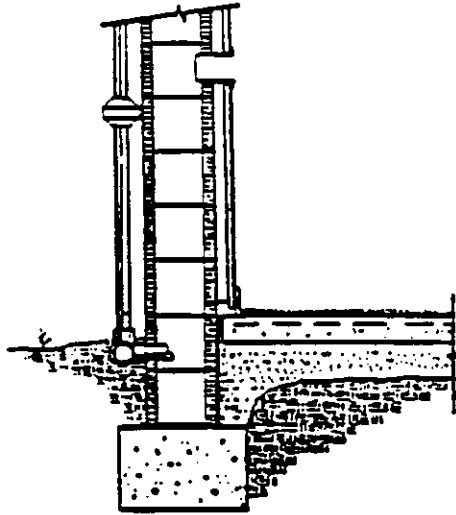
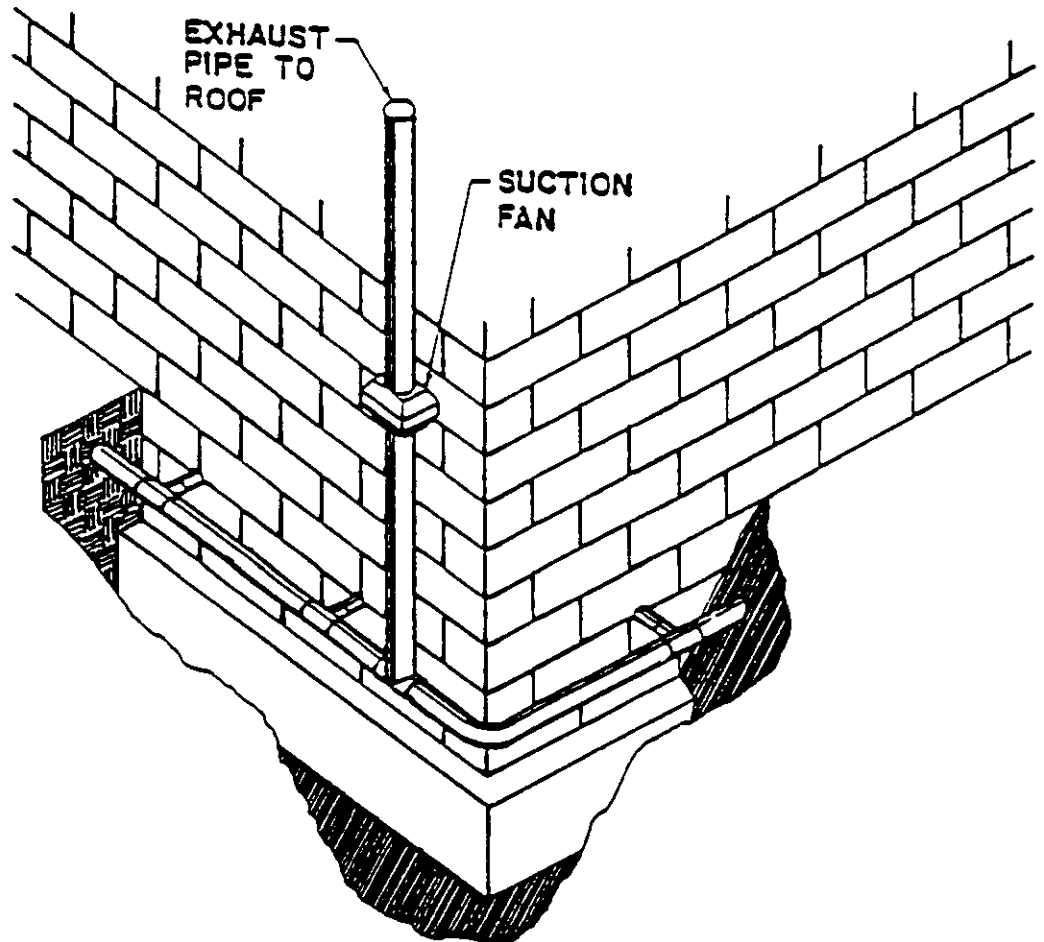
WALL CAVITY DEPRESSURIZATION SYSTEM

Additional testing was conducted to determine the degree of effectiveness of each of the mitigation systems. The results proved to be very interesting. With the Phase 2 system disconnected the indoor radon levels were maintained at the 3.0 pCi/L level. When the Phase 2 system was reactivated the indoor radon levels only dropped an additional 0.2 pCi/L to 2.8 pCi/L. This meant that the sub-slab depressurization system was effectively reducing the level of radon by itself. The additional level of reduction achieved by the HVAC house pressurization system, 0.2 pCi/L, could be viewed as a beneficial effect, but based upon the cost of the systems, the Phase 2 installation was not judged to be very cost effective.

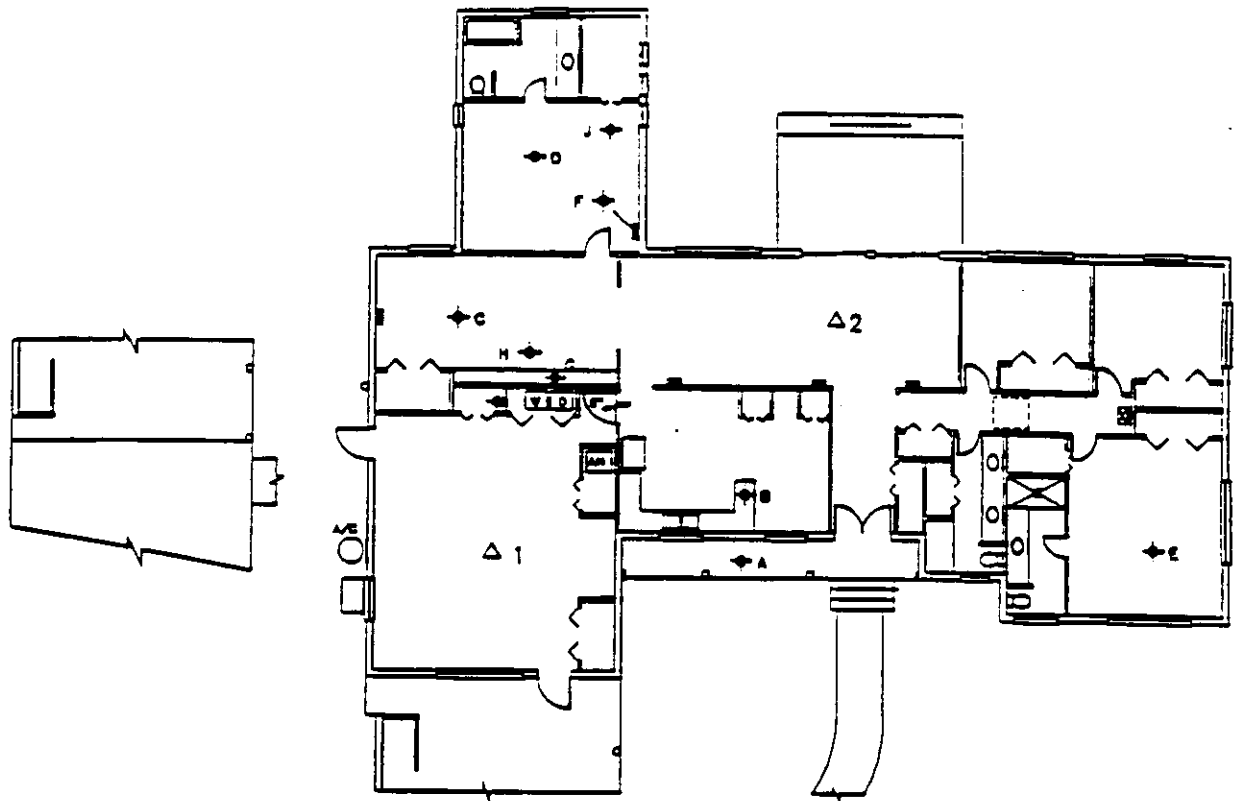
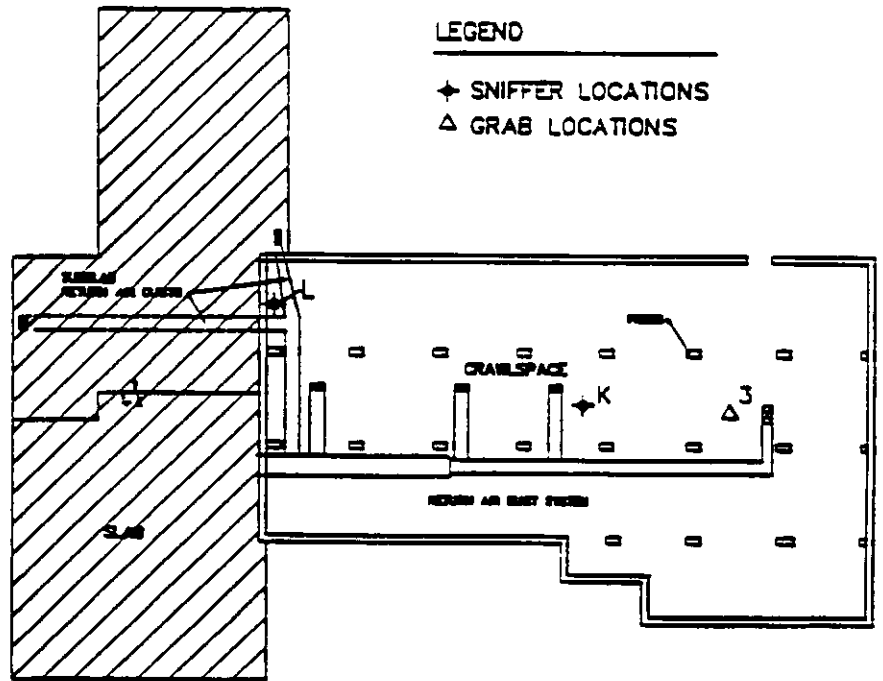
GRAB SAMPLE AND SNIFFER MEASUREMENT LOCATIONS

Grab samples and sniffer measurements were taken inside the house and in the crawlspace; see Figures 23-A & 23-B and Table 2 for the results. These tests confirmed the presence of elevated levels of radon and indicated that the area of higher concentration was in the new master bedroom area. This information, coupled with the outdoor gamma readings, seemed to reinforce

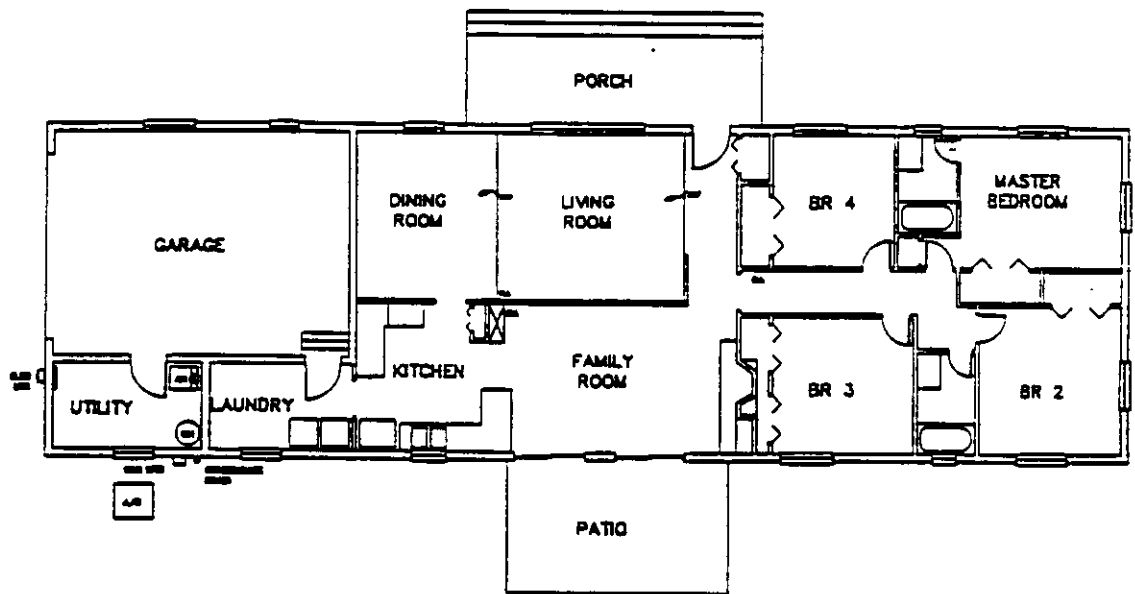
FLOOR PLAN

During the preliminary construction investigation the homeowner disclosed that some settlement had occurred along the rear of the house during the early 1980's. At this time, the

homeowner hired a geotechnical engineering firm to perform a sub-soil investigation program in order to determine the cause of the settlement. A sinkhole was suspected by the homeowner to be the cause of the problem, but following the sub-surface testing it was revealed that the house had been constructed over a depression that had been filled with debris and rubble. Much of this material was compressible in nature and over time had decayed and resulted in the settling of overlying soils to settle. This subsidence caused observable external cracking of the exterior masonry wall and the interior slab, and major cracking to the exterior patio slab. The patio slab was removed and replaced some time later.

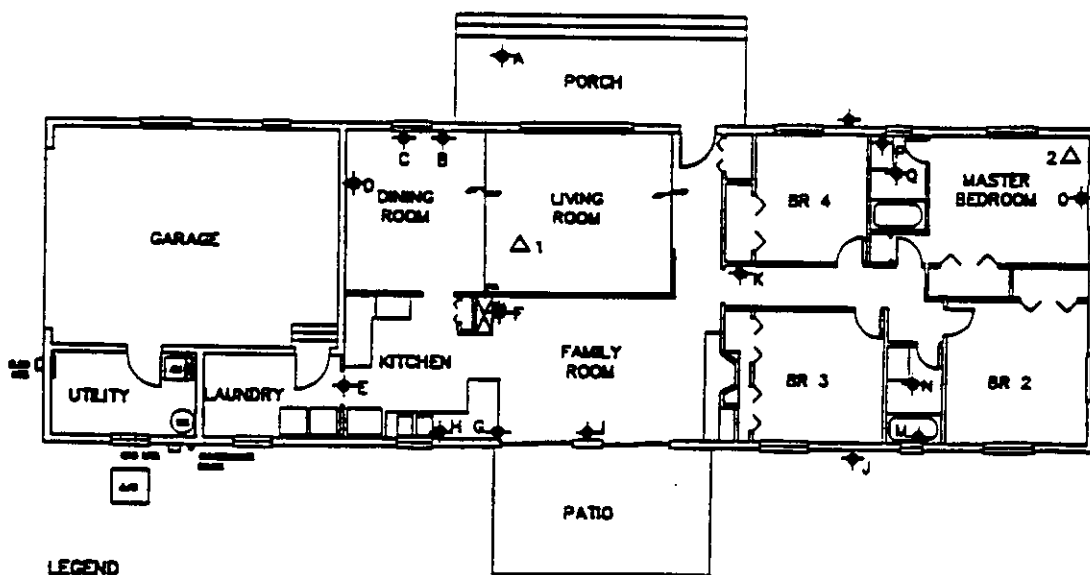
Sniffer measurements were made in various locations in an attempt to locate any "hot spots." Figure 38 shows the locations of the tests and the resulting radon levels. Test point "S"

MARK	SAMPLE LOCATION	RADON LEVEL (pCi/l)
A	BACKGROUND - OUTSIDE	1.9
B	DINING ROOM - INSIDE WALL RECEPTICLE	22.8
C	DINING ROOM - JUNCTION BOX - DEEP	53.5
D	DINING ROOM - RECEPTICLE	30.9
E	KITCHEN - FLOOR EXPANSION JOINT	301.8
F	FAMILY ROOM - RETURN-AIR PLENUM	7.5
G	FAMILY ROOM - INSIDE WALL RECEPTICLE	17.4
H	KITCHEN - INSIDE WALL RECEPTICLE	31.9
I	FAMILY ROOM - INSIDE WALL SWITCH	13.6
J	SUB-SLAB - THROUGH FOUNDATION WALL OPENING	156.6
K	HALL - RETURN-AIR DUCT	44.0
L	SUB-SLAB - THROUGH FOUNDATION WALL OPENING	42.5
M	HALL BATH - TUB GROUT JOINT	17.3
N	HALL BATH - TOILET BASE	28.0
O	MASTER BEDROOM - INSIDE WALL RECEPTICLE	13.3
P	MASTER BATH - INSIDE WALL RECEPTICLE	12.7
Q	MASTER BATH - TOILET BASE	15.4
R	SUB-SLAB - BEDROOM #2 CLOSET - NEAR EXTERIOR WALL	352.0
S	SUB-SLAB - BEDROOM #2 CLOSET - AWAY FROM EXTERIOR WA	6861.0
GRAB 1	LIVING ROOM	8.6
GRAB 2	MASTER BEDROOM	10.2
