TECHNICAL PUBLICATION NO. 74

**A STUDY OF MARCITE (PLASTER)
DETERIORATION IN SWIMMING POOLS**

M. E. Rinker, Sr., School of Building Construction
and
College of Engineering - Department of Materials Science and Engineering

March 30, 1991

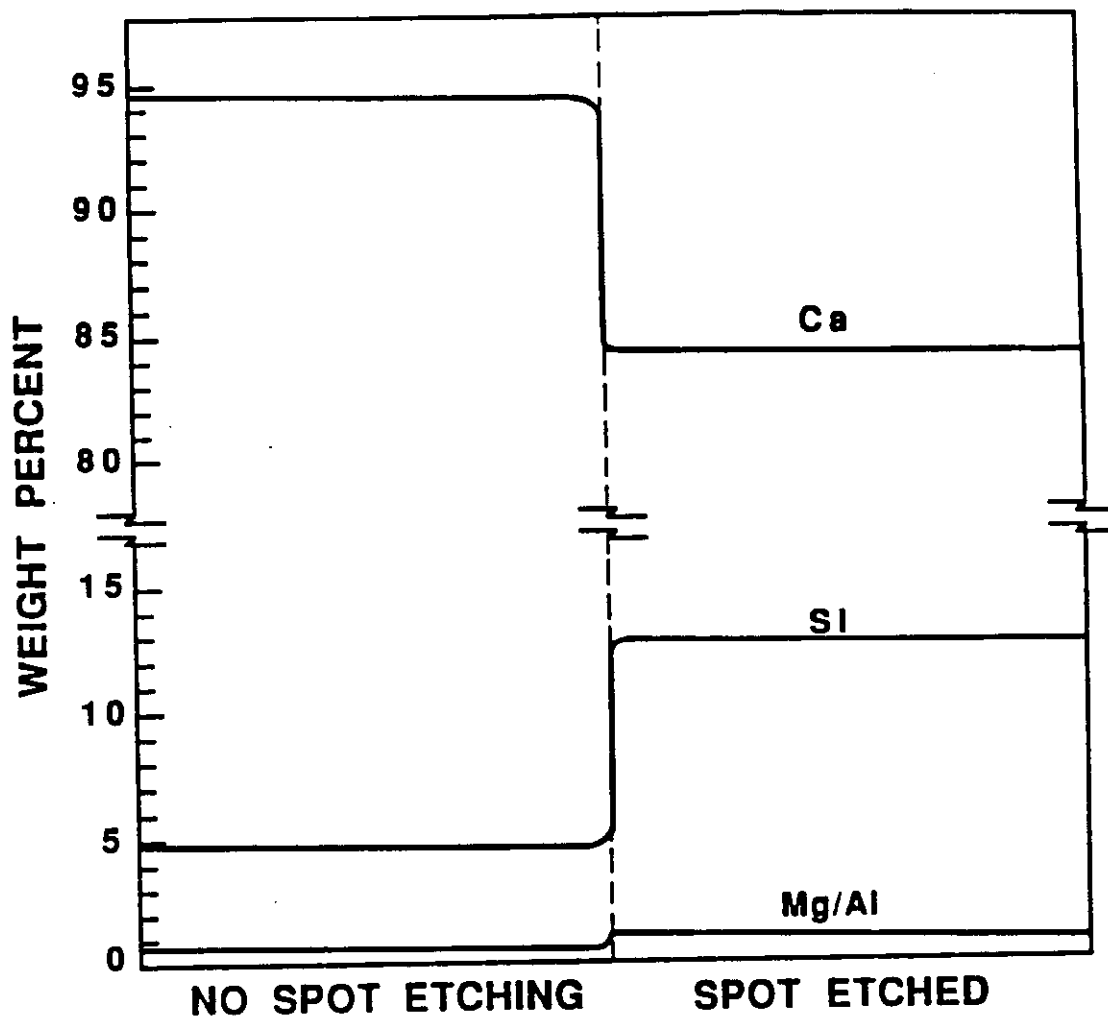
The other analytical method employed in this phase of the work was scanning electron microscopy (SEM). Marcite was observed up to 15000x on the SEM. Also in conjunction with SEM, energy dispersive spectroscopy (EDS) was performed. While the sample is in the SEM, elemental analysis can be done using this technique. In Figure 3 are shown the results of EDS scans for the elements Ca, Si, Mg and Al while traversing a marcite sample from an existing swimming pool from a non-etched to a spot etched area. The sharp drop in relative concentration of calcium and corresponding relative increase in silicon concentration is evident in going from the non-etched to etched areas.

Figure 3. Calcium, silicon, magnesium and aluminum concentration profiles (EDS) in traversing from a non-etched to an etched area in marcite taken from a pool in Gainesville, Florida.

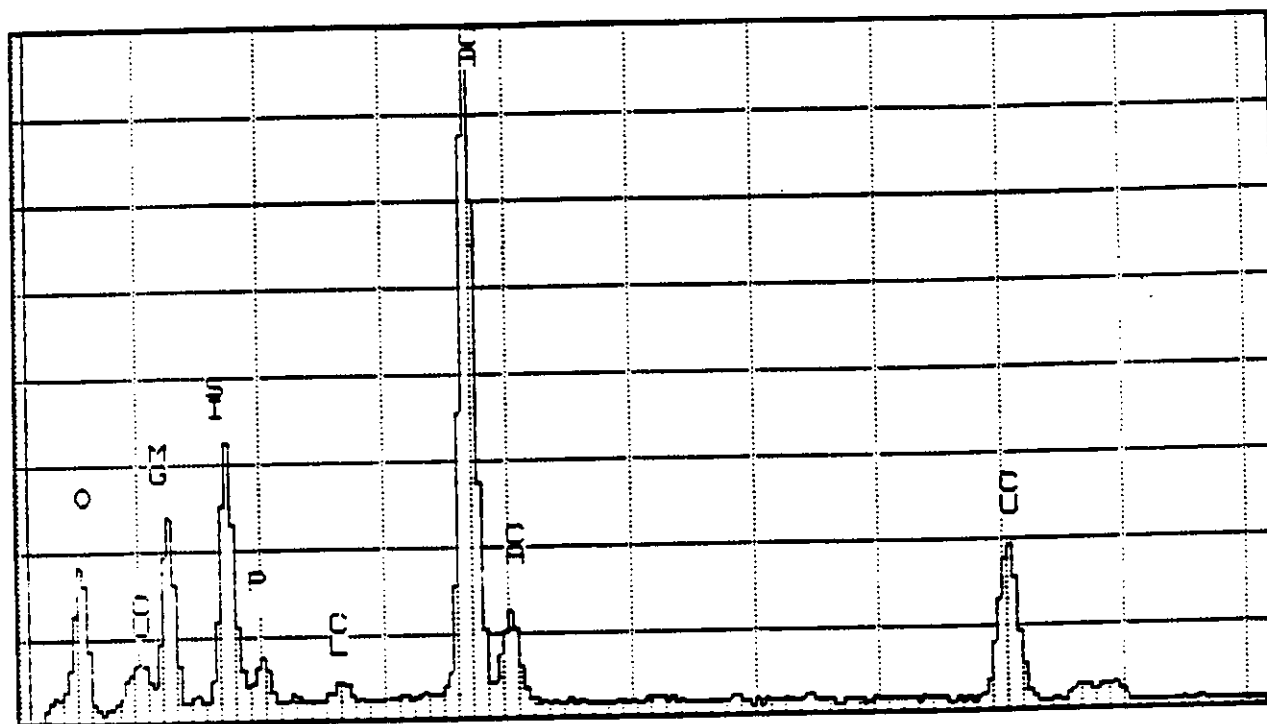
or 2) copper ions from corroded bronze or brass plumbing. Once copper ions are in solution in pool water, they combine to form complex compounds on the surface of the plaster. In Figure 4 is shown an EDS scan on a sample of marcite with blue/green staining. In addition to the expected peaks for Ca, Mg, Si and O, a very distinct peak for Cu is noted. Figure 5 is a similar EDS scan on marcite from a swimming pool with distinctive yellow/brown staining. In this case the iron (Fe) peak is predominant.

Figure 4. EDS Scan on marcite with blue/green staining.

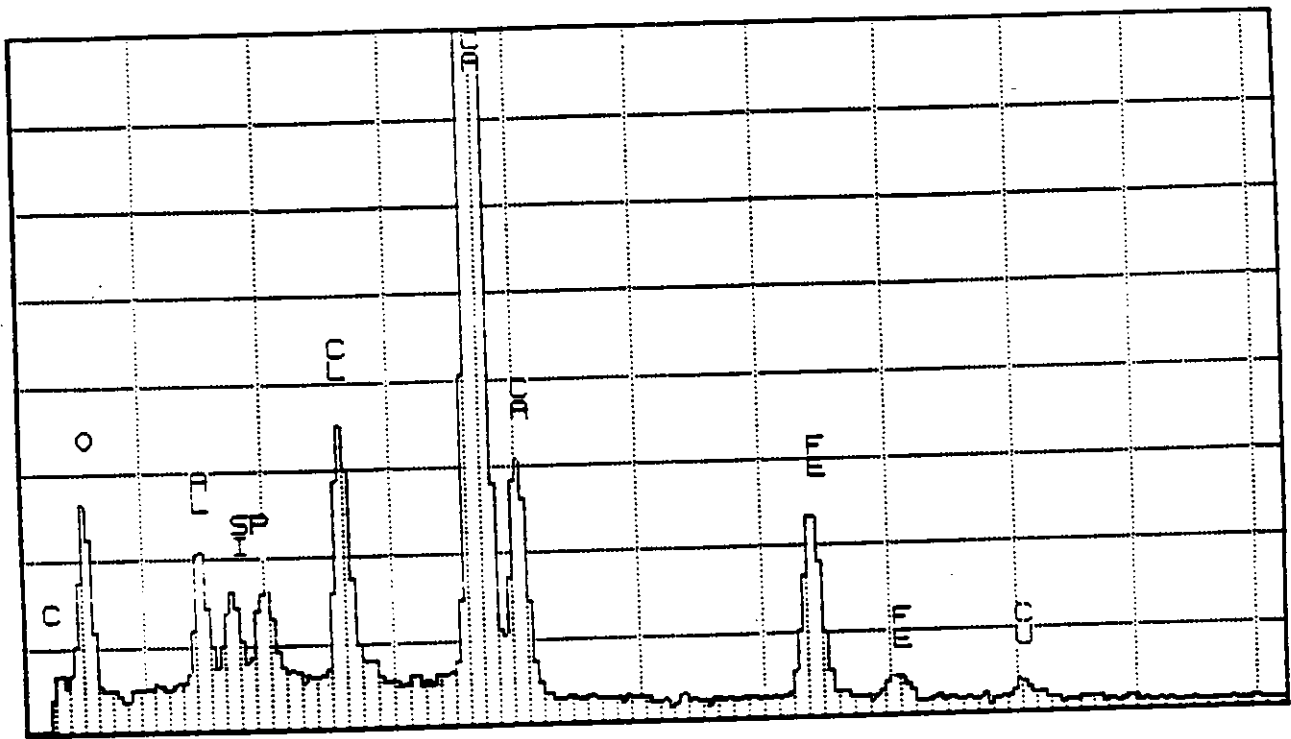
Figure 5. EDS Scan on marcite with yellow/brown staining.
