### **3. Period of Significance (1938 - 1946)**

## 4. Rehabilitation and Adaptive Use Potential:

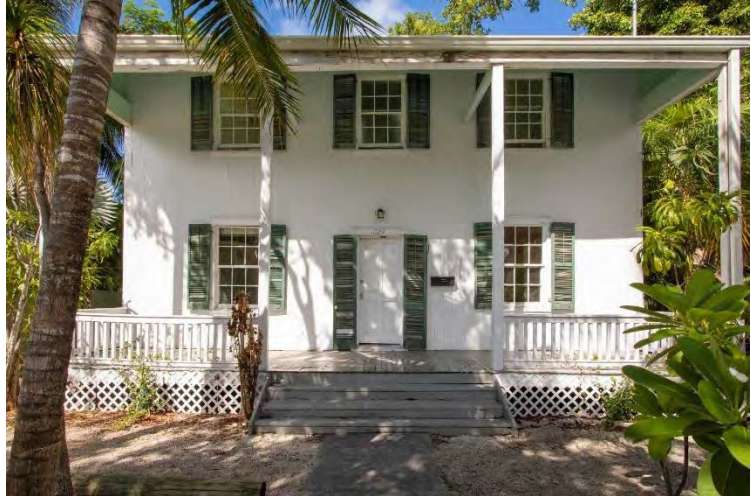
The front façade of 624 White Street.

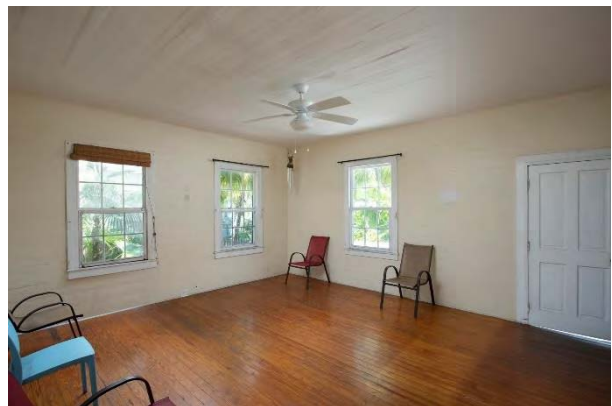
General view of the interiors of 624 White Street. Finishes consist of stained wood floors, painted wood ceilings, and painted wood walls.

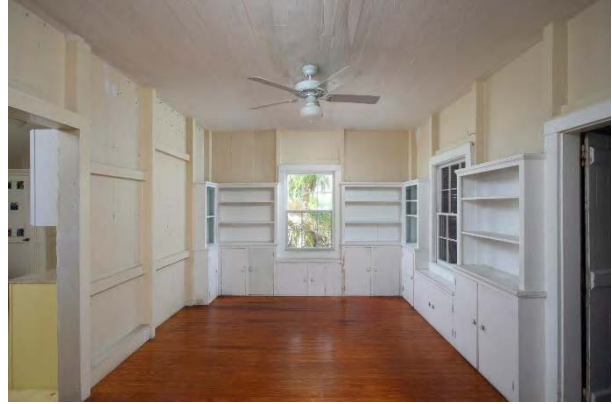
Interior view of the one story room at the rear center of the house.

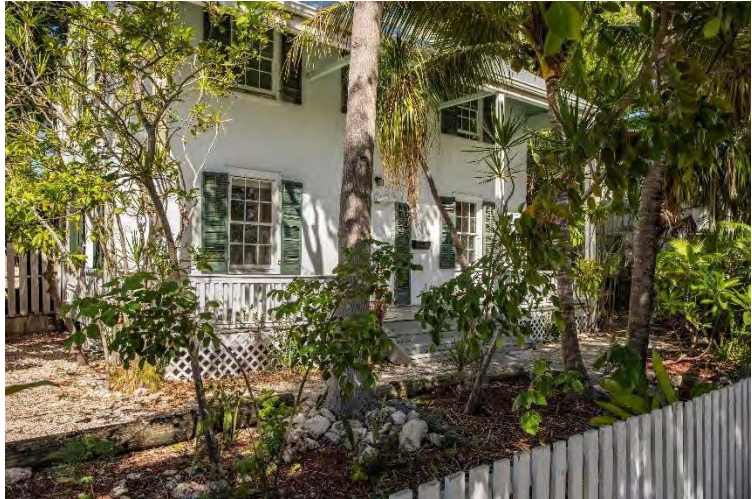
This general view of the front yard shows the typical landscape of mature trees and ground cover surrounded by white pea gravel.

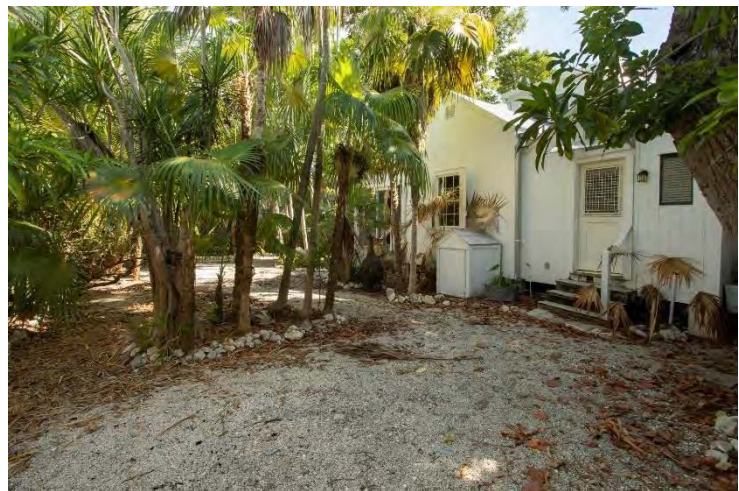
General view of the rear yard of 624 White Street.

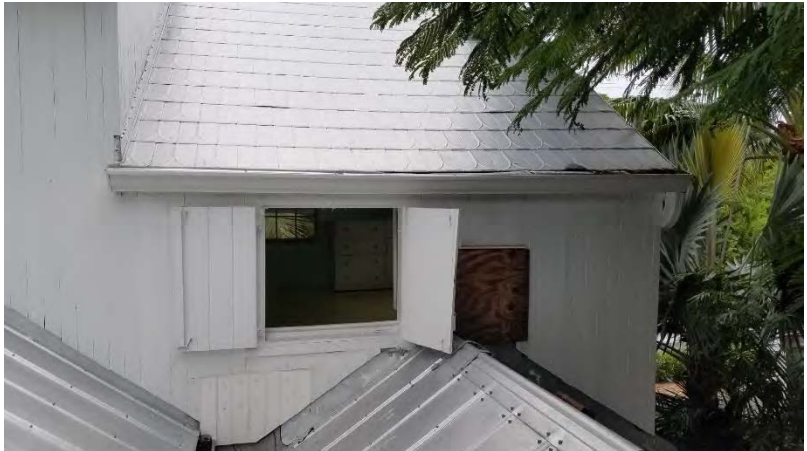
There is a small attic above the second story of the house. This attic is framed with the same dimension roof rafters. The attic is accessed by a hatch in the south bedroom.

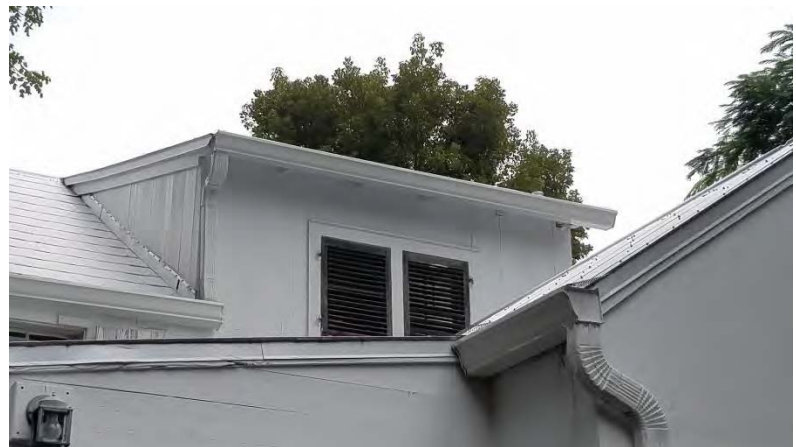
This view of the 2<sup>nd</sup> floor dormer shows the aluminum ogee gutters and square downspouts on the house. These gutters and downspouts are not appropriate for the house.

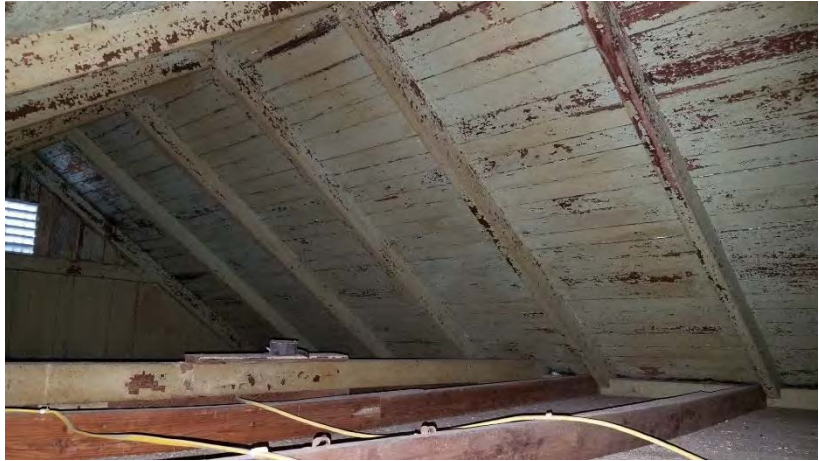
Painted aluminum ogee style gutters are installed at the entire roof. This gutter and downspout system was installed when the roof was replaced within the last few years. This style of aluminum gutter is inappropriate for the period of concern. It is likely that galvanized half-round gutters and round downspouts would have been installed on the house, piped into the cistern.

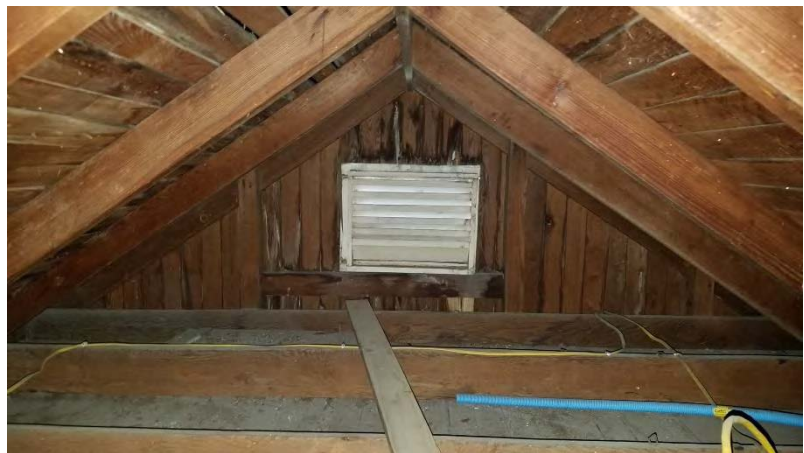
General view of the attic above the second floor. A wood louvered vent can be seen at the gable wall.

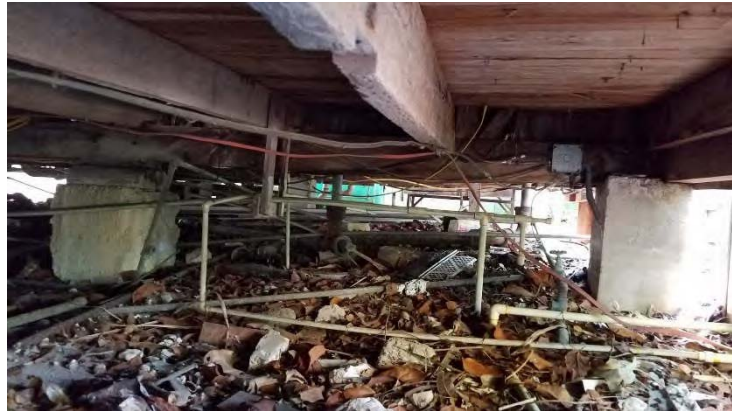
The flooring in the Living Room area consists of stained T&G wood, and the flooring in the south bedroom is painted T&G wood.

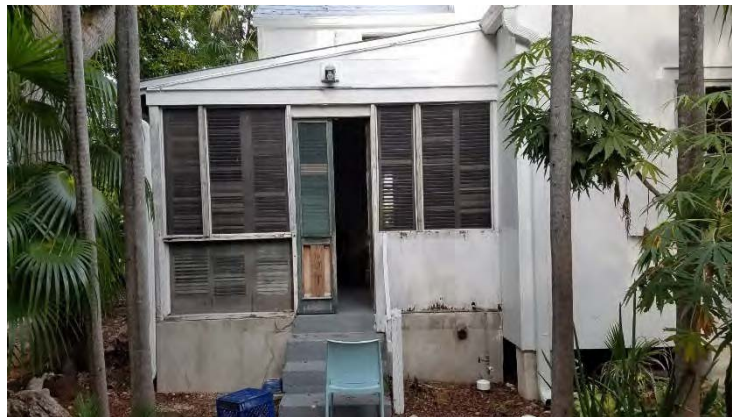
The flooring at the center one-story rear consists of stained tongue in groove wood over a tongue in groove subfloor over wood joists over concrete and limestone piers.

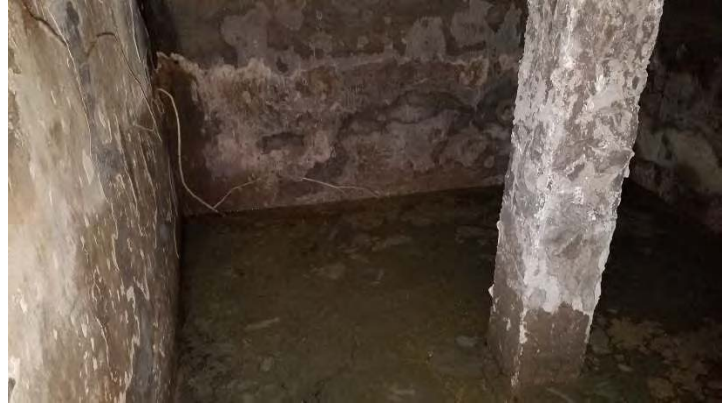
This photo shows the interior of the cistern. There is approximately 4" of water in the cistern. Cracked and delaminated plaster is visible on the walls, as well as tree roots which have penetrated the concrete walls. The cistern is no longer watertight. Approximately 48" of the cistern lies below grade.

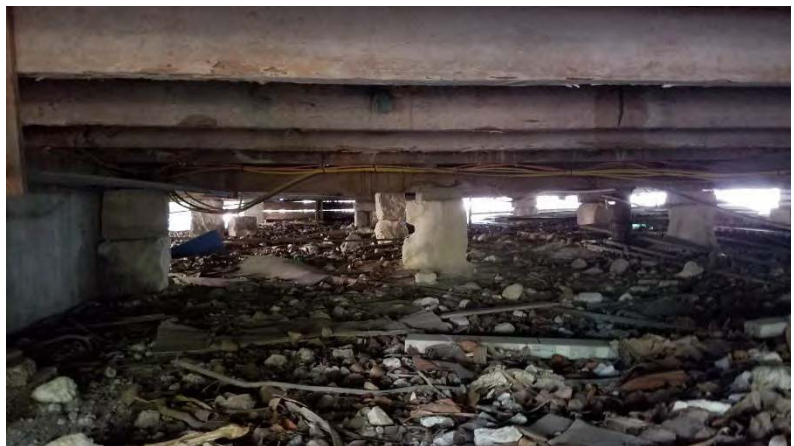
Another photo of the underside of the house shows a deteriorated limestone foundation pier and the historic floor framing.

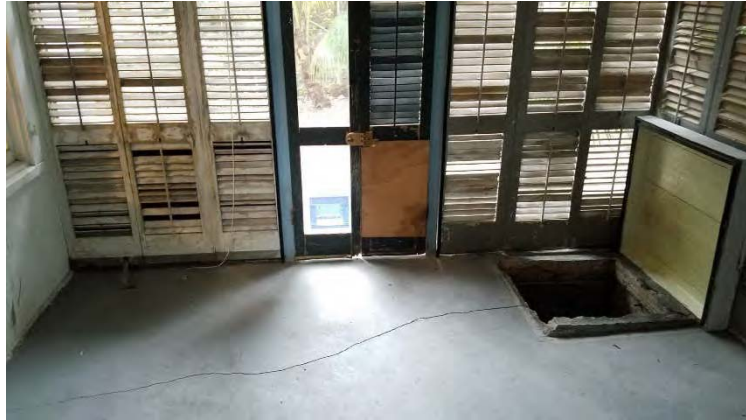
This photo shows the painted concrete top slab of the cistern. The access hatch can be seen at right. A crack is visible leading from the access hatch to the wall.

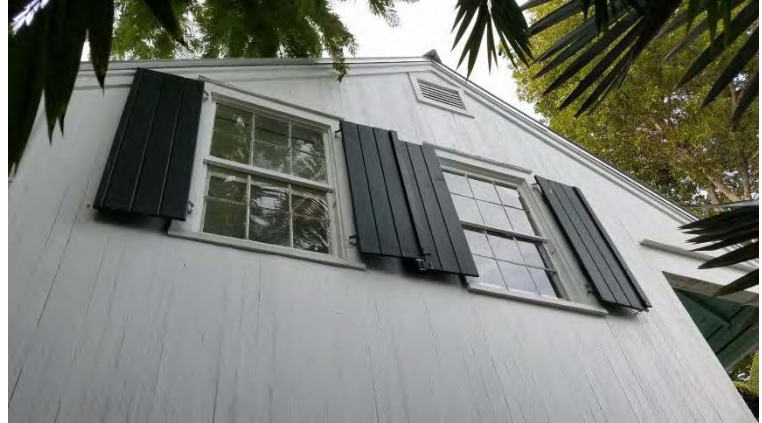
This view of the south façade of the house shows the painted wood vertical siding.

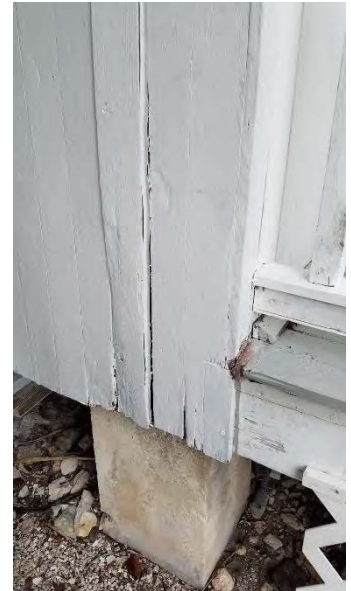
This view of the SE corner of the house shows damaged siding at the base of the building. The front porch can be seen at right.

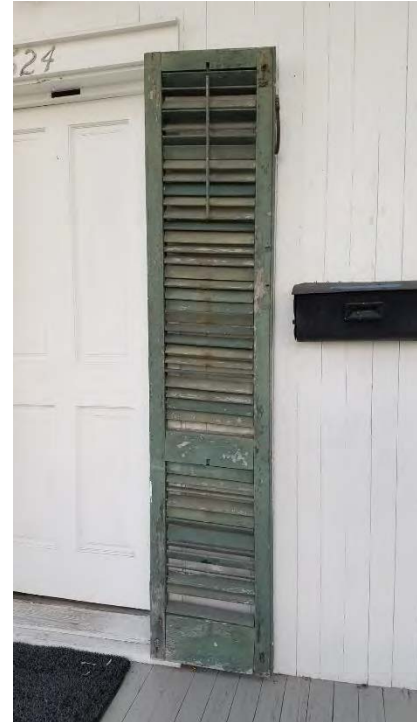
This partial view of the front door shows the painted wood 4- panel door with painted wood operable louvered shutters. The shutters are extremely significant.

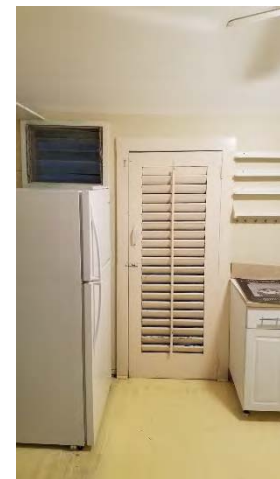
The painted wood louvered west door of the kitchen. This door leads to the west porch.

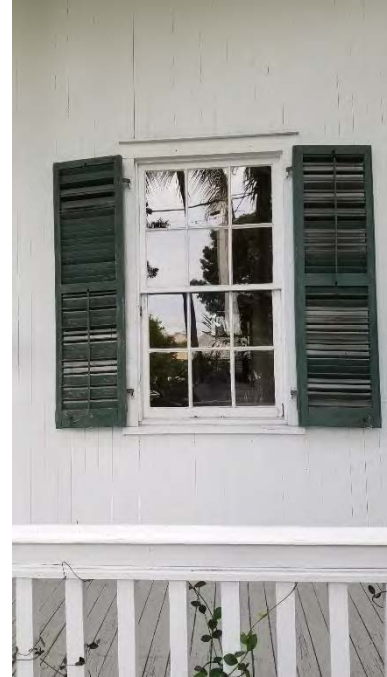
A typical window at the front façade of the house. The windows and the louvered shutters are very significant.

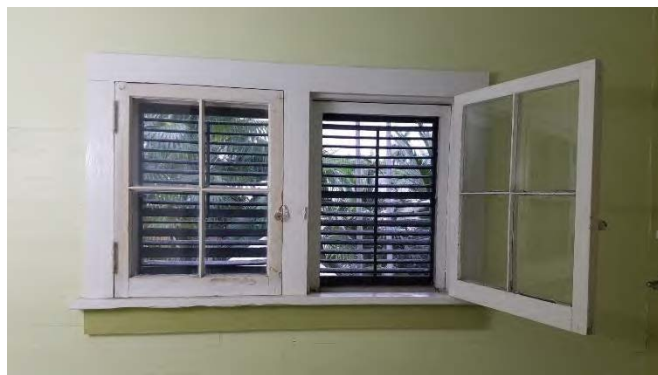
This photo shows the painted wood inswing casement window at the bathroom dormer. The window was operable louvered shutters at the exterior.

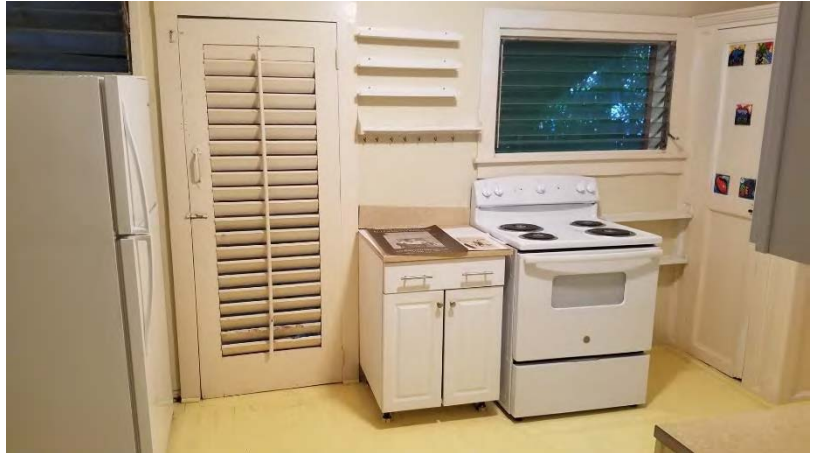
The two aluminum jalousie style kitchen windows at the south façade. The windows should be removed and replaced with painted wood windows.

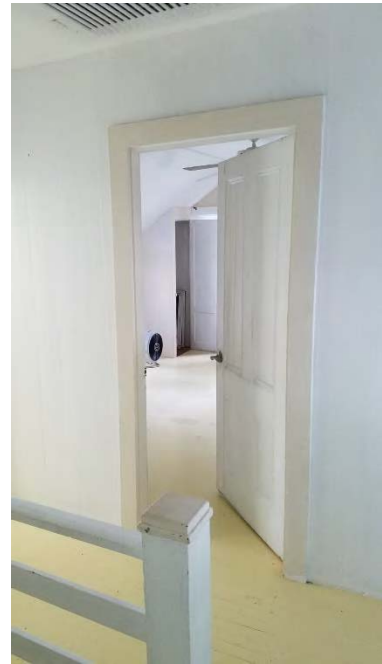
The 4 panel painted wood door leading to the north bedroom. The door is significant; the hardware is a contemporary replacement.

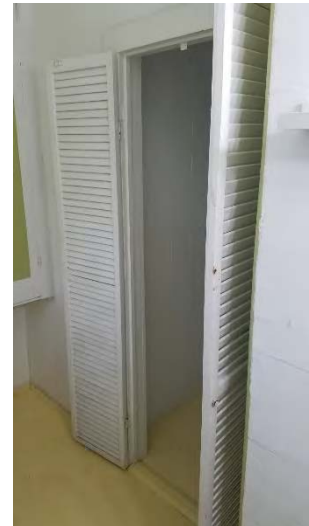
The louvered door leading to the second floor bathroom. This door is contemporary.

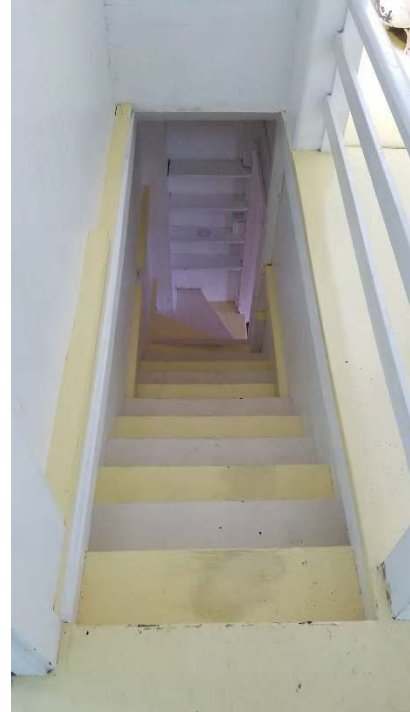
The interior stair, viewed from the second floor landing. The painted wood stair is very significant and probably original to construction.

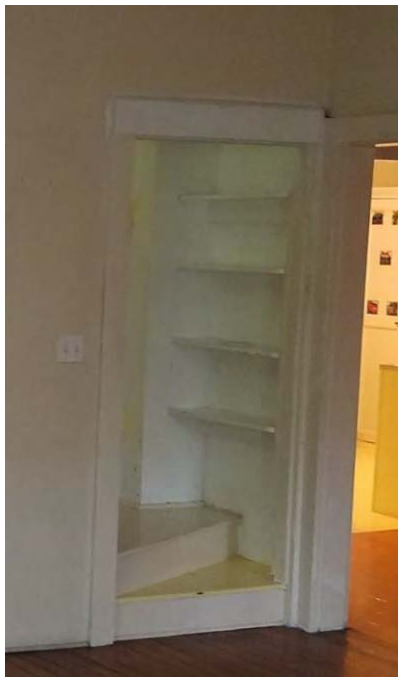
The interior stair as viewed from the Living Room. The winder treads can be seen, as well as the painted wood shelving.

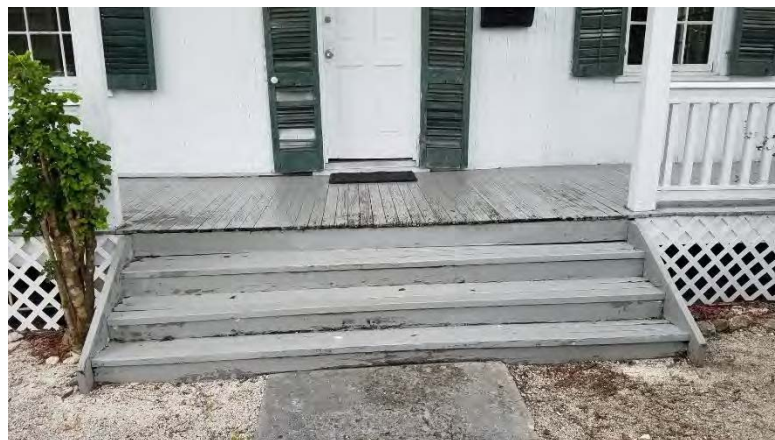
The painted wood main stair leading from grade to the front porch.

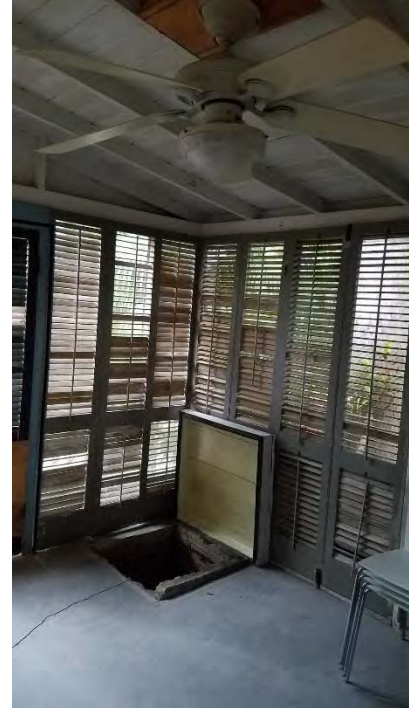
General view of the covered porch at the NW corner of the house. The porch is built atop the concrete cistern cover.

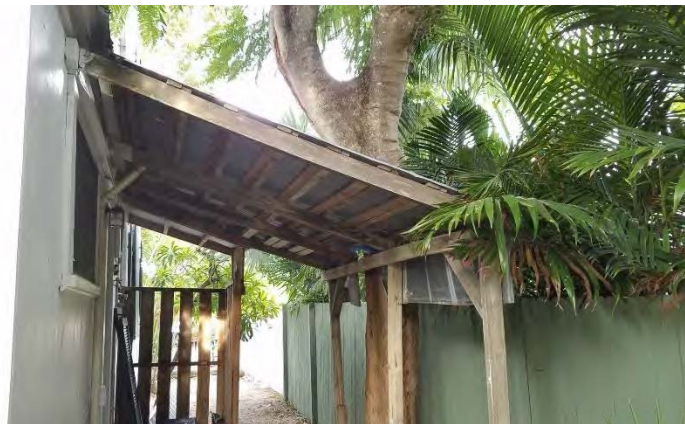
The side porch at the south side of the house covers a utility area used for a laundry, outdoor shower, a stone laundry sink and storage.

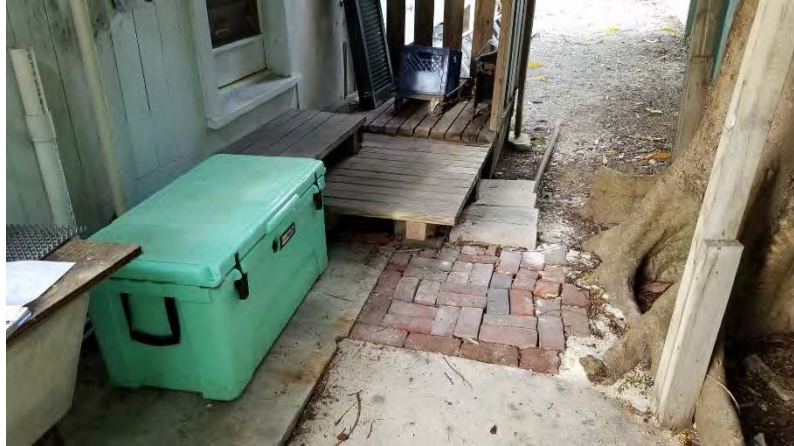
The south porch is deteriorated and probably does not date to the period of significance. Consideration should be given to removing the porch. If the porch is retained, major repairs will be required, including repairs to the columns, paving, roof and decking. Foundations will also have to be installed at the columns.

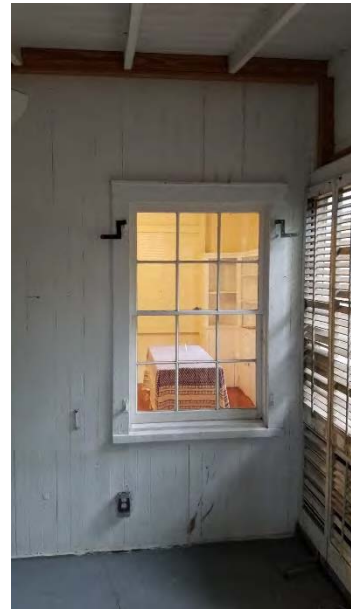
The south wall of the cistern porch. A window leads to the central room. This was once an exterior wall of the house.

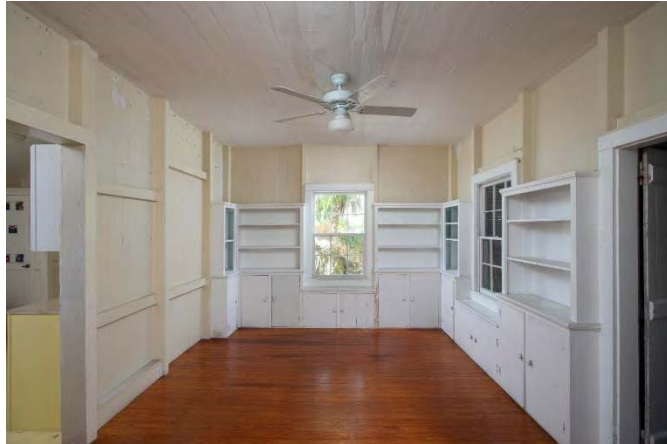
The center rear room features two walls of built-in shelving. All of the finishes are likely original to construction, or shortly after.

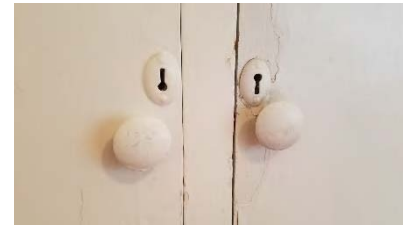
Detail photo of the locks and handles of the cabinets in the center rear room. According to records, Bishop had these cabinets installed.

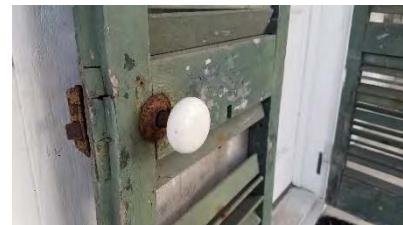
Detail photo of the white ceramic knobs and lockset on the louvers at the main entry door.

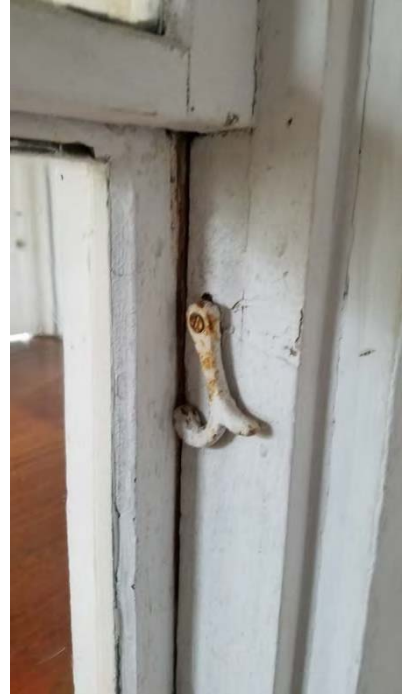
This piece of hardware holds the single hung windows in an open position. It is found on virtually all of the windows.

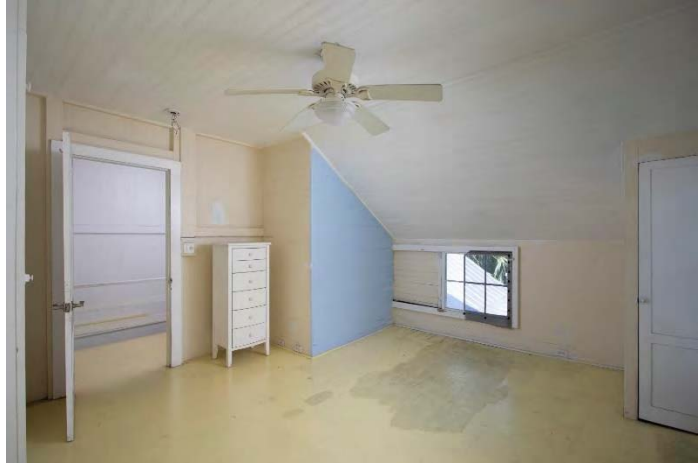
This photo of the north bedroom at the second floor shows the general features of the interior: painted wood floors, walls and ceilings, with flat 1x4 or quarter round trim.

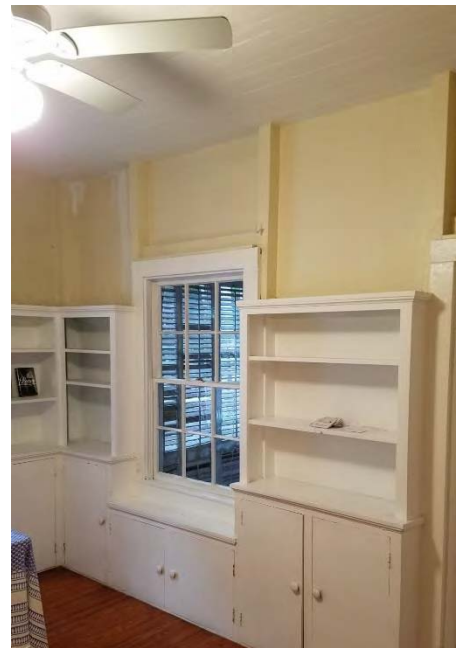
An area of built-in shelving at the center rear room. The shelving and cabinets are simple face frame units. Elizabeth Bishop likely had these cabinets installed.

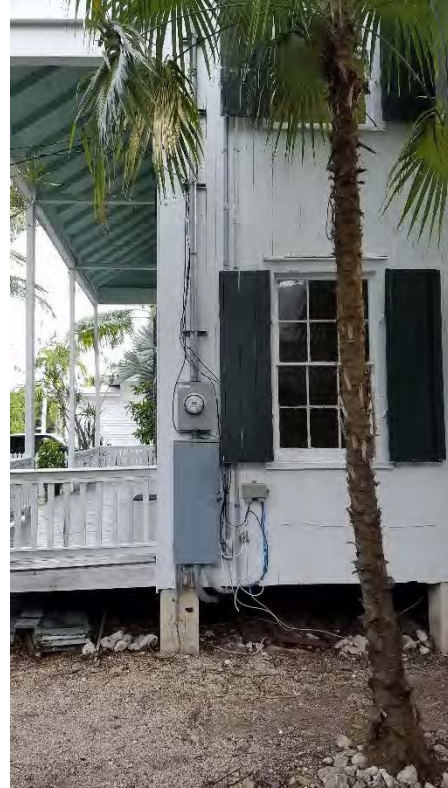
The meter, panel and weatherhead are located at the NE corner of the building. The electrical system has been recently replaced.

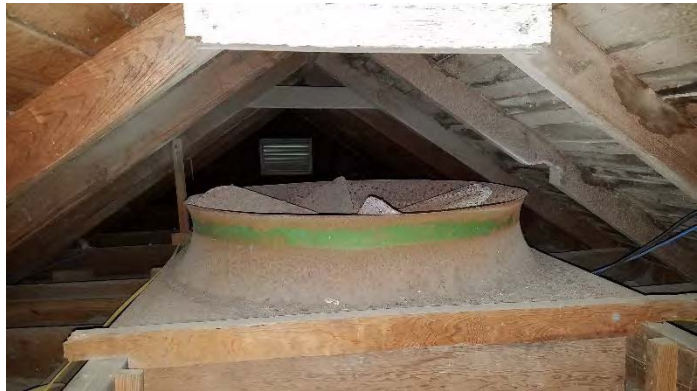
The whole-house fan as seen from the attic. The unit is functional, but very worn. It probably dates from the early 20<sup>th</sup> century.

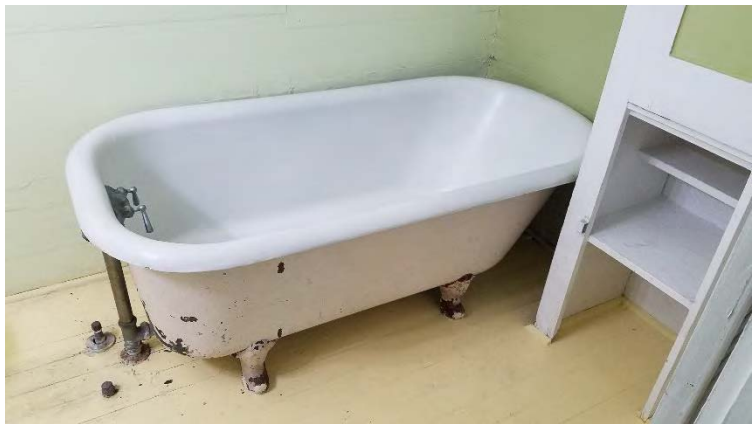
The second floor bathtub is significant and probably dates to the period of significance.

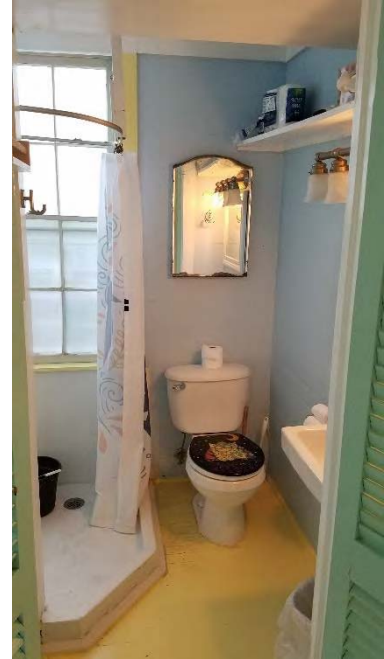
The first floor bathroom. This bathroom was probably installed in the late 20<sup>th</sup> century and is not significant.

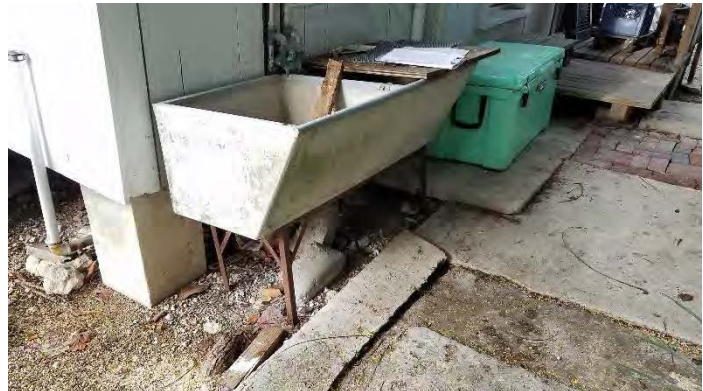
The cast stone laundry sink at the south side of the house. This sink probably dates to the early 20<sup>th</sup> century.
