SURVEY DRAWINGS

ELIZABETH BISHOP HOUSE
HISTORIC STRUCTURES REPORT
624 WHITE STREET - KEY WEST FLORIDA
KEY WEST LITERARY SEMINAR

EXISTING STRUCTURAL CONDITIONS EVALUATION CRITERIA

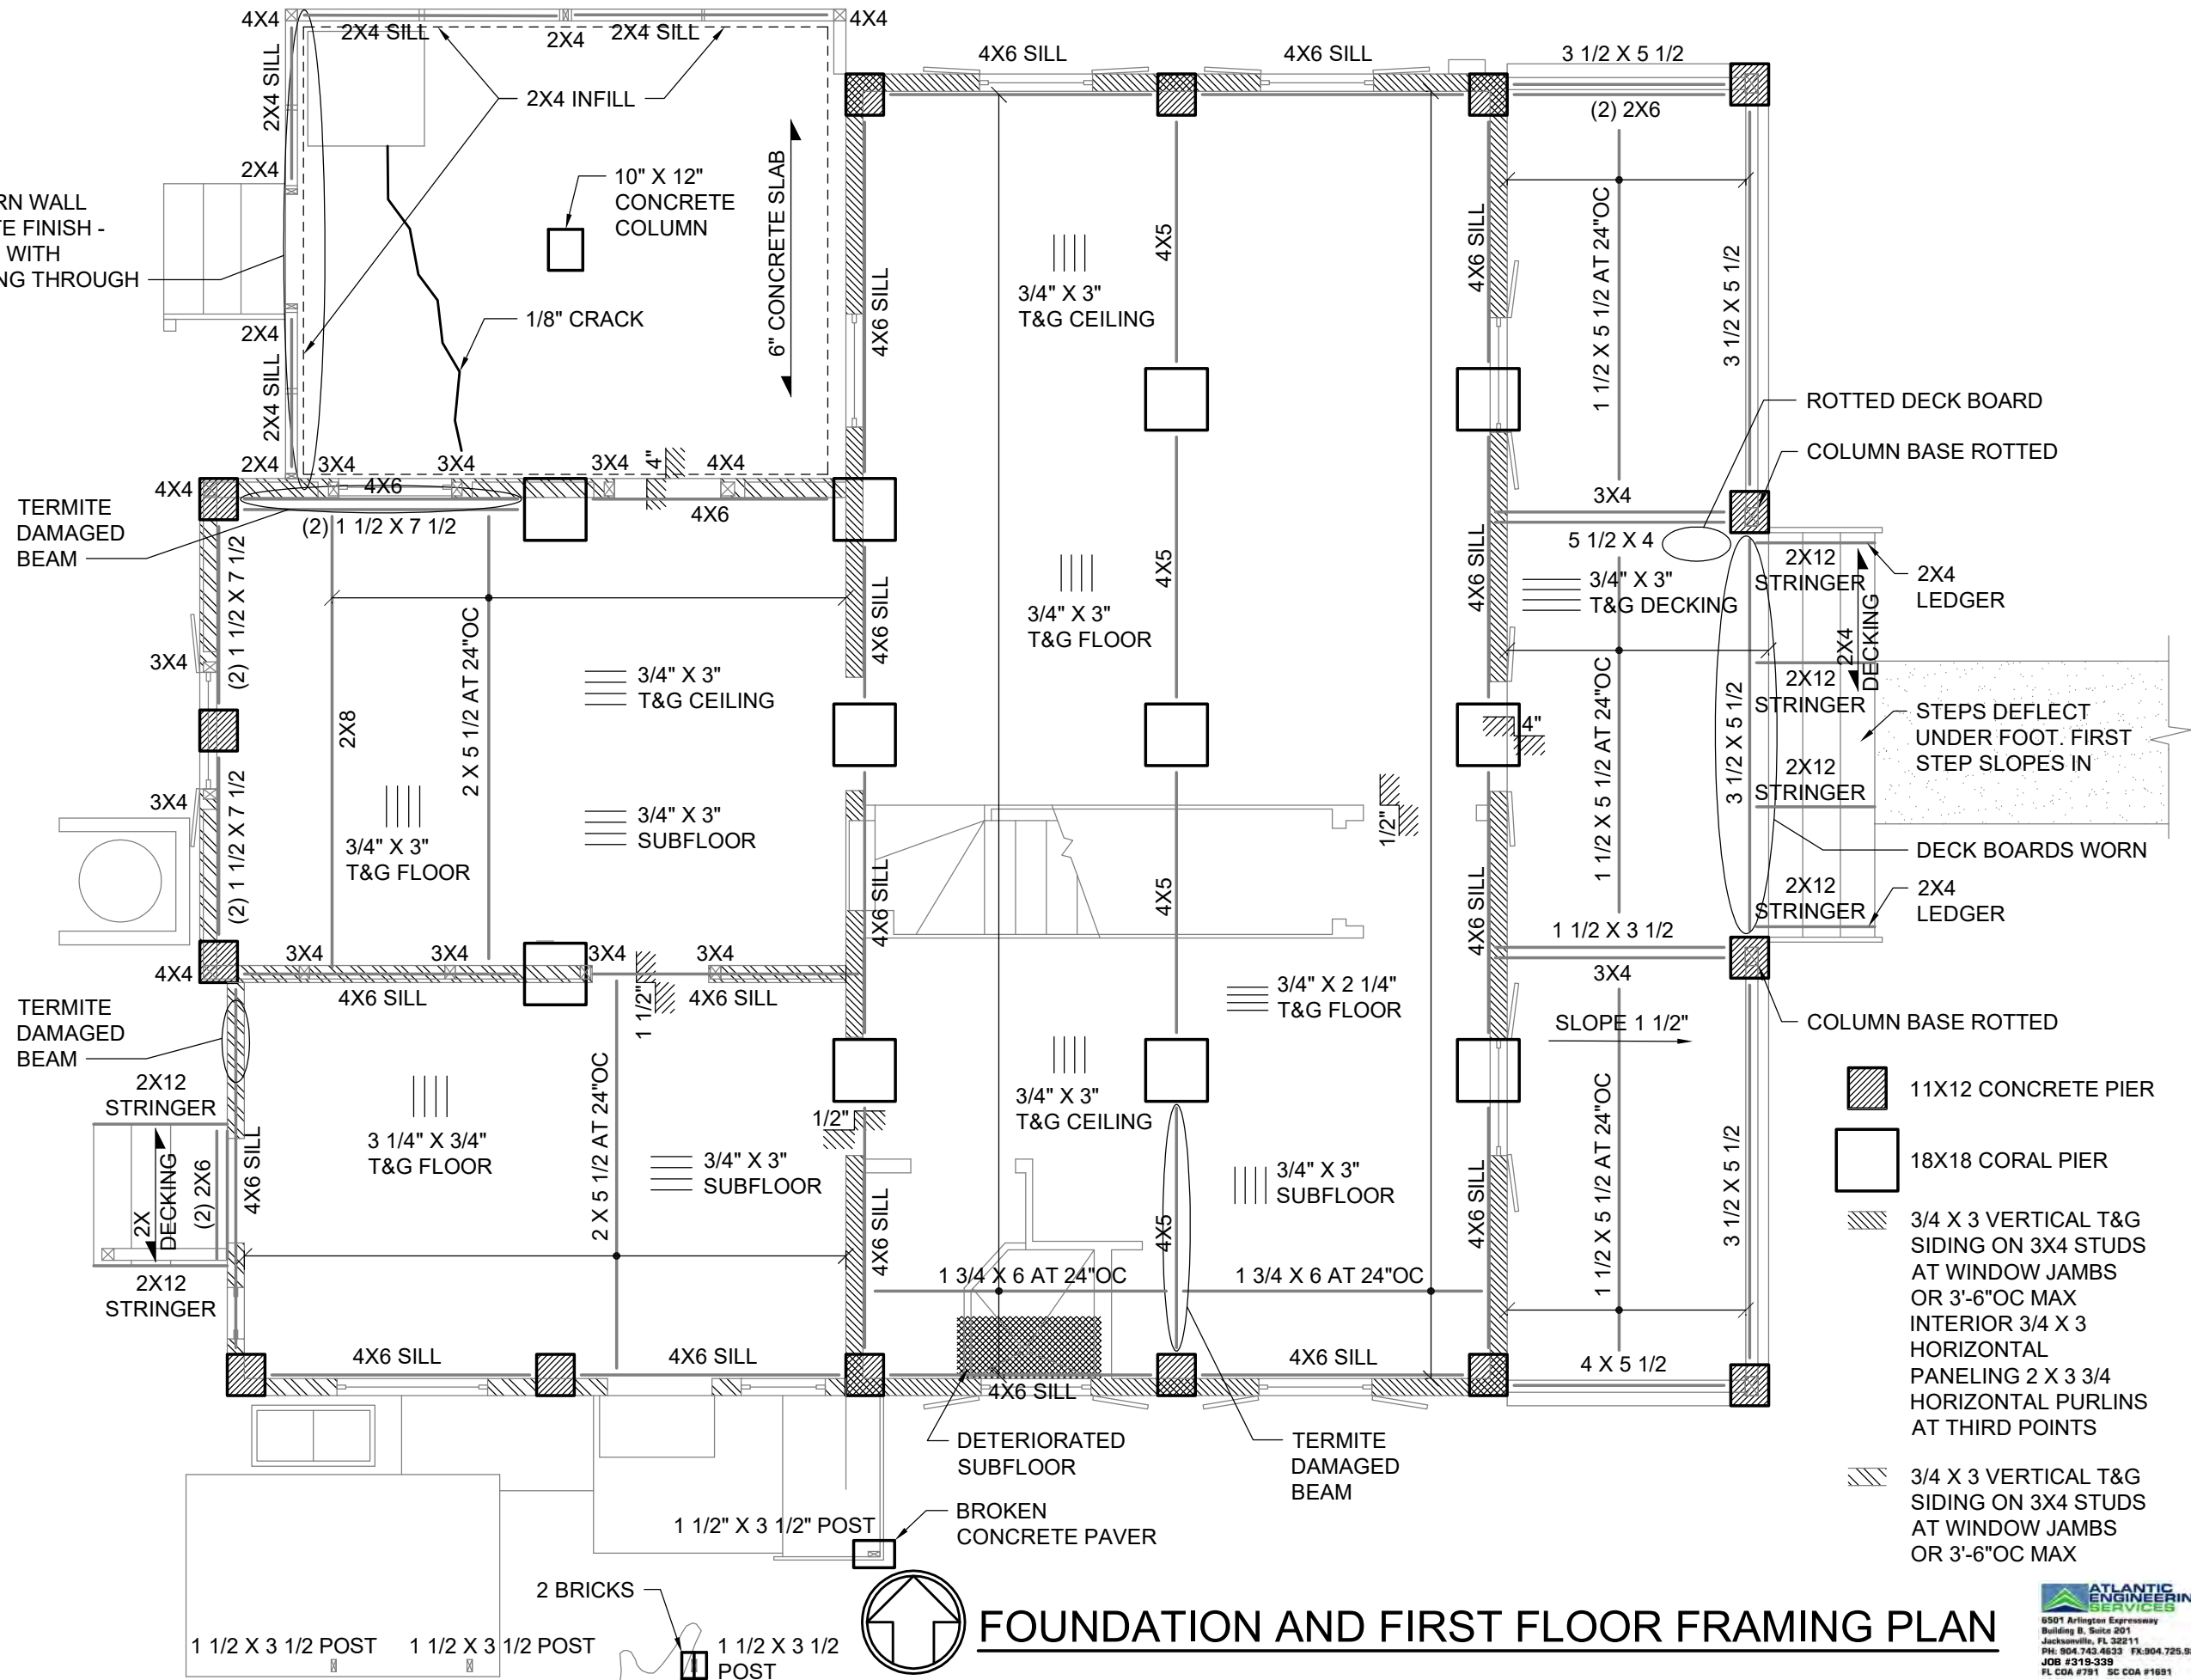
S1.1

BASE OF CISTERN WALL
POOL CONCRETE FINISH -
HONEYCOMBED WITH
ROOTS GROWING THROUGH

- 5. Structural work:** Structural upgrades, including repair of porch columns and beams, foundation piers, cistern cap, floor joists, front porch stairs. Additionally, the building's sill beams should be structurally attached to the existing foundation piers. See structural conditions report for more

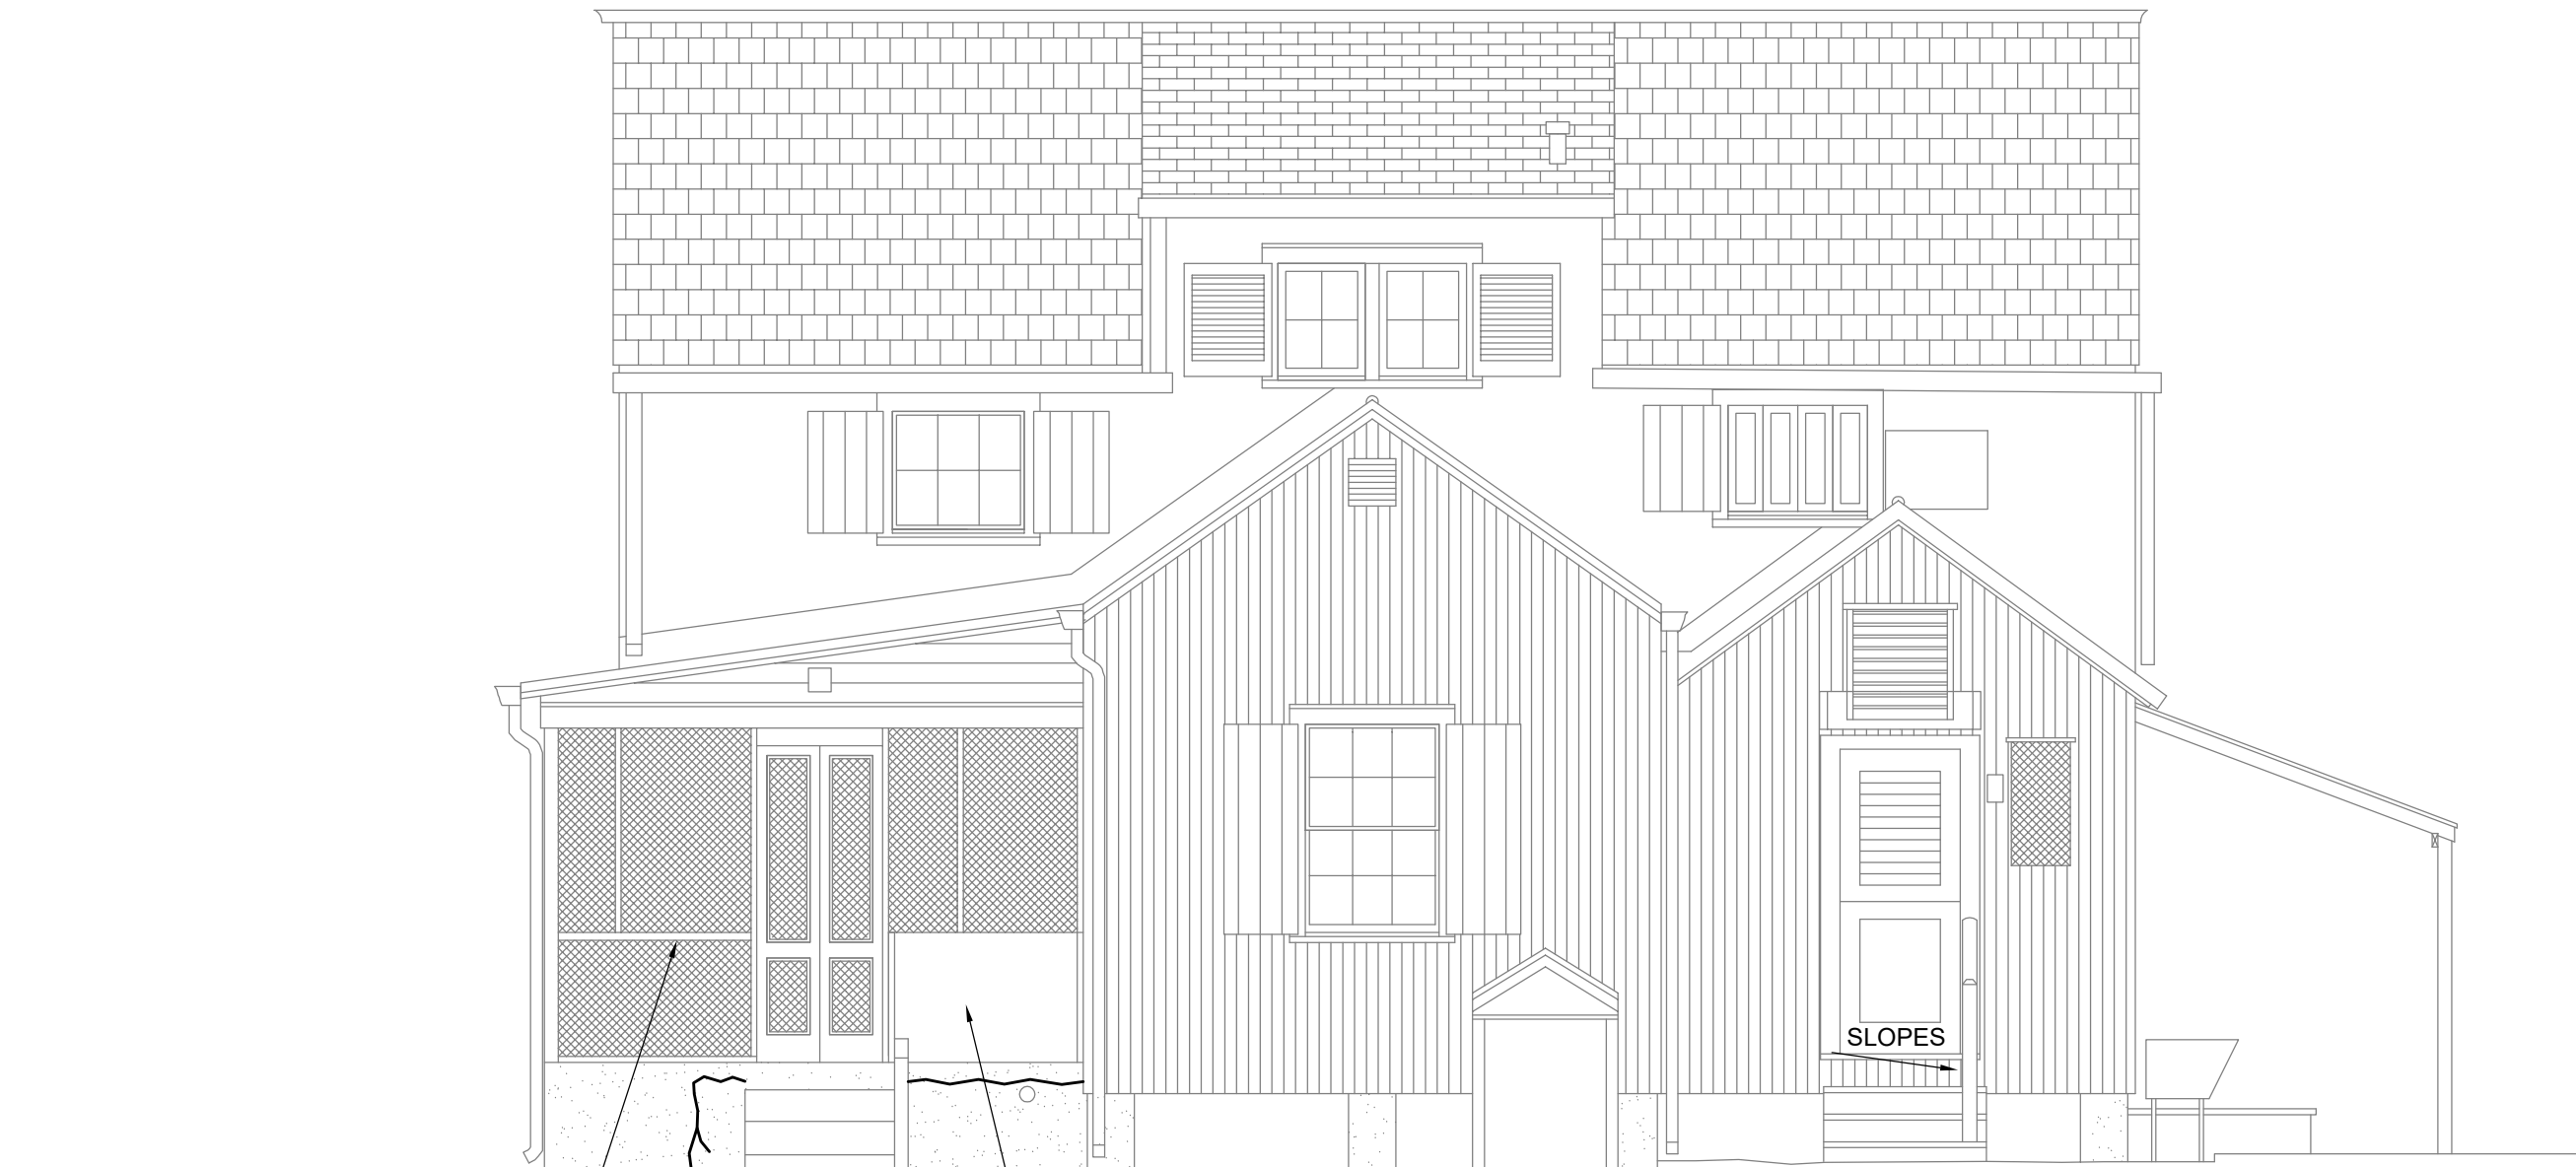
S3.3

DETERIORATED SILL CRACK PLYWOOD DETERIORATED

SLOPES

- 2. Exterior Siding Repair:** Repair deteriorated exterior siding as required to make the building watertight, taking care to match the existing dimension and species of the original vertical wood siding. Stagger the construction joints to blend the repair. Prior to commencing work, a written report of findings and proposed methods of repair should be submitted to the architects for review and modifications as required for compliance with accepted preservation standards.

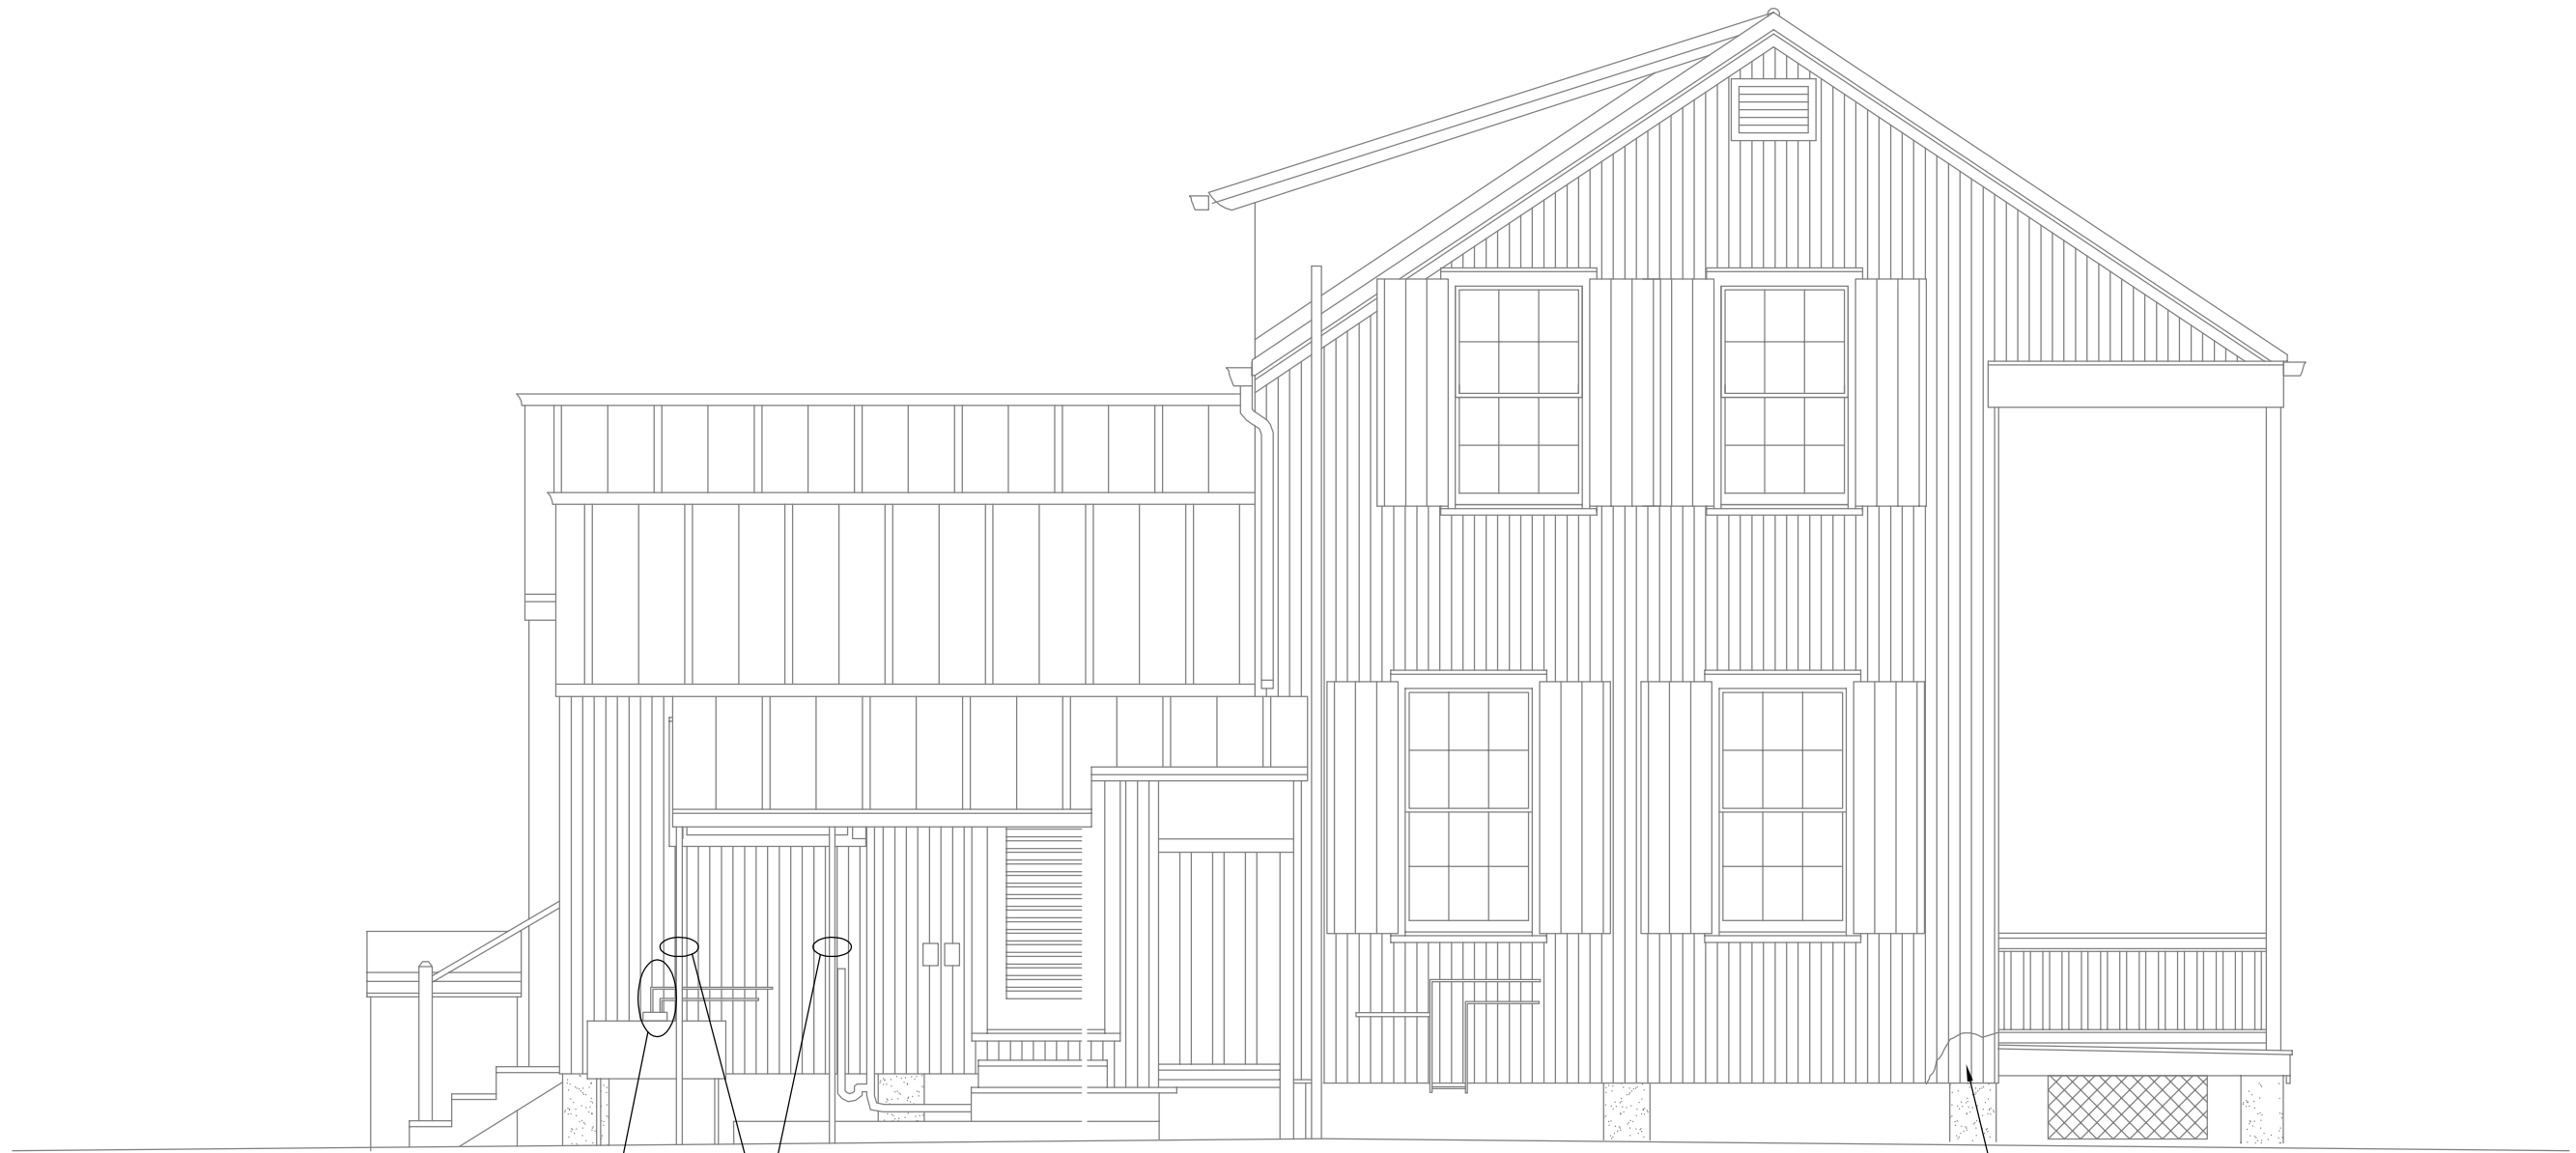
S3.4

DETERIORATED
SIDING

COLUMN NOT
PLUMB

DAMAGED
WOOD SIDING
