Right-Energy Review Notes

This document includes the results of limited testing and verification of the Rightsoft software submitted as a simulation tool for demonstrating compliance with Section 405 of the 2014 FL Building Code, Energy Conservation. The testing was limited to some of the basic requirements due to time constraints and did not fully cover all aspects of the 2014 FL Building Code or the TAM.

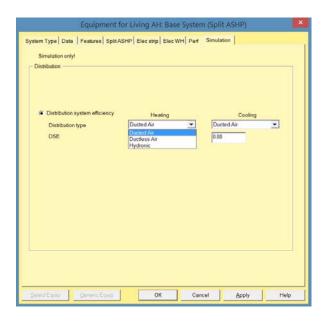
- What duct leakage is being using for the code calculation and can one enter non-default duct leakage values (Qn_{out} or CFM25)? Equipment Distribution screen only shows what appear to be FEC Table R405.5.2(2) default leakage options. Also, how are untested ducts in unconditioned space handled?

- The Duct Loads for Living Attic screen capture that the Results section at the bottom of the screen shows "0" heat loss, sensible gain and latent gain—it's not clear how to get non-zero values in the Results section.

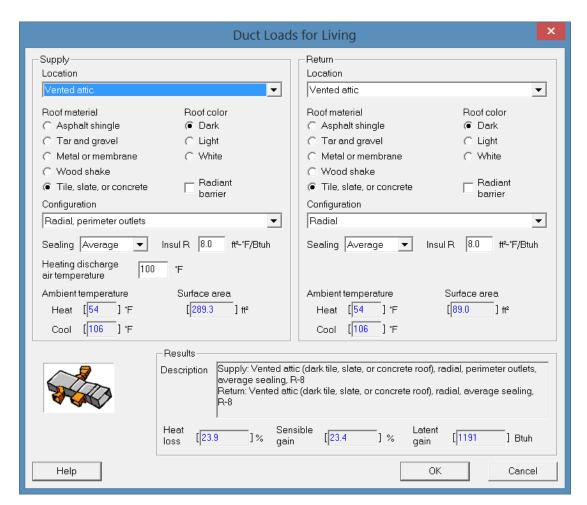
- 1. Equipment changes affected Summary e-Ratios but did not affect Form 405 e-Ratios.
- In test #4 above, changing from ducted to ductless air distribution did not change either the Summary of Form 405 e-Ratio; double check project, but appears to be vented attic with ducts in attic so would expect a difference here.
