RE: Test results for wind loading of wood structural panels as referenced in Section 1609.1.2 of the 2007 Florida Building Code, Building.

This letter is being provided to summarize the results of the structural wind load testing which was recently performed by Architectural Testing, Inc. on OSB and CDX plywood sheathing at the Architectural Testing, Inc. test facility in Tampa, Florida. Included with this letter is Appendix A which includes a table containing details of each test specimen and the results they achieved.

Appendix B

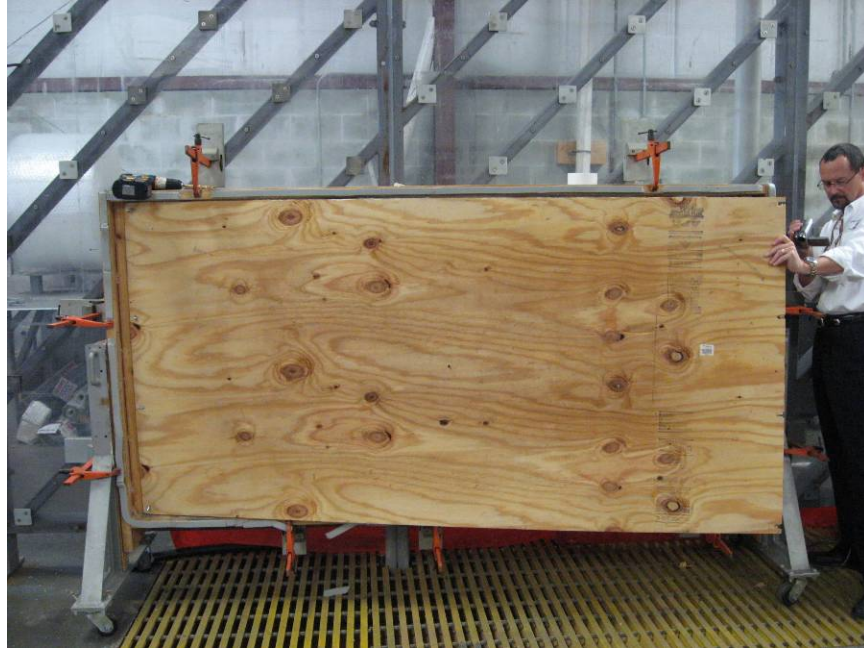
**Photo No. 1**  
**Specimen # 1**  
**1/2" CDX plywood with 16" on center spacing;**  
**test specimen after structural loading**

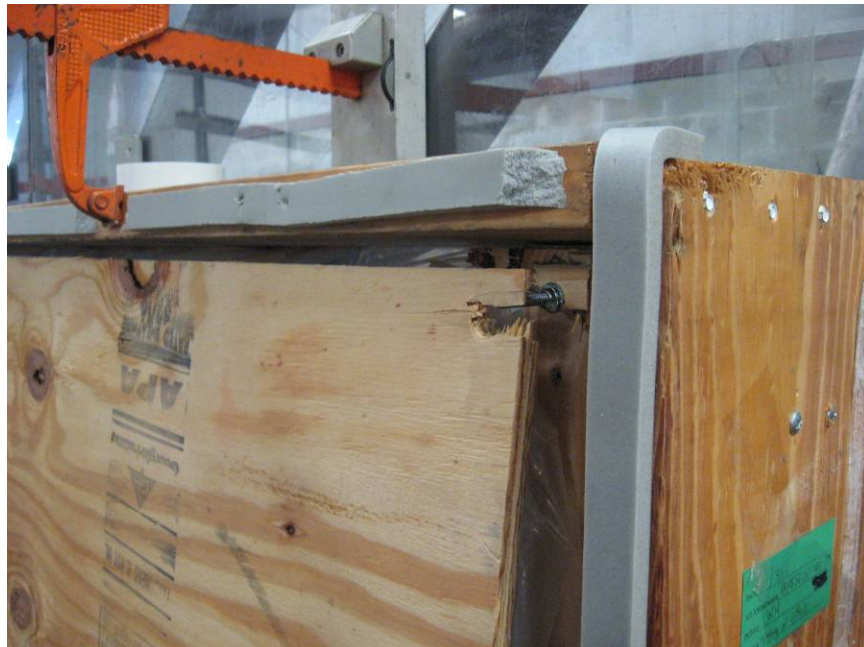
**Photo No. 2**  
**Specimen # 1**  
**Failure on right side at 33.2psf**

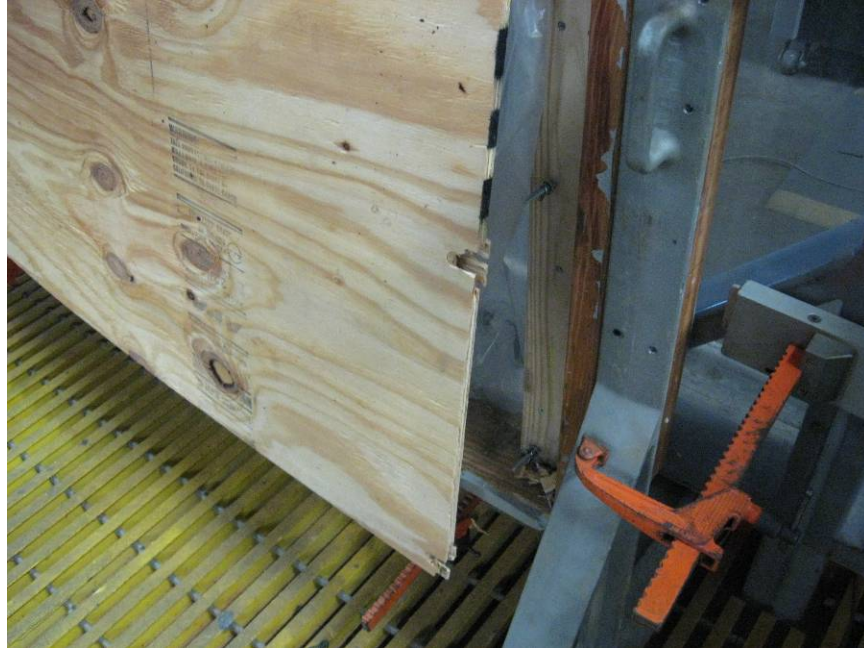
**Photo No. 3  
Specimen # 1  
Failure on right side at 33.2psf**

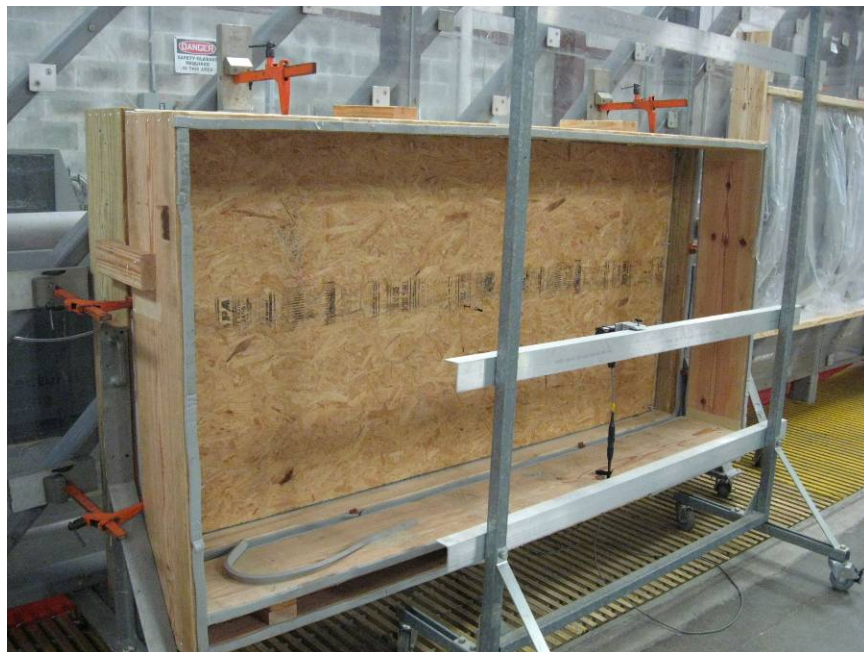
**Photo No. 4  
Specimen # 2  
7/16" OSB with 16" on center spacing**

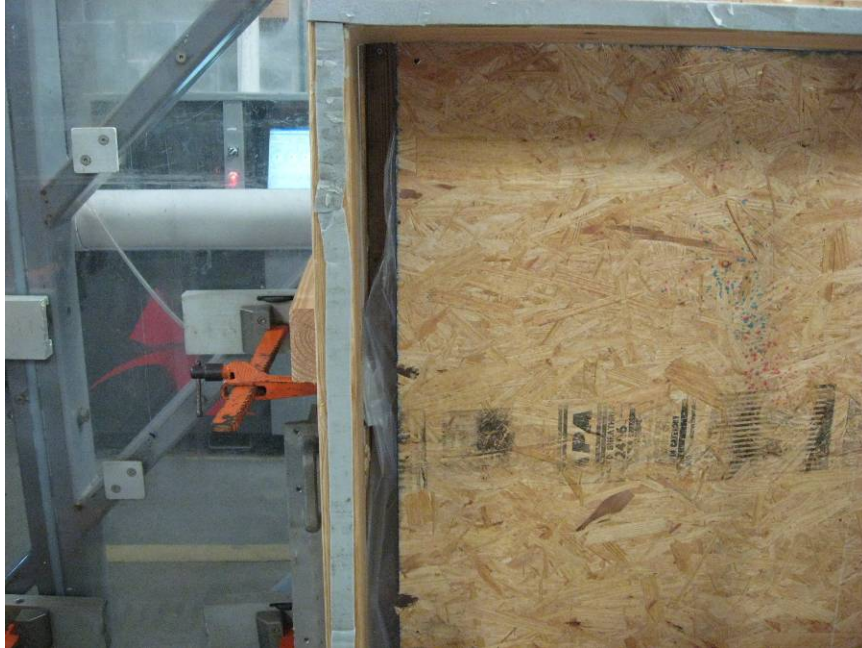
**Photo No. 5  
Specimen # 2  
Failure on left side at 30.0psf**

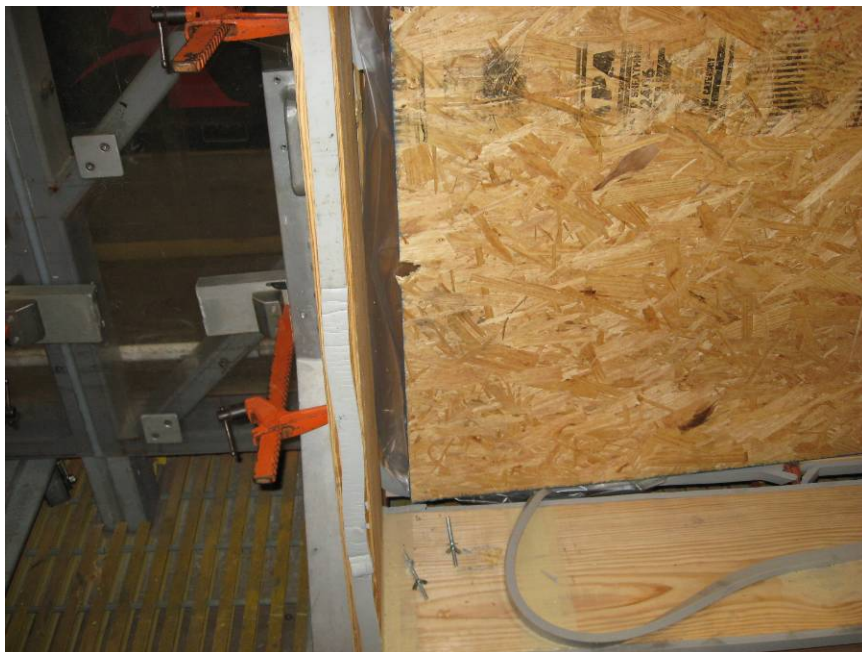
**Photo No. 6  
Specimen # 2  
The two middle fasteners pulled through the plywood transferring point loads to the two end fasteners causing them to pull away from the 2x4 substrate and split the host wood bucking**

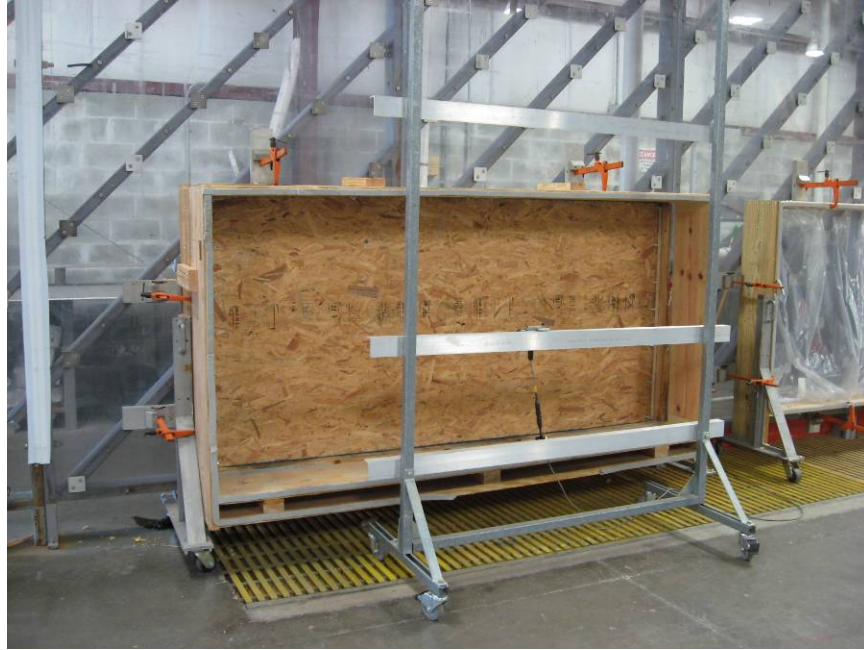
**Photo No. 7**  
**Specimen # 3**  
**7/16" OSB with 8" on center spacing**

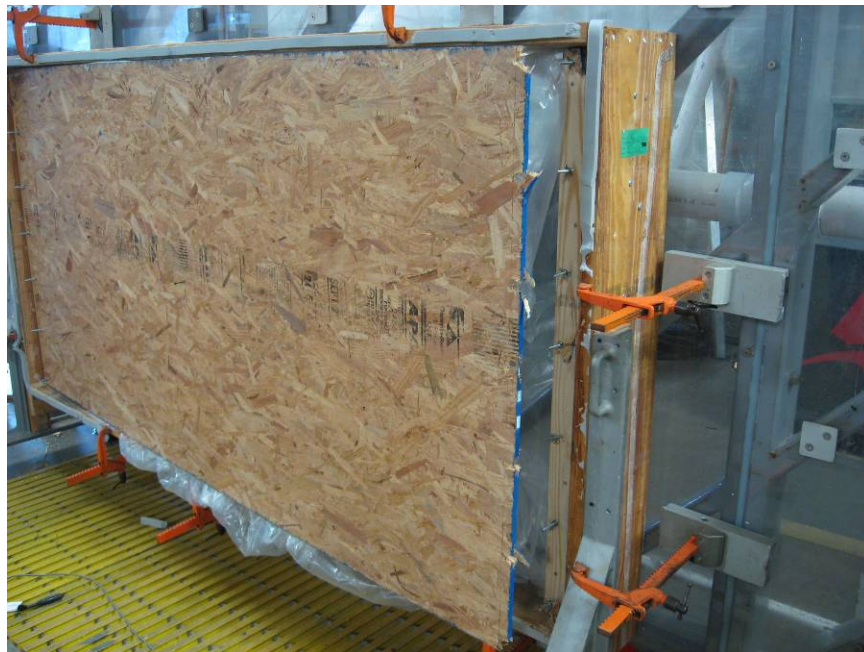
**Photo No. 8**  
**Specimen # 3**  
**Failure on right side at 52.6psf**
