EC&M

POOL SHOCK PERIL RESURFACES

Push for low-voltage lighting and more careful inspection/maintenance follows electrocutions, shocking incidents

The Case of the Improperly Terminated Motor

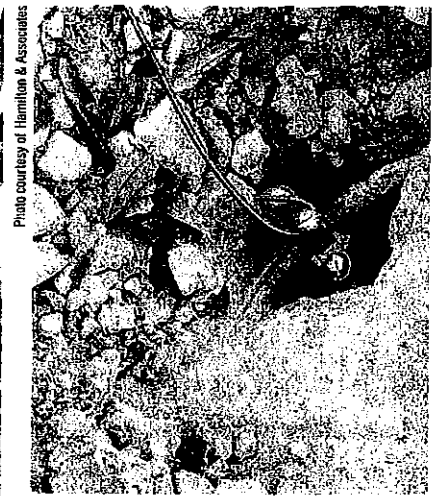
Photo 7. This photo shows an improper connection of the bonding ring to the pool's structural steel. Plated steel screws, even in listed devices, generally will not last in a corrosive pool environment.
