A. Baskaran,<sup>1</sup> S. Molleti,<sup>2</sup> and D. Roodvoets<sup>3</sup>

## Understanding Low-Sloped Roofs Under Hurricane Charley From Field to Practice

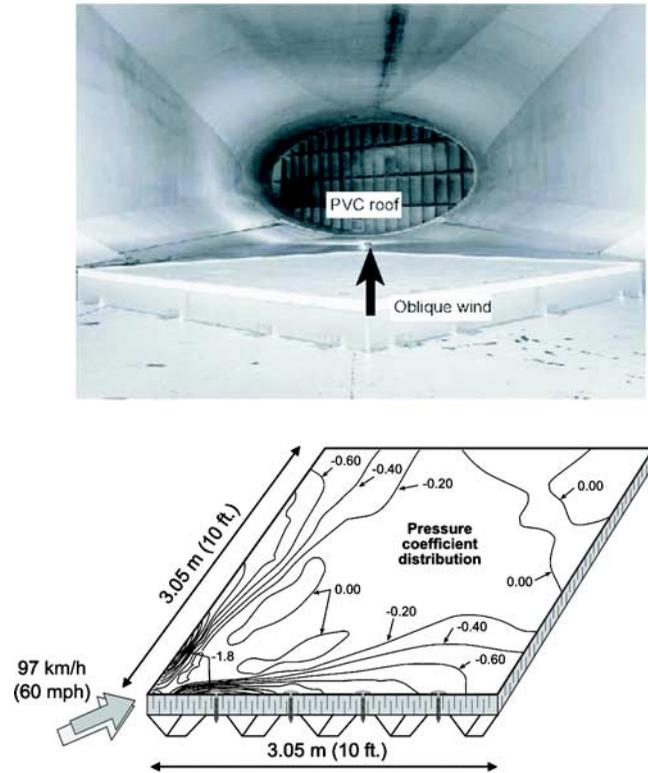
FIG. 2—Wind tunnel model and wind-induced pressure distribution over a roof assembly [6].

As mentioned before, wind pressure distribution varies spatially over a roof and it can have high suction at the corner and perimeter, due to vortex flow and separations. This science is clearly displayed in Fig. 2, which represents pressure variation on a building roof taken from a wind tunnel study at National Research Council of Canada (NRC) [6]. The wind tunnel tests were carried out in the 30-ft by 30-ft (9-m by 9-m) NRC wind tunnel. These tests used full-scale roofing components 10-ft by 10-ft (3 by 3-m in size) having different heights. For wind directions perpendicular to a building face (normal wind) and at 45 degrees to a face (oblique wind) measurements were made in smooth wind and turbulent wind conditions for five wind speeds, ranging from 30 to 60 mph (13.4-m/s to 26.8-m/s). As shown in Fig. 2, a PVC (polyvinyl chloride) roofing system was tested with 81 pressure taps fitted on the single-ply membrane to measure the unsteady pressure loads on the roof [6]. In total, 30 configurations were tested in this wind tunnel study. Wind-induced corner suctions are evident from Fig. 2 with maximum measured mean pressure coefficient ( $C_p$ ) of 1.8 on corners. Pressure coefficients ( $C_p$ ) are the nondimensional ratios of wind-induced pressures on a building to the dynamic pressure (velocity pressure) of the wind at the reference height, which is the roof eave height.

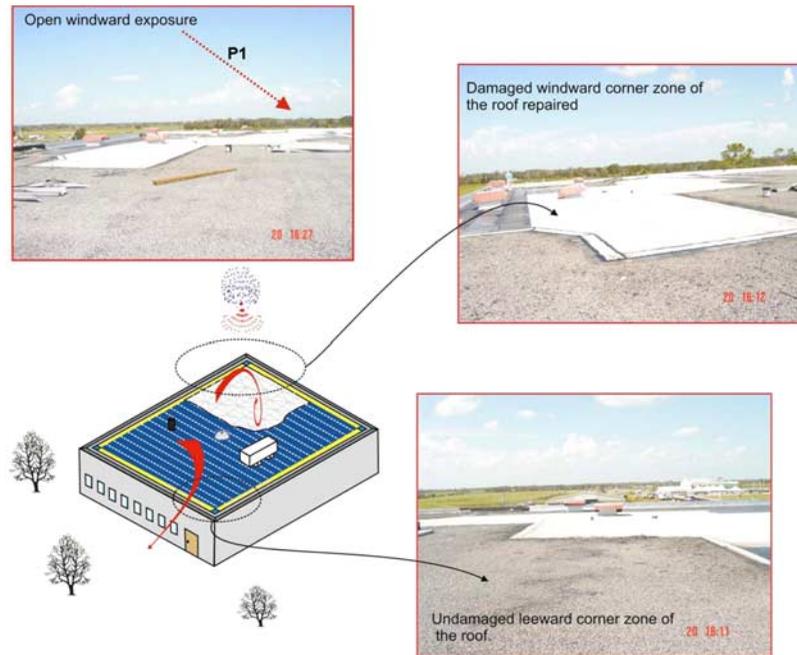
*Case Study 1: Failure Investigation of a School Roof*—Figure 3 shows the failure investigation of a school roof in which the above-discussed scientific data have been correlated to the field observation. All the photographs shown in Fig. 3 are taken from the top of the roof under investigation. P1 shows the

FIG. 3—Roof assembly failure due to high suction caused by cornering wind (not to scale).

prevailing windward exposure condition. According to the American codes standards of practice [7], this can be classified as Exposure C whereas the Canadian building code [8] classifies it as open country exposure. Even though there is variation in the terminologies, both of them define that “open terrain with scattered obstruction having flat open country, grasslands and water surface as the criteria for this exposure condition.”

The building under investigation was a 40-ft (12-m) high concrete-walled gymnasium. It is part of a school used as a shelter during Hurricane Charley, although it was not designated as a shelter. The building is of substantial construction with concrete walls and a lightweight concrete deck. There was only one exterior fire escape door that led to the outside. It was reported as closed during the storm. Primary access was through the corridors of the adjacent building. The entire complex with several roof areas totaled more than 140 000-ft<sup>2</sup> (13 000-m<sup>2</sup>). The damaged roof area section was about 40 000-ft<sup>2</sup> (3700-m<sup>2</sup>) and had a stone surface four-ply BUR (built-up roofing). The membrane was attached to a lightweight concrete deck mechanical fastener. A large section of the gymnasium roof (over 40 % of the membrane) blew off during the storm when about 400 people were inside. This released a large volume of water that spread across most of the school complex. Other than some limited edge metal damage, there was no damage to about 100 000-ft<sup>2</sup> (9300-m<sup>2</sup>) of roof on adjacent parts of the structure. These sections were all BUR membrane roofs appearing to be of the same construction as the sections that were blown off.

The gymnasium roof structure did not appear to fail because of pressurization below the deck; the cause appears to have been purely suction force. The school roof was the highest point in several miles, so it took the brunt of the hurricane’s force. The low 2-ft (0.7-m) parapet in the upwind corner did not help to reduce the maximum uplift (also refer to discussion of Figs. 4 and 5). The roof failure pattern was typical of the uplift forces that would be present in a cornering wind with an L-shaped area. As temporary repairs had been made, it was not possible to determine the sequence of failure. It is interesting to correlate the failure shape with the wind pressure distribution diagram of Fig. 2 where the roof corner experiences high suction. This was the similar phenomenon in the case of the school roof, where those high suction pressures on the corner of the roof caused the failure of the roof.

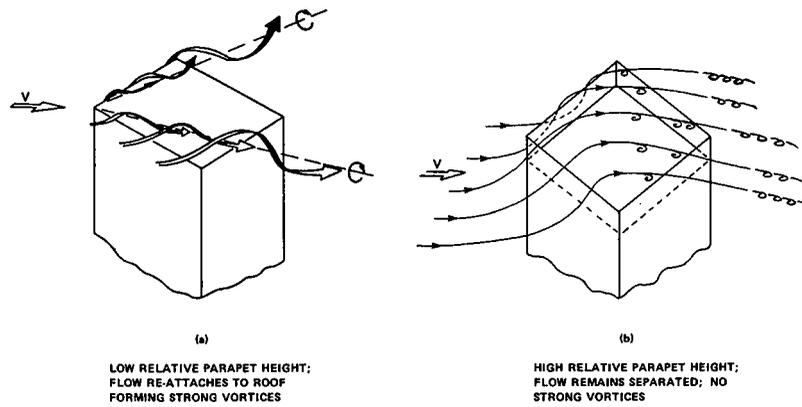
FIG. 4—Effect of parapet height on wind flow over roofs [19].

wind studies are being carried out to quantify the influence of a parapet on roof wind loads [9–14]. Figure 4 shows a typical wind flow over roofs with parapet. According to Kind et al. [15–19], increased parapet height generally resulted in more favorable pressure distributions. That is, maximum suctions were reduced and suction peaks were broadened so that pressures are less nonuniform and monotonic, there was no “worst” nonzero parapet height. Parapets are also effective in preventing stone blow-off from the buildings having ballasted roof systems. However, limitations do exist regarding the effectiveness of the parapet height in providing resistance to the phenomenon of stone blow-off [15,20]. Field observation on a gravel roof with a low parapet confirms these scientific theories (Fig. 5).

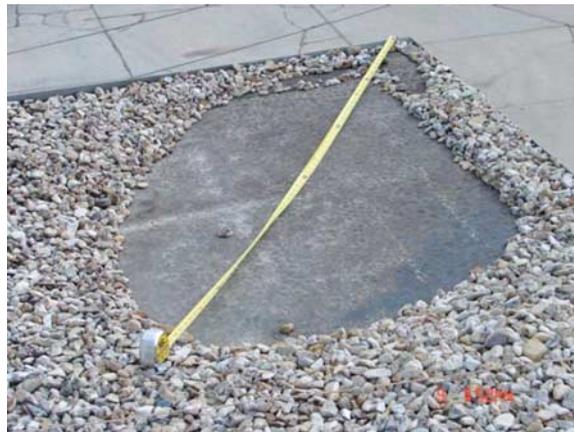
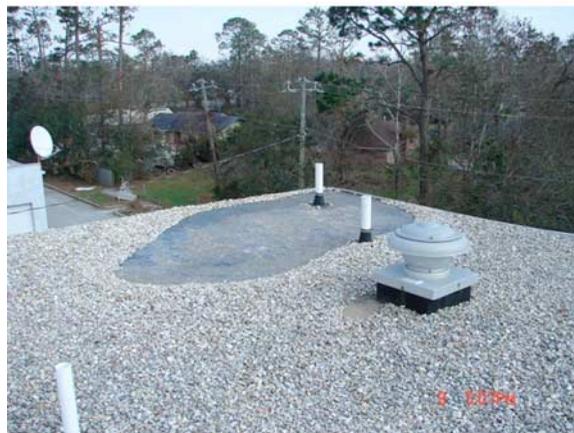
FIG. 5—Wind vortex formation on gravel roofs due to low parapet.

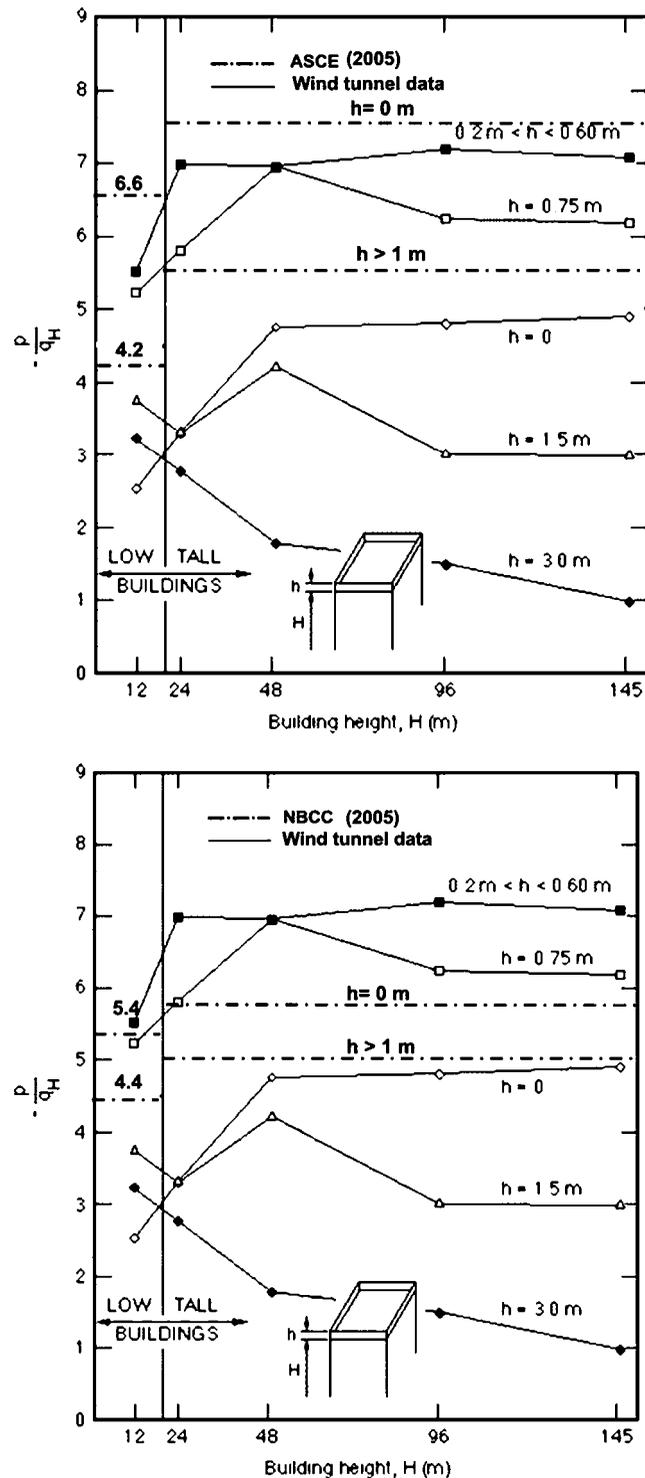
- At corner regions (Fig. 6), low parapets tend to increase both the mean and peak pressure coefficients. In fact, with winds approaching a roof obliquely (at 45°), 1 to 1.2-ft (0.3 to 0.4-m) high parapets can roughly double the pressure coefficients at the corner regions of a roof of both low and tall buildings. Parapets of 3-ft (1-m) or higher, however, reduce the pressure coefficients of roof corners of tall buildings significantly, but only marginally on low buildings.

FIG. 6—Relationship of code specifications (NBCC [8] and ASCE [7]) to measured data [9] regarding pressure coefficients on roof corners with parapet.

Corner wind can cause high wind suction and the use of a high parapet can mitigate those high suction. Wind flow aerodynamics over a roof area has been modified based on the presence of a parapet and its height. These modifications affect the wind-induced suction on the roof assembly. Measured data show that high parapets on a tall building show a beneficial effect in suction reduction. Therefore, in hurricane-prone regions use of parapets over 3-ft (1-m) high are recommended.

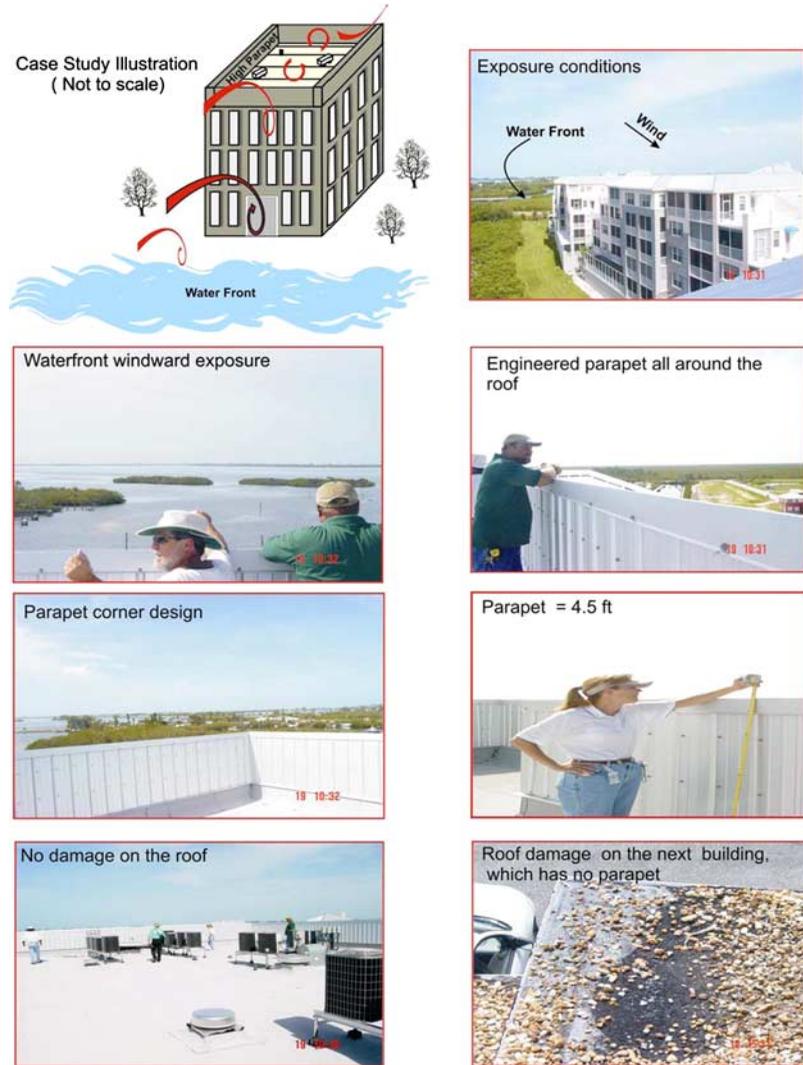
*Case Study 2: Success Story of Condominium Building*—Figure 7 shows the beneficial effect of a parapet on the wind uplift resistance of a roof assembly. The investigated building was a six-story condominium building, stucco wall construction with a poured concrete roof deck. Granule surface BUR system was over mopped-in-place with perlite insulation. Roof was approximately 37 000 ft<sup>2</sup> (3400 m<sup>2</sup>). The perimetric parapets were designed well and the field measurements indicated they are about 5-ft (1.5-m) high. Parapet corners are also well designed and capped with a single piece of metal coping. Wind-related damages were limited to approximately 5 % of the wall/parapet cap and the underside of the soffit. No damages were observed to the roof. As shown in the photograph of Fig. 7, the building is relatively new and exposed to waterfront exposure (“Exposure C”—ASCE 7 [7], “Open terrain”—NBCC [8]). This exposure condition is considered to be the most severe exposure condition. As illustrated in Fig. 6, due to high perimetric parapet configuration, the wind suctions on the rooftop of the condominium might have reduced, which possibly could have caused fewer damages to the roof assembly. Also there were many individual HVAC units that were mounted on the condominium rooftop stands and all of these were in excellent condition. No movement was apparent for any of the HVAC units. However, the surrounding buildings in the neighborhood of this condominium, which had no parapets, experienced severe damages. One such building with gravel blow-off from the roof is also shown in Fig. 7. This gravel blow-off exposed the membrane to the ultraviolet radiation which may eventually reduce the durability of the roof assembly. Note that the parapet is not the only important factor for the roof assembly to sustain hurricane force uplift. Parapets with sufficient height can influence in reducing the wind-induced loads. It is equally important that other good roofing practices such as attachment of the assembly (i.e., adhesion, cohesion, mechanical attachment, air barrier, etc.) should be adequate to sustain whatever uplift forces it experiences. Failure to do so can blow off the roof whether a sufficient height parapet is present or not.

FIG. 7—Beneficial effect of parapet on the wind uplift resistance of a roof system.

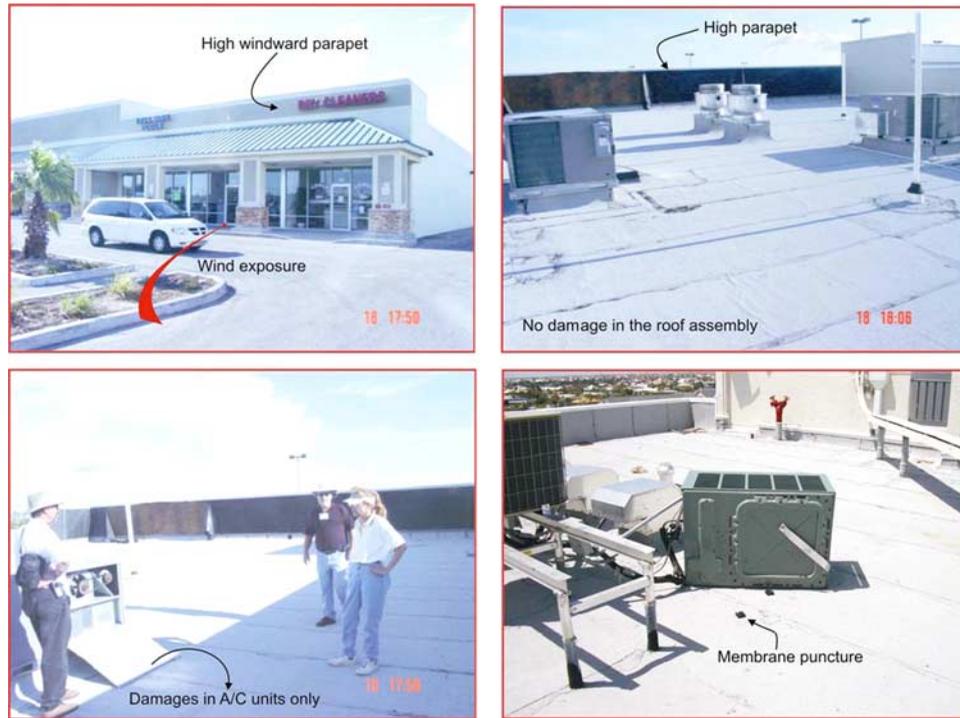
*Case Study 3: Success Story of Commercial Building*—Figure 8 presents a success story of a commercial building roof assembly, which might have survived due to the high parapet. Roof area was approximately 5 000 ft<sup>2</sup> (460 m<sup>2</sup>) with a 5.5-ft (1.8-m) parapet on the storefront side, a 4.5-ft (1.5-m) shared wall on one side, a 3-ft (1-m) parapet on the third side, and a gutter edge along the rear side. Granule surface modified bituminous membrane was installed directly over mechanically attached insulation, which had metal deck as the substrate. No damages were noticed on the roof assembly. However, contrary to Case Study 2, there were several blow-offs of HVAC (heating ventilation and air conditioning) panels. More severely, some of the air-handling units lifted from their base due to the lack of proper attachment. It has also been observed that these units moved in distance from the base as far as the electric wiring allowed. These blow-offs and flip-flop movements caused punctures of the roof membrane and resulted in the failure of the waterproofing capacity of the roof assembly.

FIG. 8—Survived roof assembly due to high parapet and damages caused by the rooftop equipments.

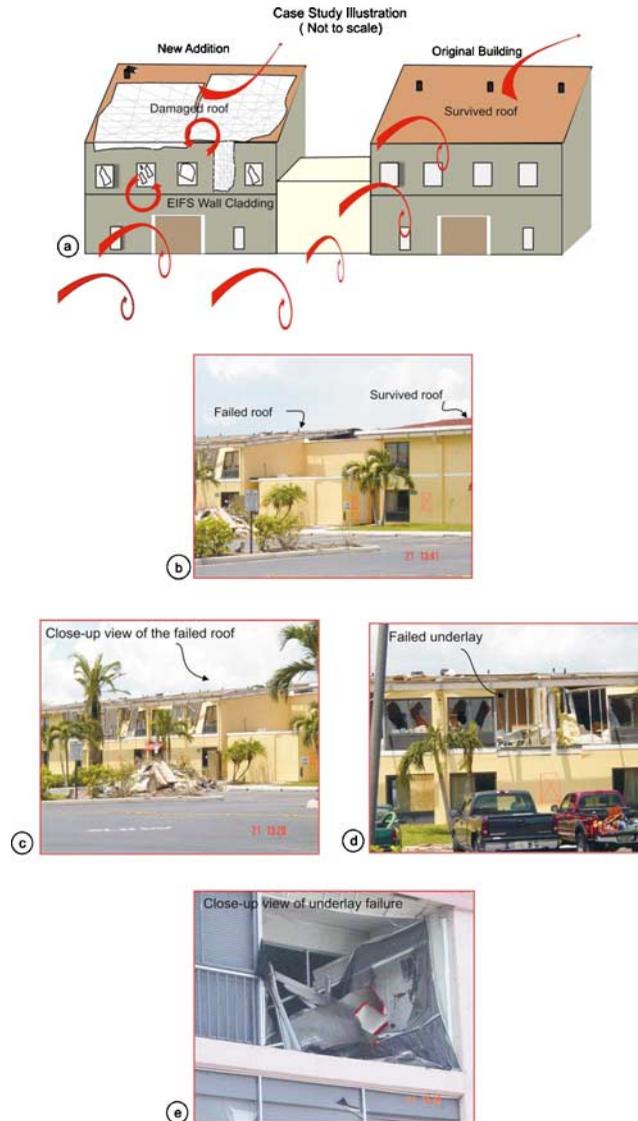
FIG. 9—(a–e) Roofing assembly failure due to sudden build-up in the internal pressure.

*Case Study 4: Failure Investigation of a Multi-Occupancy Building*—As shown in Fig. 9, the failed

roof assembly belongs to a multi-occupancy building. The building is comprised of two sections, the section on the right was an old construction on which the roof survived. An addition to this section on the left was a relatively new construction on which the roof assembly completely failed. The walls of this new addition were constructed of EIFS (Exterior Insulation and Finish System). Field failure observation indicated poor integration of wall/window interface. In other words, windows were just plastered without any anchorage to the structural support to the walls as part of the whole building envelope system. As a result, the blowing wind on the windward side, as shown in Fig. 9, ripped apart the windows from the EIFS, surged inside the building and increased the internal pressure, which ultimately lifted the entire roof assembly. In contrast, the old construction was of brick cladding and the windows were properly integrated with the building envelope, and as shown in Fig. 9, it was devoid of any damage. This case study is a good illustration of the scientific phenomenon of internal pressure build-up and the severity of the damage it can cause to the roof assembly.

Internal pressure build-up can increase the roof failure probability. Probabilities of window cladding failures are high in hurricane-prone regions and such failures can significantly increase the internal pressure that can lead to roof uplift failures. It is recommended that the designer should allow provisions to account for such failures during the design and the selection of the roofing system. This can be achieved by classifying the building as Category 3 as per NBCC [8] or partially enclosed building as per ASCE 7 [7].
