# **Investigation of the Wind-borne Debris Regions in ASCE 7-22**

## **Interim Report**

Florida Department of Business and Professional Regulation

Engineering School of Sustainable Infrastructure and Environment (ESSIE)

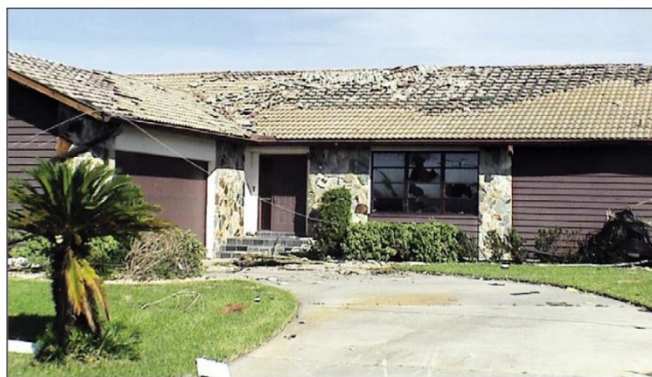
Figure 5. Extensive damage of pre-2001 FBC home. Broken windows caused by wind-borne debris during Hurricane Charley (2004).

Significant damage was frequently observed in areas where clay and concrete tiles were used as roof coverings and in neighborhoods where the building began to fail and wood structural members were released as missiles. Although a number of buildings with mortar-set tiles lost significant number of tiles (Figure 5), many landed a relatively short distance from the building. Figure 6 shows the impact of a roof tile that punctured a Miami-Dade County-approved shutter and broke the window.

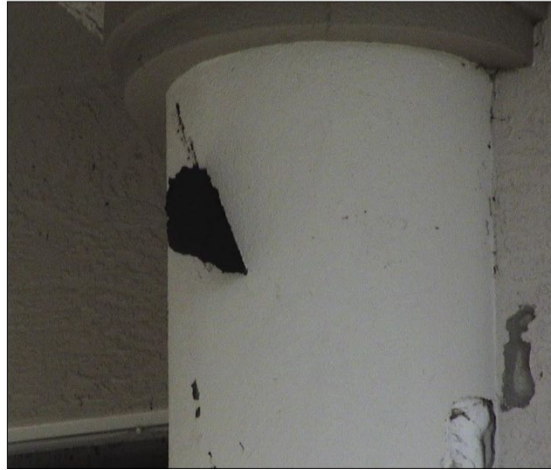
Figure 8. Asphalt shingle on a column in Punta Gorda during Hurricane Charley (2004)

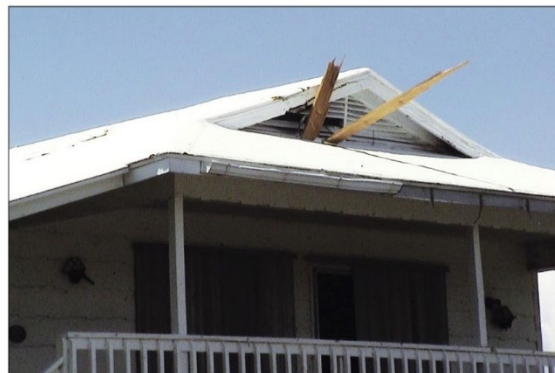
Figure 10. Impact of structural wood in the gable end in Pine Island during Hurricane Charley (2004)

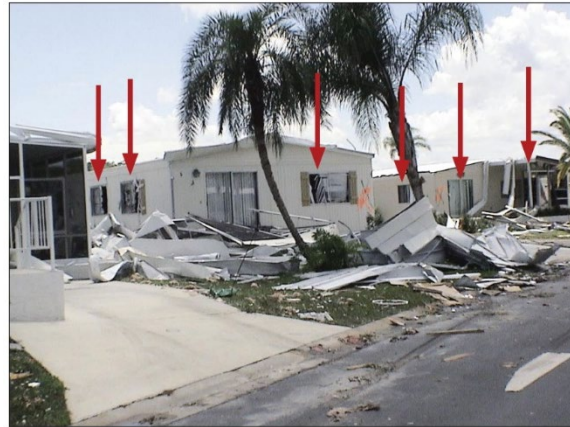
Figure 11. Wind-borne debris damage on windows caused metal roof panel and siding in Port Charlotte during Hurricane Charley (2004).

While the Florida Building Code does not apply directly to manufactured homes, a significant amount of aluminum and sheet metal debris from attached structures that failed and glazing damage was observed even in inland mobile home parks. A manufactured home park observed with homes spaced considerable distances apart appeared to have greater wind-borne debris damage (Figure 11).

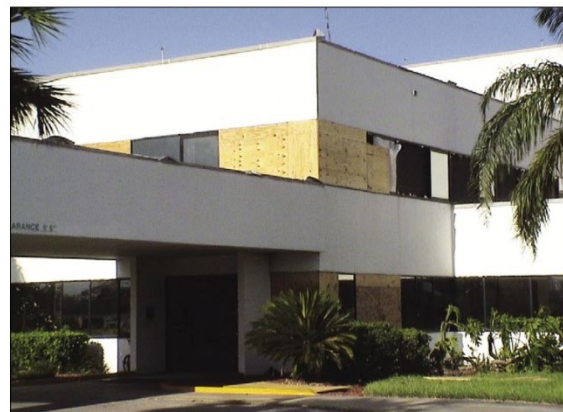
Figure 12. Damage in the windows in a hospital in Arcadia during Hurricane Charley (2004).  
EWS = 110-120 mph.

It was clear, through investigations at a number of hospitals and other buildings with aggregate roof surfacing, that the aggregate could cause damage to windows on the building itself. The damage to windows in the intensive care unit of the hospital in Arcadia (Figure 12) was a prime example of this effect.

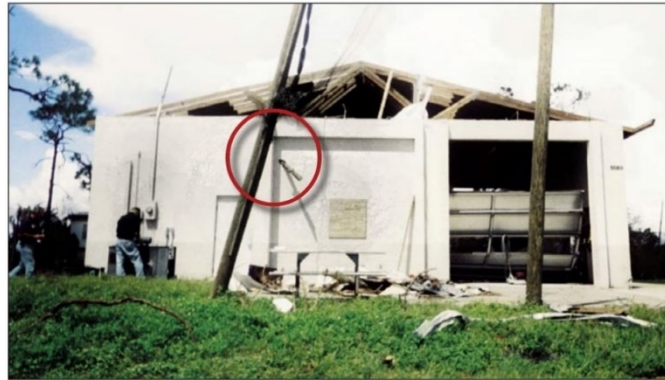
Figure 13. Fire station with a missile (in the red circle) caused by Hurricane Charley (2004), in Punta Gorda.

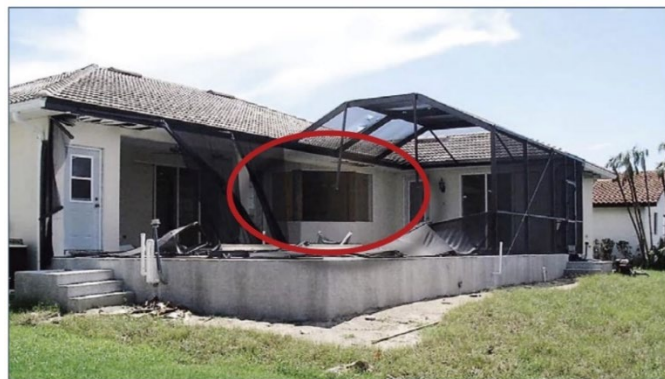
Figure 14. Broken window from debris (in the red circle) caused by Hurricane Charley (2004), in Punta Gorda.

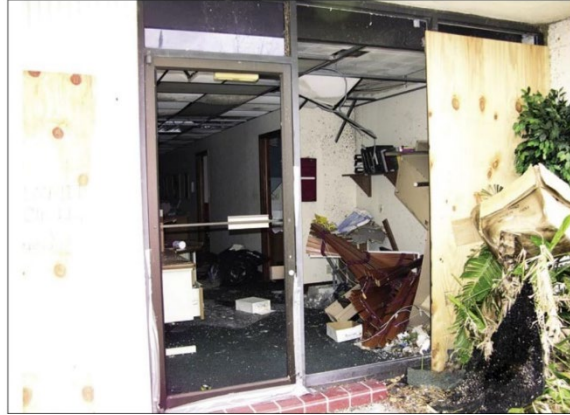
Figure 15. Broken windows in an office caused by Hurricane Charley (2004) in Punta Gorda.

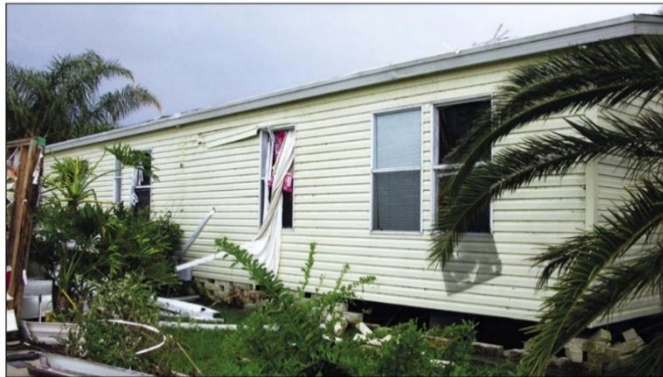
Figure 16. Windows broken in a manufactured home by wind-borne debris during Hurricane Charley (2004) at the east of Port Charlotte.

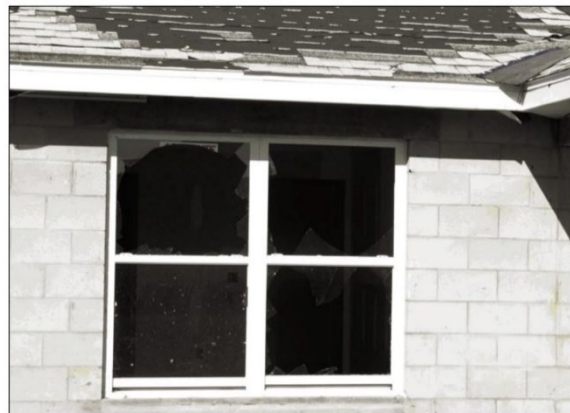
Figure 17. Broken window by wind-borne debris during Hurricane Charley (2004), in Deep Creek.

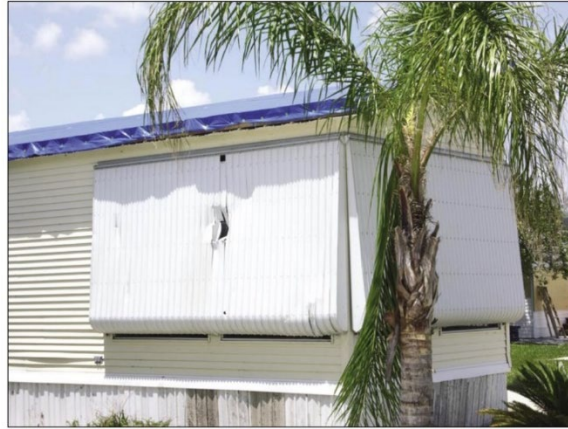
Figure 18. Metal awning shutter penetrated by a missile in Zolfo Springs during hurricane Charley (2004).

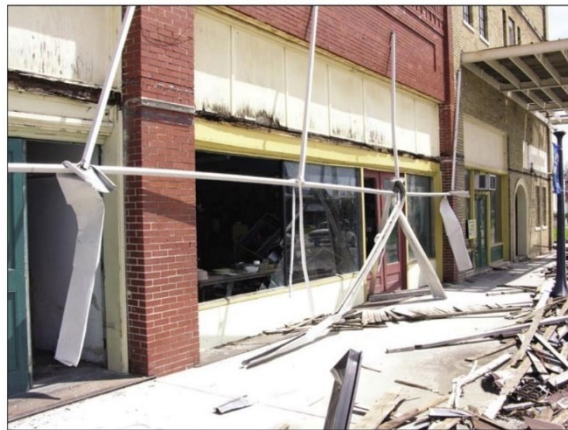
Figure 19. Broken glass windows caused by wind-borne debris during hurricane Charley (2004) in Wauchula.

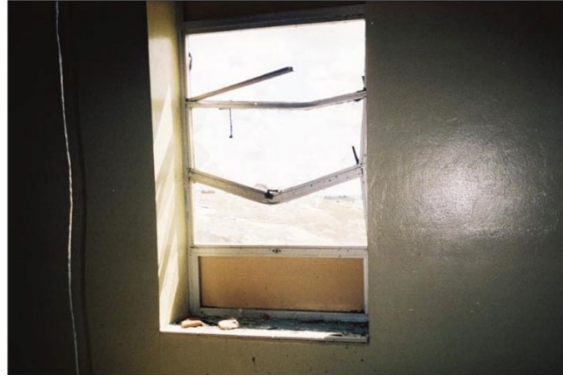
Figure 21. Broken window caused by wind-borne debris in a high school in Punta Gorda during Hurricane Charley (2004).

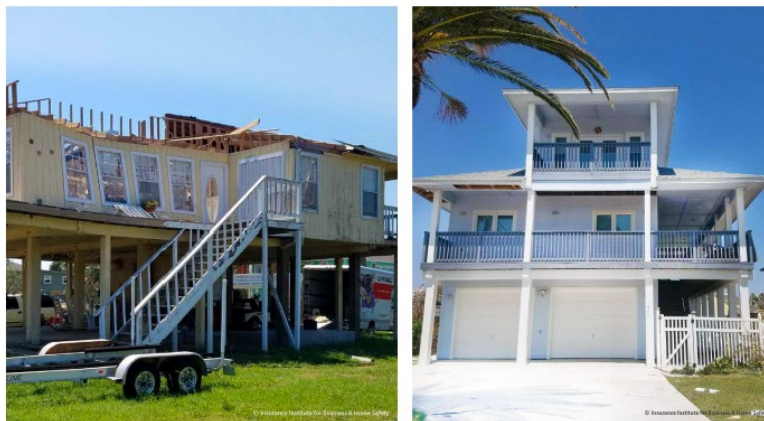
Figure 24. Comparison of two homes located 250 ft apart that experienced similar wind speeds during hurricane Harvey (2017) but performed very differently in Port Aransas North. The older construction was built in 1987(left), and newer construction was built in 2006 (right).

The IBHS team noted generally better performance of both residential and commercial buildings in areas of newer construction compared to older construction. Examples are shown in Figure 24 and Figure 25.

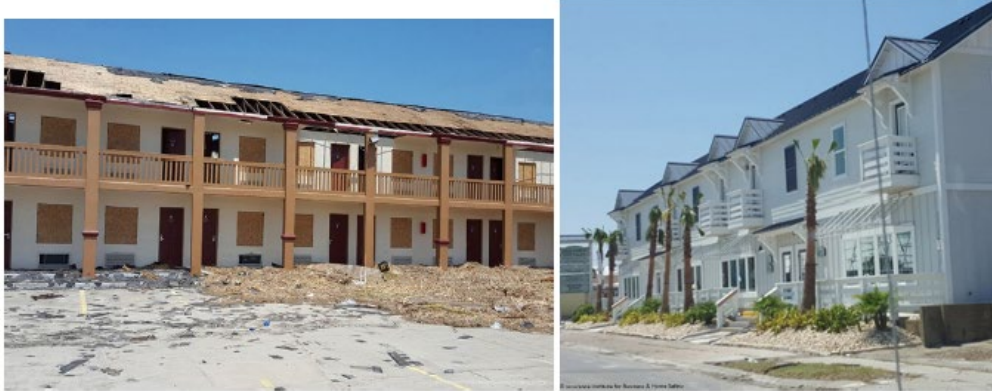
Figure 25. Comparison of two commercial buildings located 1 mile apart that experienced similar wind speeds during hurricane Harvey (2017) but performed very differently in Port Aransas North. The older construction was built in 1984(left) and newer construction was built in 2017 (right).

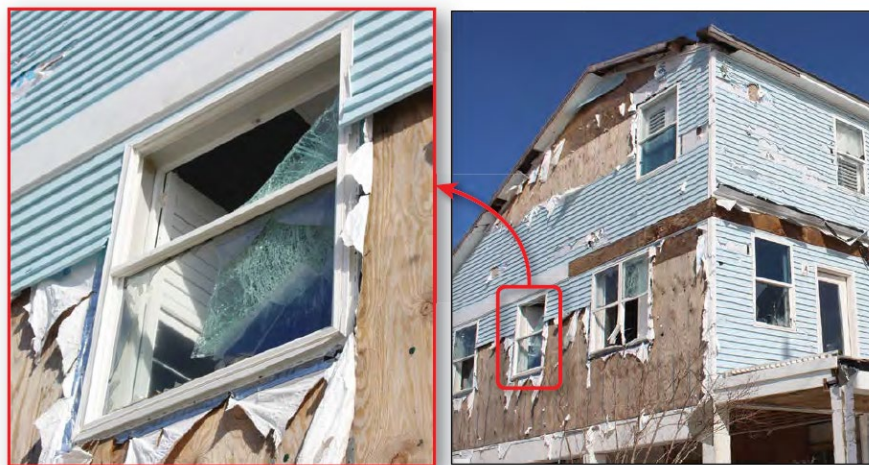
Figure 29. Impact resistant window after Hurricane Michael (2018) in a house built in 2010, located in Mexico Beach. Estimated wind speeds (150 mph) exceeded the design wind speeds (130 mph).

FEMA compared Hurricane Michael’s estimated 3-second gust wind speeds to the basic design wind speed from the ASCE 7-10 for Risk Category II buildings. Many communities along the track of Hurricane Michael experienced wind speeds that exceeded design level wind speeds. Wind speeds in excess of ASCE 7-10 design levels occurred in Bay, Calhoun, Gadsden, Gulf, Jackson, and Liberty Counties (see Figure 26). In some locations, the wind speeds produced by Hurricane Michael exceeded ASCE 7 Risk Category II wind speeds by more than 10 percent. The highest wind gust recorded on land was 129 mph at a mobile weather station at Tyndall Air Force Base. This mobile weather station was installed by the University of Florida/Weatherflow in the hours preceding landfall. Shortly after recording the gust of 129 mph, the mobile weather station failed. A wind gust of 102 mph was recorded at the airport in Marianna, FL, near the state line with Georgia; the weather station at the airport remained in operation throughout the event. The mitigation assessment team report from FEMA found some wind-borne debris in residential buildings in Mexico Beach and Panama City (Figure 27). In those cases, the estimated wind speed exceeded the design wind speed. However, the observations correspond to areas not considered as wind-borne debris areas according to ASCE-7 because the observations were beyond 1-mile of the coast (Figure 28 to Figure 33).

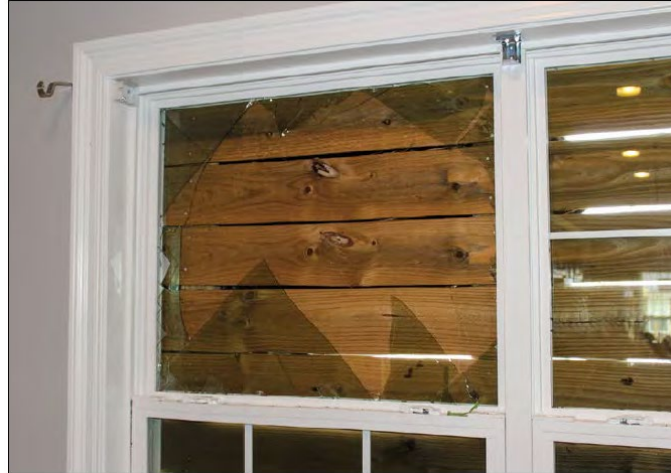
Figure 32. Glazed opening damage caused by an asphalt shingle after Hurricane Michael (2018) in a house built in 2012, located in Panama City. Estimated wind speeds (150 mph) exceeded the design wind speeds (126 mph).

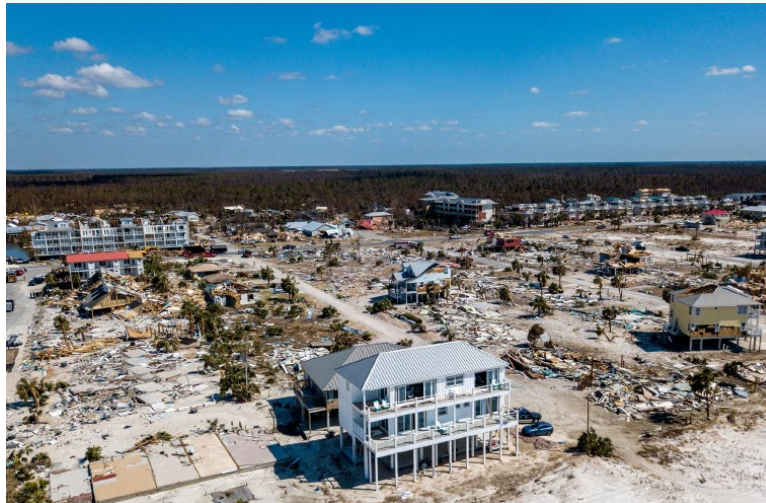
Figure 34. Widespread devastation to wood-framed single and multi-family residences in Mexico Beach with few survivors in areas with highest inundations (Source: New York Times)

The StEER Hurricane Michael Preliminary Virtual Assessment Team Report analyzed the structural impacts of Hurricane Michael. The report highlighted extensive wind and storm surge damage, with wind speeds exceeding design levels and storm surge causing catastrophic destruction, particularly in Mexico Beach (Figure 34). Older structures, especially those built before the 2002 Florida Building Code, experienced significant failures, including roof and wall collapses, while newer buildings fared better but still suffered damage to cladding, windows, and roof systems.

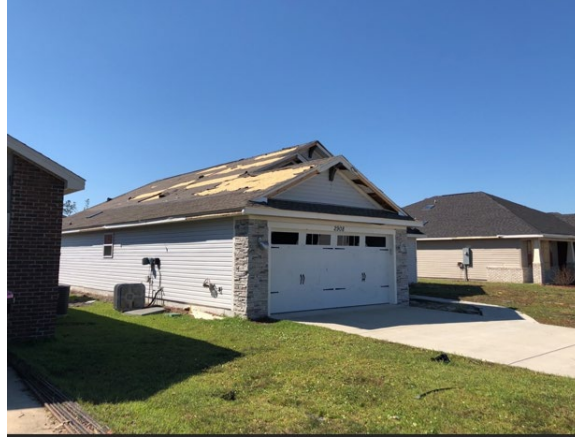
Figure 35. Damage to a garage door in Panama City during Hurricane Michael (2018). House was built between 2000-2009 and located 3.39 miles from St. Andrew Bay. Estimated wind speeds (129-150 mph) might have exceeded the design wind speeds (135 mph).

Wind-borne debris posed a major threat, leading to secondary damage in areas not classified as wind-borne debris regions under ASCE-7 standards. Figure 35 to Figure 39 show some examples of the observed wind-borne debris damage caused by Michael in Panama City and Mexico Beach, often at distances exceeding three miles from St. Andrew Bay. The report emphasized the effectiveness of updated building codes while identifying gaps in addressing extreme wind and surge events. It recommended revising codes to include higher wind speeds and storm surge considerations, improving resilient designs with elevated construction and better anchoring, and enhancing risk assessments for inland exposure and wind-borne debris impacts. Strengthening critical infrastructure and promoting public awareness of resilient practices were also highlighted as priorities to enhance disaster preparedness and recovery.

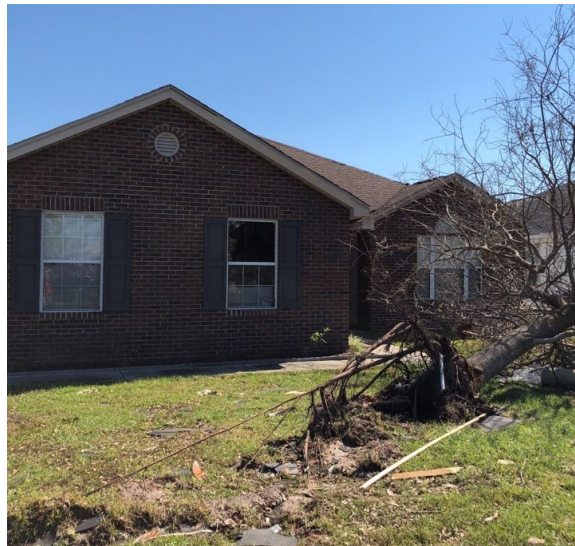
Figure 36. Damage to a window cause by wind-borne debris in Panama City during Hurricane Michael (2018). House was built between 2000-2009 and located 3.27 miles from St. Andrew Bay. Estimated wind speeds (129-150 mph) might have exceeded the design wind speeds (135 mph).

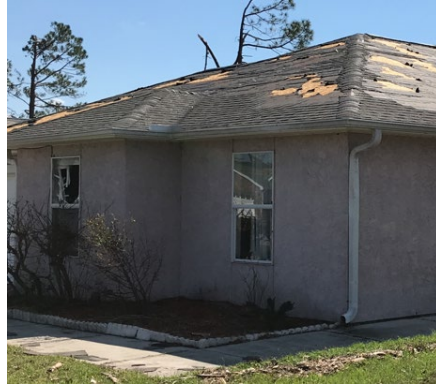
Figure 37. Damage to windows in a hose located in Panama City during Hurricane Michael (2018). House was built between 1990-1999 and located 3.25 miles from St. Andrew Bay. Estimated wind speeds (129-150 mph) might have exceeded the design wind speeds (135 mph).

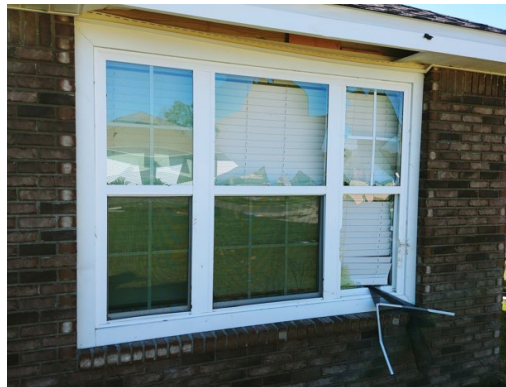
Figure 38. Damage to a window in Panama City during Hurricane Michael (2018). House was built between 2010-2019 and located 3.39 miles from St. Andrew Bay. Estimated wind speeds (129-150 mph) might have exceeded the design wind speeds (135 mph).
