TAC: Mechanical

Sub Code: Mechanical

CPSC Staff Assessment on
Eutectic-Type Thermal-Cutoff Fuse Failures
in Shaded-Pole Motors
Used in Exhaust Fans

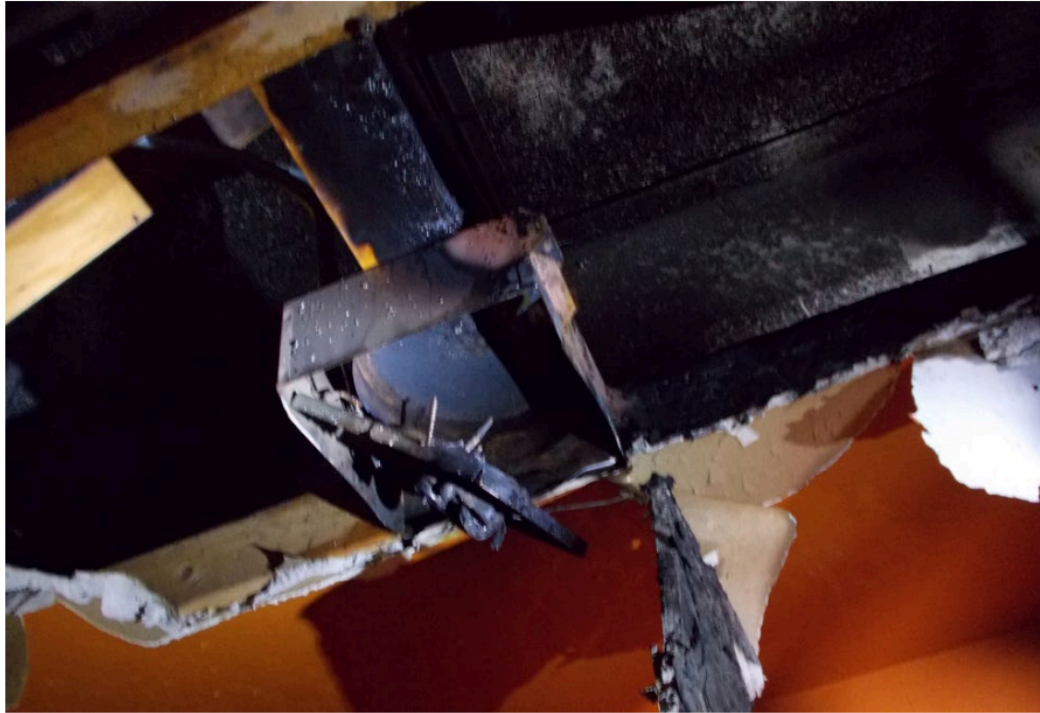
Barbershop 02/2013

Toilet exhaust fan fires in City of Coconut Creek courtesy of Ryan Banyas, MPA, CFPS, Fire Marshal

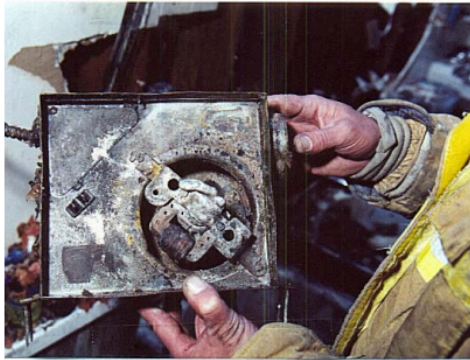
IDI 010402CCN474

In March 2001, at about 6:50 a.m. the fire department responded to an apartment structure fire. Firefighters discovered fire in the walls and the attic above the bathroom where the incident exhaust fan was located. Fire had spread into the common bathroom wall between apartment units and in the adjacent bedroom walls. The fire department determined that the fire started from a 30-year-old exhaust fan located in the bathroom of the apartment.

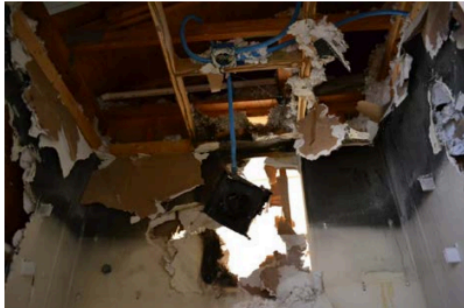
IDI 110322CCC2391

The incident occurred at a daycare facility. The building was built in 1995, and has been used as a daycare facility since its construction. The fans were original when the building was constructed. The lights and fans were controlled by a single switch. Five days a week, the switch was turned on at approximately 6:30 a.m. and turned off at about 7:00 p.m. The incident occurred in March 2011. After the daycare lights and fans were switched on, the daycare heat was also turned on. Approximately 1 hour later, a teacher and her assistant smelled something burning and assumed it was related to the heating system. Even though after the heating system was turned off, the burning smell persisted. The director went to the infant room and localized the burning smell to the changing room/bathroom. The director notified the owner of the daycare and was advised to disconnect the exhaust fans because they were old. The director was unplugging the exhaust fan when a "large fireball shot out" of the exhaust fan. The daycare was evacuated and the fire department was summoned to extinguish the fire.

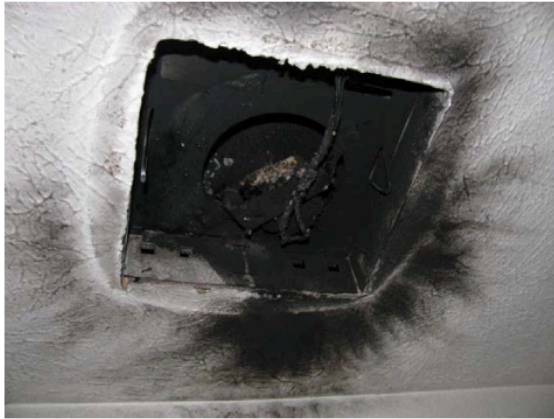
The June 12 incident occurred in a half bath in a single-family home. The Fort Riley Fire Department was dispatched to a structure fire at the residence. Upon arrival, the fire responders did not witness any signs of fire outside the home. Fire personnel entered the home to investigate and found water pouring from the first floor bathroom exhaust fan on the ceiling. The fire had been extinguished before fire fighters entered the home. The report identified that the plastic inside the fan had ignited, which then ignited the plastic vent hose. A plastic water line located above the fan had melted, which extinguished the fire. The cause of the incident was an overheated exhaust fan.

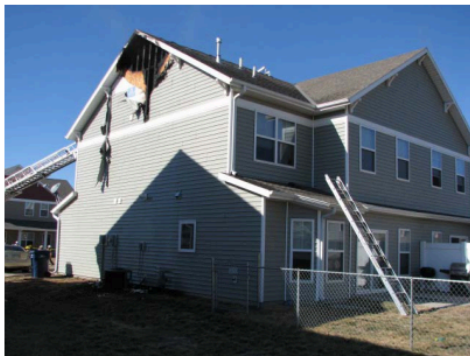
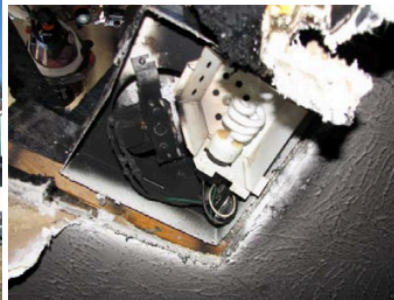
The February 5 incident occurred in a full bath on the second floor of a single-family home. There was extensive damage to the attic above the bathroom. The field investigator noted that the incident fan switch was in the “up” position, suggesting that the fan was on when the incident occurred. When the fire department arrived at the scene, fire personnel determined that the fire had spread into the attic area. An overheated exhaust fan caused the incident.

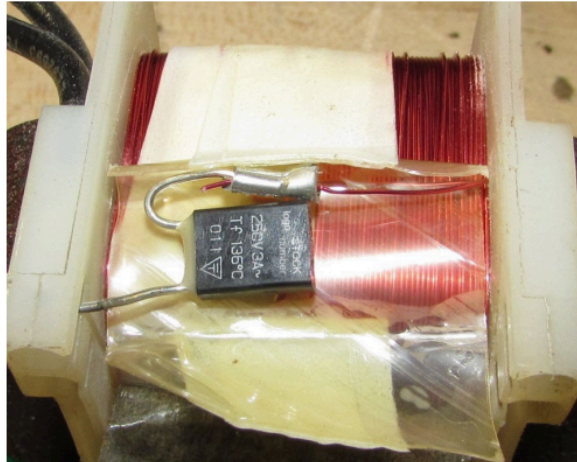
Figure 6. Radial eutectic-type thermal fuse in the sample fans

All the fan samples contained radial eutectic-type thermal fuses. The fuses are marked with a functioning temperature of 136°C and rated for 250V 3A, as shown in Figure 6.

All 100 TCOs in the fans were x-rayed and 3-D imaged by computed tomography (CT). CT imaging can reveal detailed images of the internal TCO without destructive analysis. The CT scan allows cross-sectional details of the thermal linkage that cannot be seen in conventional radiographs by X-rays. The thermal linkage connects the two wire leads, as shown in the radiograph and CT images in Figure 7. In the examined thermal linkages in the fan samples, the thermal linkages varied with the shape of the linkage, such that some of the linkages were not uniform, as shown in Figure 8. It is unknown if the variations were caused from manufacturing or usage before collection.

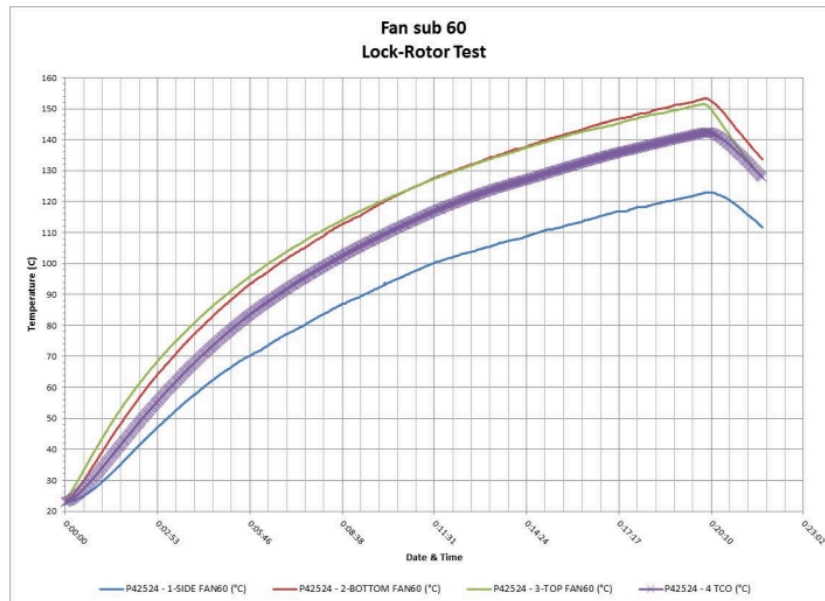
The same fan sub 60 that was instrumented with a thermocouple inside a TCO was used to measure the temperatures during lock-rotor conditions. Similar to the normal operation test, fan sub 60 had the three thermocouples on the paper wrap exterior of the winding and thermocoupled TCO. The lock-rotor condition was operated for 20 minutes to simulate the TCO tripping after 20 minutes in lock-rotor testing, as seen in Sub 45. After 9 minutes 12 seconds, the TCO temperature reached 105°C, as shown in Figure 17. At 15 minutes, the TCO temperatures reached 130°C. Shortly before 20 minutes, the TCO temperature reached 140°C. The TCO temperature measured approximately 142°C at 20 minutes or the manual trip time. The measurements in this test closely correspond to the sub 45 locked-rotor test. As mentioned previously, the TCO in sub 45 tripped at a measured temperature on the side of the winding around 120°C, and the temperature measured on the side of the winding in the test after 20 minutes of operation was about 123°C.

Figure 17. Temperature on the winding and within the TCO during a lock-rotor test

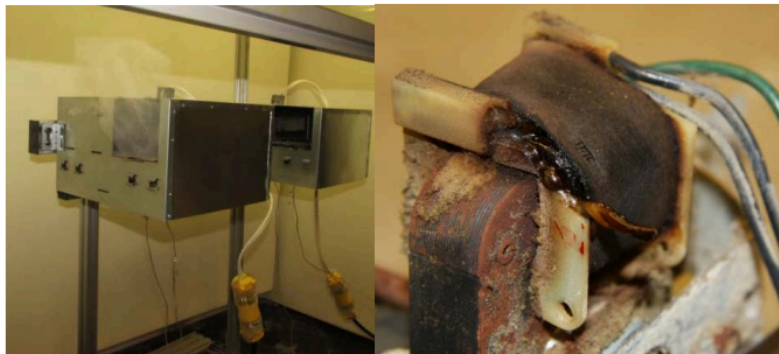
Figure 27. Sub 41 Test Group 3 - Lock-Rotor Test producing smoke and post examination

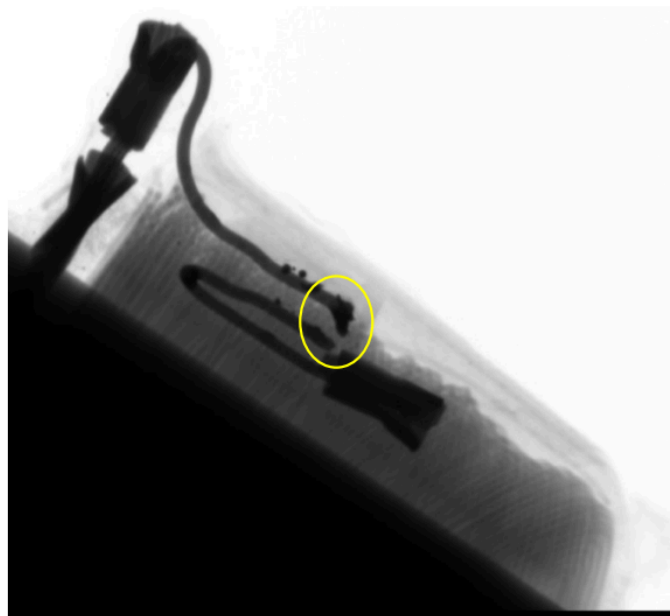
Figure 42 shows a radiograph of the TCO after the test. Post-test radiographs of the TCO show the TCO is open, which was caused by the intense heat from the flames. This would suggest that any analysis of a TCO after a fire incident does not necessarily indicate the status of the TCO during the incident.

Figure 42. Radiograph of the TCO after the test (sub 73)

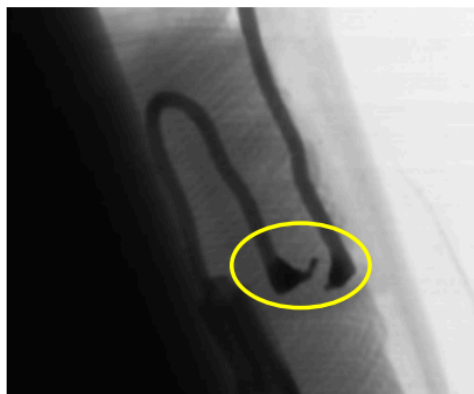
Figure 46 shows a radiograph of the TCO after the test. Post-test radiographs of the TCO show the TCO is open, which was caused by the intense heat from the flames. This would suggest that any analysis of a TCO after a fire incident does not necessarily indicate the status of the TCO during the incident. The radiograph shows a thin portion of the thermal linkage intact. It would appear even at the high temperatures when the motor ignited, portions of the eutectic material in the thermal linkage could not melt.

Figure 46. Radiograph of the TCO after the test (sub 23)

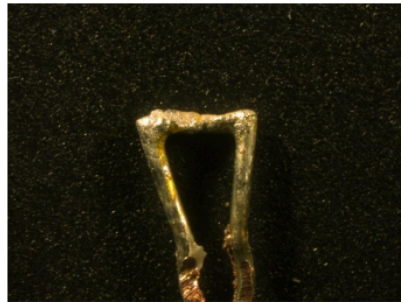
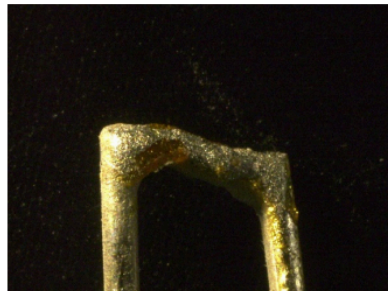
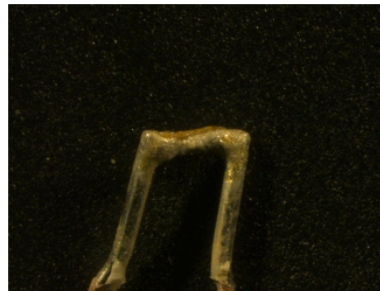
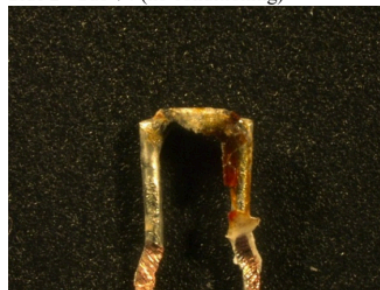
Figure 53. TCO solder link from Fan subs 74 and 85 (no conditioning)

Subs 22 and 59 (conditioned for 330 hours at 105°C) from Test Group 5 were reserved for analysis of the solder link within the TCO. The TCO casing was opened and the internal components were removed. For comparison, two TCOs, sub 74 and 85 (no conditioning), from Test Group 7 were also reserved for TCO analysis where the TCO casing was opened and the internal components removed. Figure 52 shows the solder links from Fan subs 22 and 59, which have been conditioned 330 hours at 105°C. Figure 53 shows the solder links from Fan subs 74 and 85, which have not been conditioned. Sub 85 shows some deformation in the solder link, where part of the solder link has flattened and formed to the interior of the TCO casing, but this was already present before any conditioning of the TCO. The mechanical structure of the solder linkage appeared unchanged as a result of the conditioning, when the before and after radiographs were compared.

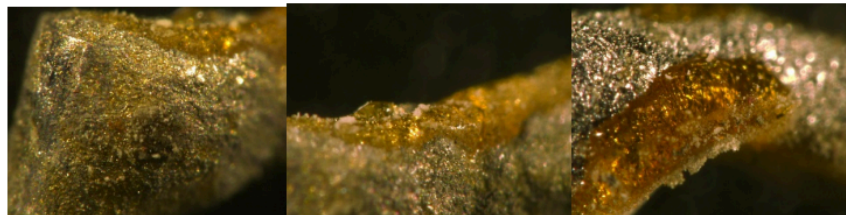
Staff observed under a microscope that a yellowish substance was on the solder link, as shown in Figures 54 and 55. This was thought to be the special coating or flux material. Staff also observed that the conditioned TCOs appeared to have less of the yellowish substance than the TCOs that were unconditioned, but staff did not measure an actual mass content or volume of the substance for each sample.

Figure 54. Close-up images of the TCO solder link (conditioned 330 hours @ 105°C)

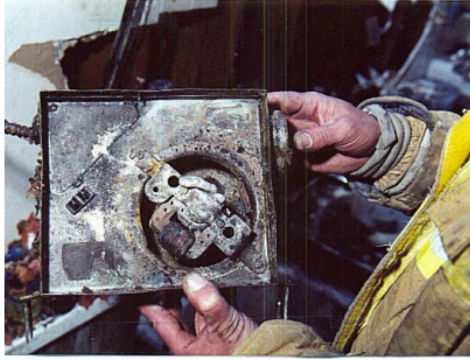
IDI 010402CCN474

In March 2001, at about 6:50 a.m. the fire department responded to an apartment structure fire. Firefighters discovered fire in the walls and the attic above the bathroom where the incident exhaust fan was located. Fire had spread into the common bathroom wall between apartment units and in the adjacent bedroom walls. The fire department determined that the fire started from a 30-year-old exhaust fan located in the bathroom of the apartment.

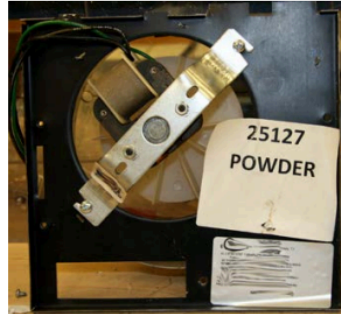
Figure 1. Fan assembly for “box” type housing

Bottom of the exhaust fan assembly

The majority of the incidents (75 percent, 318/423) involved bathroom/restroom exhaust fans. Where photographs were available, the fans appear to have similar construction. The exhaust fans contain an external housing, a motor, an impeller, and a grill cover. The exhaust fans may incorporate a light option, but the incidents did not report the lighting assembly as the cause of the incident or fire. The “box” type exhaust fans contain a box housing that is mounted to the building structure. A fan assembly is mounted in the box housing. The fan assembly typically contains a mounting frame, fan motor, impeller, and power cord as shown in Figure 1. The box housing contains the electrical connections for the fan and light option and connection for the ducting.

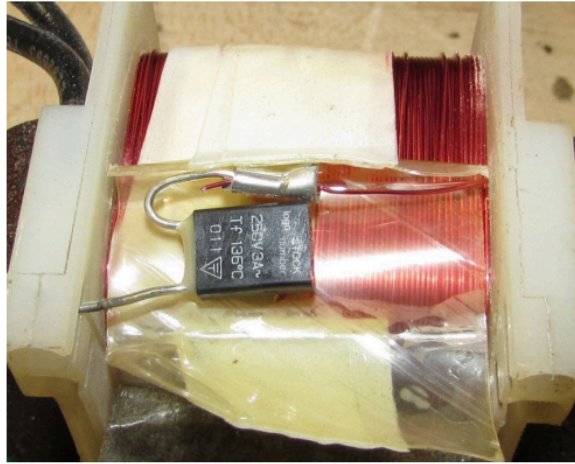
Figure 6. Radial eutectic-type thermal fuse in the sample fans

All the fan samples contained radial eutectic-type thermal fuses. The fuses are marked with a functioning temperature of 136°C and rated for 250V 3A, as shown in Figure 6.

All 100 TCOs in the fans were x-rayed and 3-D imaged by computed tomography (CT). CT imaging can reveal detailed images of the internal TCO without destructive analysis. The CT scan allows cross-sectional details of the thermal linkage that cannot be seen in conventional radiographs by X-rays. The thermal linkage connects the two wire leads, as shown in the radiograph and CT images in Figure 7. In the examined thermal linkages in the fan samples, the thermal linkages varied with the shape of the linkage, such that some of the linkages were not uniform, as shown in Figure 8. It is unknown if the variations were caused from manufacturing or usage before collection.

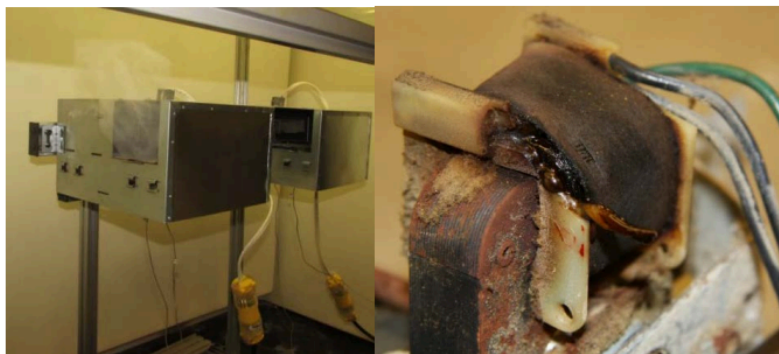
Figure 27. Sub 41 Test Group 3 - Lock-Rotor Test producing smoke and post examination

Post examination shows the TCO's fusible link to be intact, as shown by CT scans in Figure 28. During lock-rotor testing, the TCO failed to activate, but the event ended because the motor winding opened, thus de-energizing the motor.

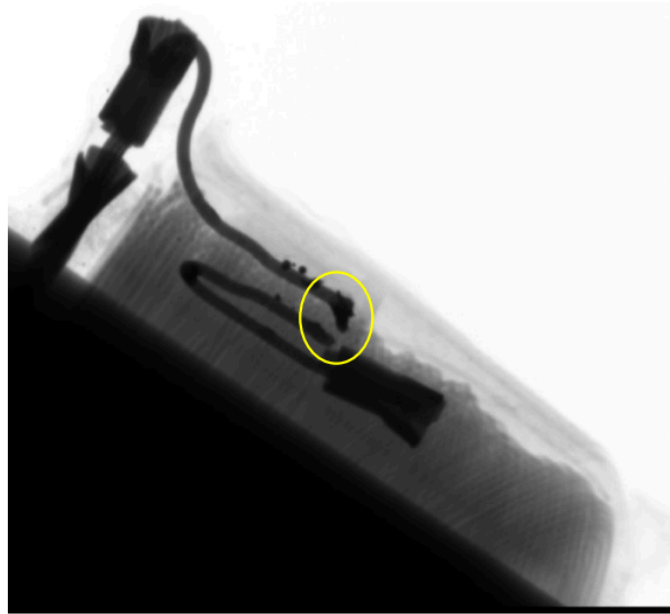
Figure 42. Radiograph of the TCO after the test (sub 73)

Figure 42 shows a radiograph of the TCO after the test. Post-test radiographs of the TCO show the TCO is open, which was caused by the intense heat from the flames. This would suggest that any analysis of a TCO after a fire incident does not necessarily indicate the status of the TCO during the incident.

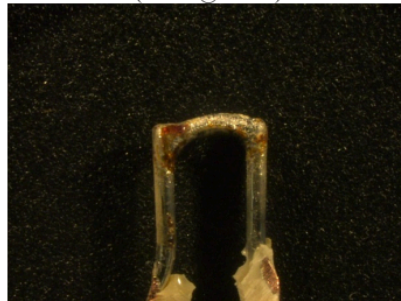
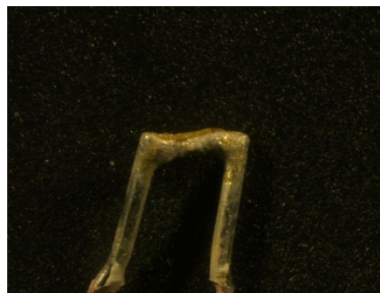
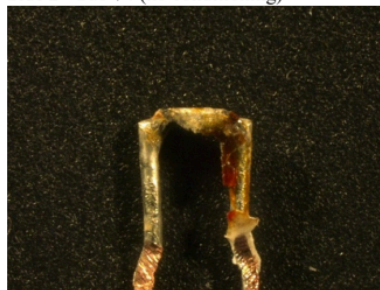
Figure 53. TCO solder link from Fan subs 74 and 85 (no conditioning)

Subs 22 and 59 (conditioned for 330 hours at 105°C) from Test Group 5 were reserved for analysis of the solder link within the TCO. The TCO casing was opened and the internal components were removed. For comparison, two TCOs, sub 74 and 85 (no conditioning), from Test Group 7 were also reserved for TCO analysis where the TCO casing was opened and the internal components removed. Figure 52 shows the solder links from Fan subs 22 and 59, which have been conditioned 330 hours at 105°C. Figure 53 shows the solder links from Fan subs 74 and 85, which have not been conditioned. Sub 85 shows some deformation in the solder link, where part of the solder link has flattened and formed to the interior of the TCO casing, but this was already present before any conditioning of the TCO. The mechanical structure of the solder linkage appeared unchanged as a result of the conditioning, when the before and after radiographs were compared.
