TAC: Mechanical

This document created by the Florida Department of Business and Professional Regulation - 850-487-1824

Total Mods for Mechanical in Approved as Modified: 1

Sub Code: Mechanical

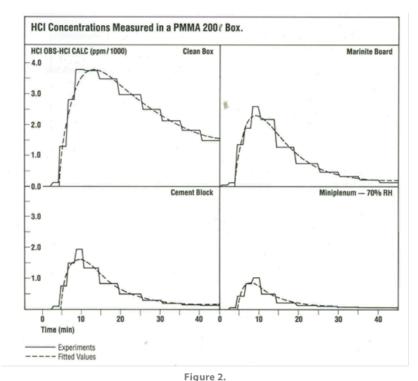
HCI from Thermal Decomposition of PVC Cables in a Lined PMMA Box

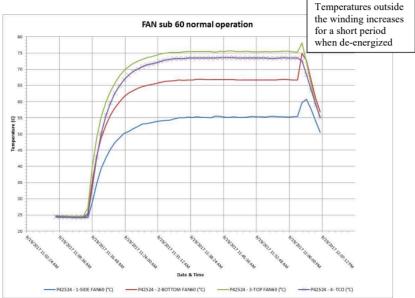
Figure 11. Temperature measurements on the winding and within the TCO (Fan 60)

impeller stopped spinning. The temperature within the TCO did not measure the same increase in temperature when the fan was de-energized. This is most likely caused by the TCO being located below the wrap, which caused the TCO not to be affected by the airflow.

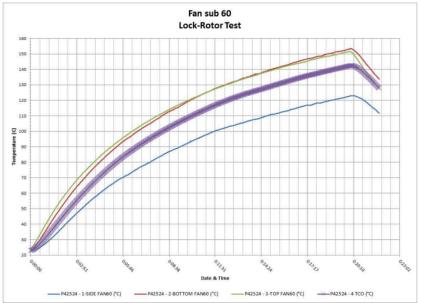
Figure 17. Temperature on the winding and within the TCO during a lock-rotor test

The same fan sub 60 that was instrumented with a thermocouple inside a TCO was used to measure the temperatures during lock-rotor conditions. Similar to the normal operation test, fan sub 60 had the three thermocouples on the paper wrap exterior of the winding and thermocoupled TCO. The lock-rotor condition was operated for 20 minutes to simulate the TCO tripping after 20 minutes in lock-rotor testing, as seen in Sub 45. After 9 minutes 12 seconds, the TCO temperature reached 105°C, as shown in Figure 17. At 15 minutes, the TCO temperatures reached 130°C. Shortly before 20 minutes, the TCO temperature reached 140°C at 20 minutes or the manual trip time. The measurements in this test closely correspond to the sub 45 locked-rotor test. As mentioned previously, the TCO in sub 45 tripped at a measured temperature on the side of the winding around 120°C, and the temperature measured on the side of the winding in the test after 20 minutes of operation was about 123°C.

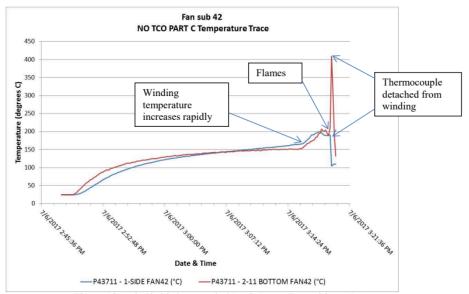
Figure 18. Sub 42 third test period Lock-Rotor Test with no TCO

For the third test period, the fan was energized in the lock-rotor condition, and after about 30 minutes, the temperature increased rapidly, which resulted in smoke and flames. The thermocouple temperature traces are shown in Figure 18. The motor winding ignited, which then ignited the plastic impeller, as shown in Figure 19. The plastic impeller resulted in dripping, flaming plastic. The total lock-rotor test time was about 4.5 hours (period 1 + period 2 + period 3).

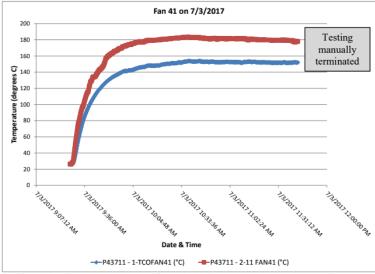
Figure 25. Temperature traces for Sub 41 Test Group 3 - Lock-rotor Test

Staff conditioned the fan (sub 41) for 232 hours 30 minutes. During the lock-rotor testing, the TCO did not activate. After about an hour, the temperature appeared to have leveled to a constant temperature or steady state. Staff terminated the lock-rotor testing after approximately 2 hours 30 minutes. Figure 25 shows the temperature traces for the thermocouples during the lock-rotor test on July 3, 2017.

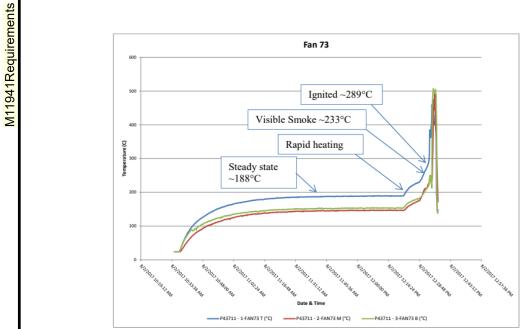
Figure 40. Winding temperatures during lock-rotor test for Fan sub 73

Fan sub 73 was in lock-rotor condition for about 1 hour and 56 minutes before the unit ignited, as shown in Figure 40. The fan's winding temperature was at a steady-state temperature (~188°C) above the TCO function temperature for about 1 hour, until the winding temperature began to increase rapidly. This rapid increase in temperature is an indication of shorting in the winding, which reduces the winding resistance and increases the current. Before ignition, with the winding temperature at about 233°C, the unit was producing visible white smoke. When the unit ignited around 289°C, there was a large flash and flames for a brief moment. It appears that the gaseous vapors driven off the winding coating ignited. The flames subsided slightly until the wrap around the winding and the coating on the windings started to burn, growing in intensity. The flames impinged on and ignited the plastic impeller. The burning impeller and bobbin resulted in dripping flaming plastic. Four layers of cheesecloth were placed under the fan to be used as an ignition indicator to verify that the dripping plastic continued to burn as it landed on the surface below. The dripping flaming plastic caused the cheesecloth to ignite, which indicates that the fan's plastic grill could also ignite in this type of situation. Figure 41 shows a sequence of photographs demonstrating the progression during lock-rotor testing on sub 73.

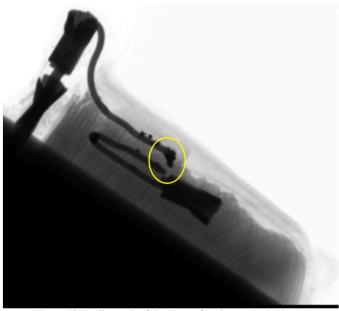
Figure 42. Radiograph of the TCO after the test (sub 73)

Figure 42 shows a radiograph of the TCO after the test. Post-test radiographs of the TCO show the TCO is open, which was caused by the intense heat from the flames. This would suggest that any analysis of a TCO after a fire incident does not necessarily indicate the status of the TCO during the incident.

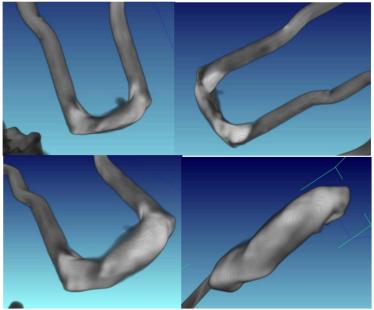
Figure 47. CT scans of the TCO before conditioning (sub 23)

The CT scans of the thermal linkage for fan sub 23 were reviewed. The thermal linkage shows some abonormalities, as shown in Figure 47. The CT scans appear to show the linkage uneven and bulging in some areas.

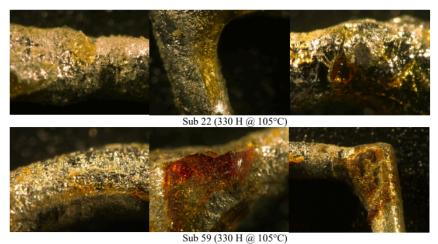
Figure 54. Close-up images of the TCO solder link (conditioned 330 hours @ 105°C)

Staff observed under a microscope that a yellowish substance was on the solder link, as shown in Figures 54 and 55. This was thought to be the special coating or flux material. Staff also observed that the conditioned TCOs appeared to have less of the yellowish substance than the TCOs that were unconditioned, but staff did not measure an actual mass content or volume of the substance for each sample.

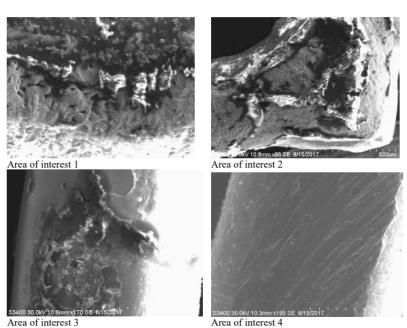
Figure 56. SEM scans for Sub 59

Areas of interest 3 and 4 are the copper terminals. This is mainly comprised of Cu and Sn. There are lower amounts of C and O.

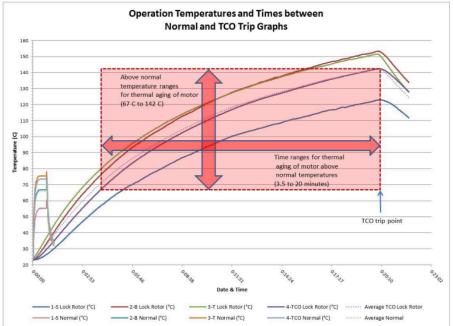
Figure 59. Potential thermal aging of the motor between normal and TCO trip conditions

Figure 59 shows Fan sub 60 temperatures for normal and lock-rotor operation. In normal operations, the TCO temperature stabilizes at around 68°C. For lock-rotor condition, the TCO activates at a TCO temperature around 142°C after 20 minutes. This would suggest that an exhaust fan that is in lock-rotor condition, but is operated for less than 20 minutes, can have the TCO heated to temperatures up to 142°C. If the exhaust fan is operated for more than 3 minutes, the TCO is experiencing temperatures above normal operation.

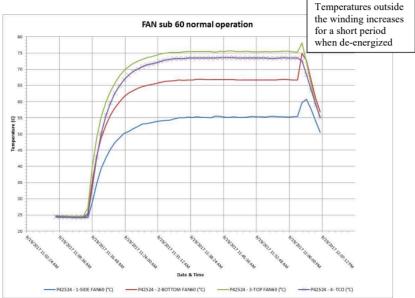
Figure 11. Temperature measurements on the winding and within the TCO (Fan 60)

The testing showed that the TCO's internal temperature for this freely spinning motor with impeller is about 73°C. The thermocouple at the top of the winding measured slightly higher, at 76°C, than the TCO temperature as shown in Figure 11. When the fan was deenergized, the thermocouples located on the winding wrap measured an increase in the winding temperature because of the lack of airflow over the thermocouples when the

impeller stopped spinning. The temperature within the TCO did not measure the same increase in temperature when the fan was de-energized. This is most likely caused by the TCO being located below the wrap, which caused the TCO not to be affected by the airflow.

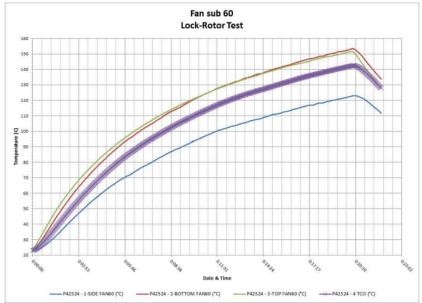
Figure 17. Temperature on the winding and within the TCO during a lock-rotor test

The same fan sub 60 that was instrumented with a thermocouple inside a TCO was used to measure the temperatures during lock-rotor conditions. Similar to the normal operation test, fan sub 60 had the three thermocouples on the paper wrap exterior of the winding and thermocoupled TCO. The lock-rotor condition was operated for 20 minutes to simulate the TCO tripping after 20 minutes in lock-rotor testing, as seen in Sub 45. After 9 minutes 12 seconds, the TCO temperature reached 105°C, as shown in Figure 17. At 15 minutes, the TCO temperatures reached 130°C. Shortly before 20 minutes, the TCO temperature reached 140°C at 20 minutes or the manual trip time. The measurements in this test closely correspond to the sub 45 locked-rotor test. As mentioned previously, the TCO in sub 45 tripped at a measured temperature on the side of the winding around 120°C, and the temperature measured on the side of the winding in the test after 20 minutes of operation was about 123°C.

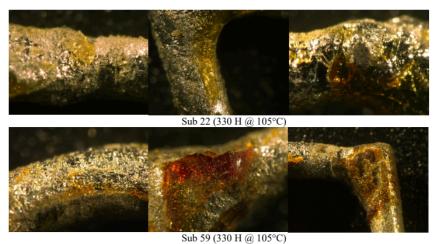
Figure 54. Close-up images of the TCO solder link (conditioned 330 hours @ 105°C)

Staff observed under a microscope that a yellowish substance was on the solder link, as shown in Figures 54 and 55. This was thought to be the special coating or flux material. Staff also observed that the conditioned TCOs appeared to have less of the yellowish substance than the TCOs that were unconditioned, but staff did not measure an actual mass content or volume of the substance for each sample.

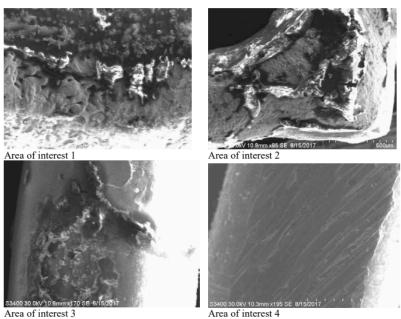
Figure 56. SEM scans for Sub 59

Areas of interest 3 and 4 are the copper terminals. This is mainly comprised of Cu and Sn. There are lower amounts of C and O.
