**PERFORMANCE TEST REPORT**

**GLASSCRAFT DOOR COMPANY**

**SERIES/MODEL: Mahogany Entry Door**

**PRODUCT TYPE: 3' x 8' Single Outswing TDL Hardwood Door  
with TDL Sidelites**

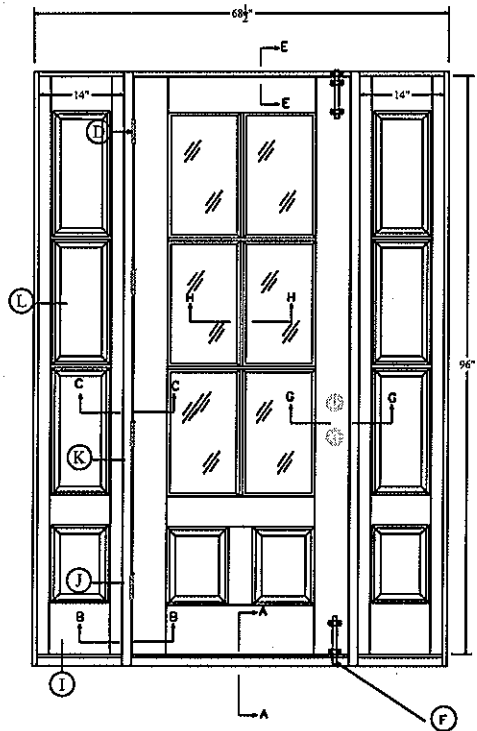
ELEVATION

Out Swing

**Overall Size:** 68-1/2" wide by 98" high

**Leaf Size:** 36" wide by 96" high

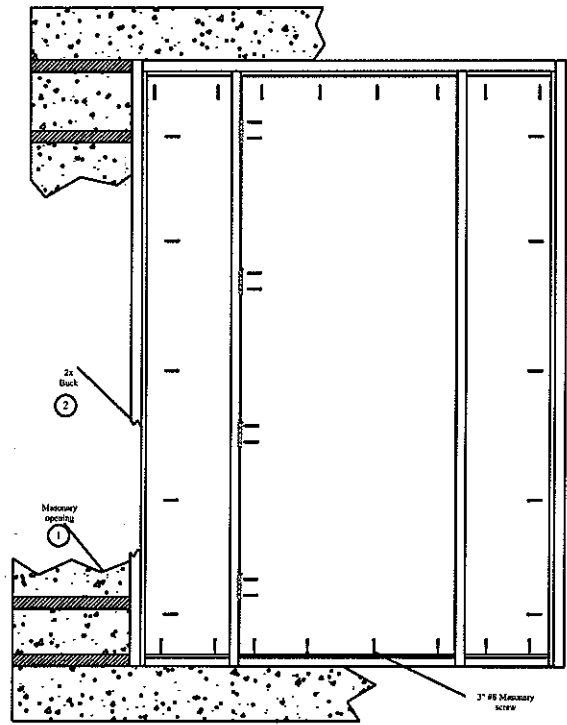
ANCHORING LAYOUT

3" #8 Masonry screw

Set frame sill in concrete or bed of caulk

**Installation:** The jambs were secured to a 2x4 #2 Pine test buck with one #8 x 3" screw located 2" from each corner and on 12" spacing thereafter.

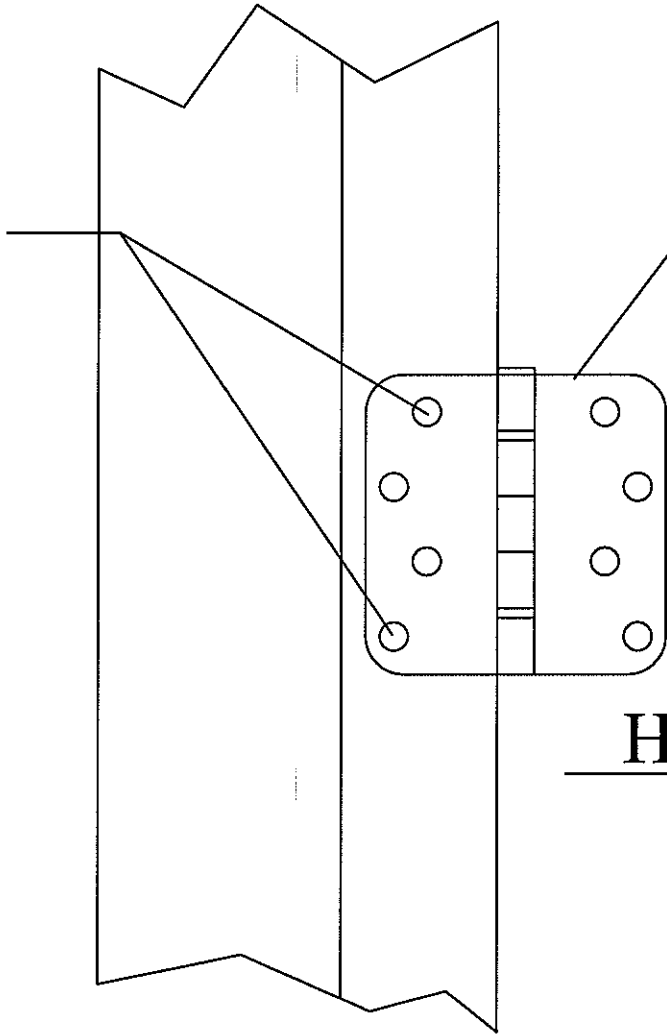
## Hinge Detail

# Penrond 4"x4" 5/8" Radius Hinge

Install (2) 3" #8 Wood Screws Per Henge.

**Hardware:** One Schlage F-300 Series single-point lockset was located 36" on center from bottom of the leaf and one Schlage deadbolt was located 41-5/8" on center from the bottom of the leaf. Four 4" butt type hinges were fastened to each leaf with four #8 x 3" screws. Each hinge was secured to the jamb with two #8 x 3" screws and two #8 x 1" flat head screws. The hinges were located at 9-1/8", 34-1/2", 59-1/2" and 84-3/4" on center from the top of the jamb. Surface bolts were attached to the top and bottom of the leaf with four #10 x 1" flat head machine screws with a 1-1/2" long blind nut. Strike plates for the surface bolts were attached to the head with two #8 x 3" screws and to the threshold with two #10 x 3" sheet metal screws.

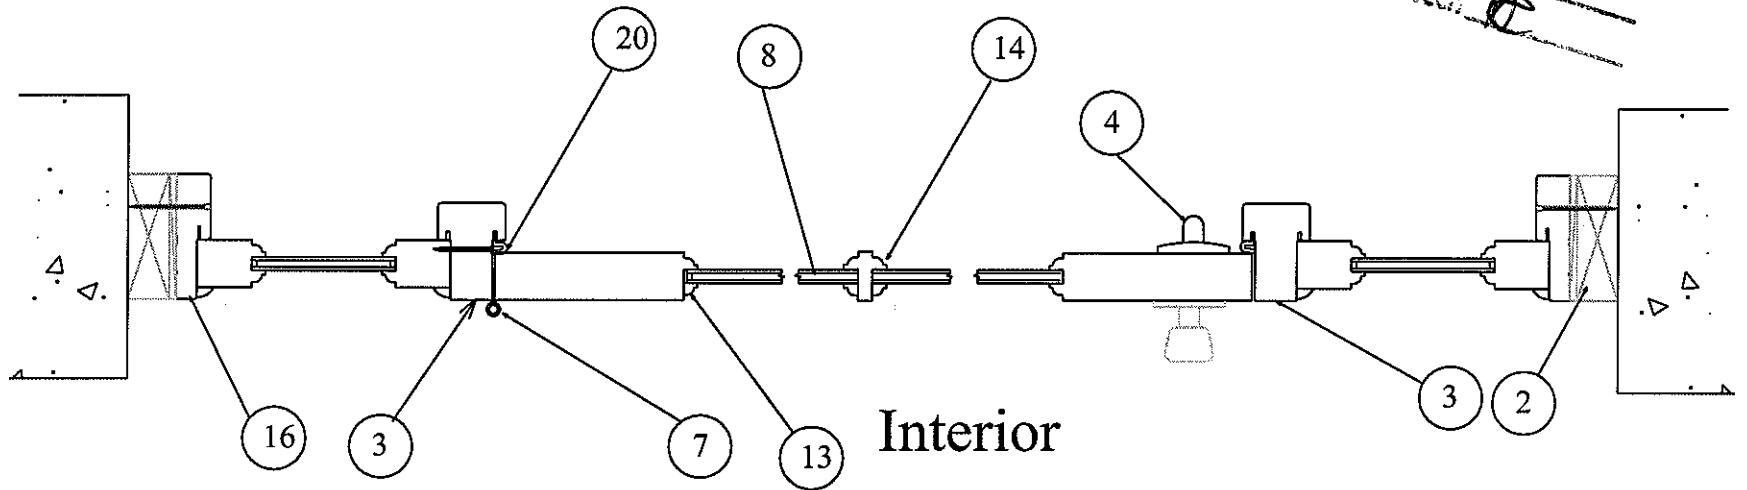
Horizontal Cross Section

Exterior

Interior

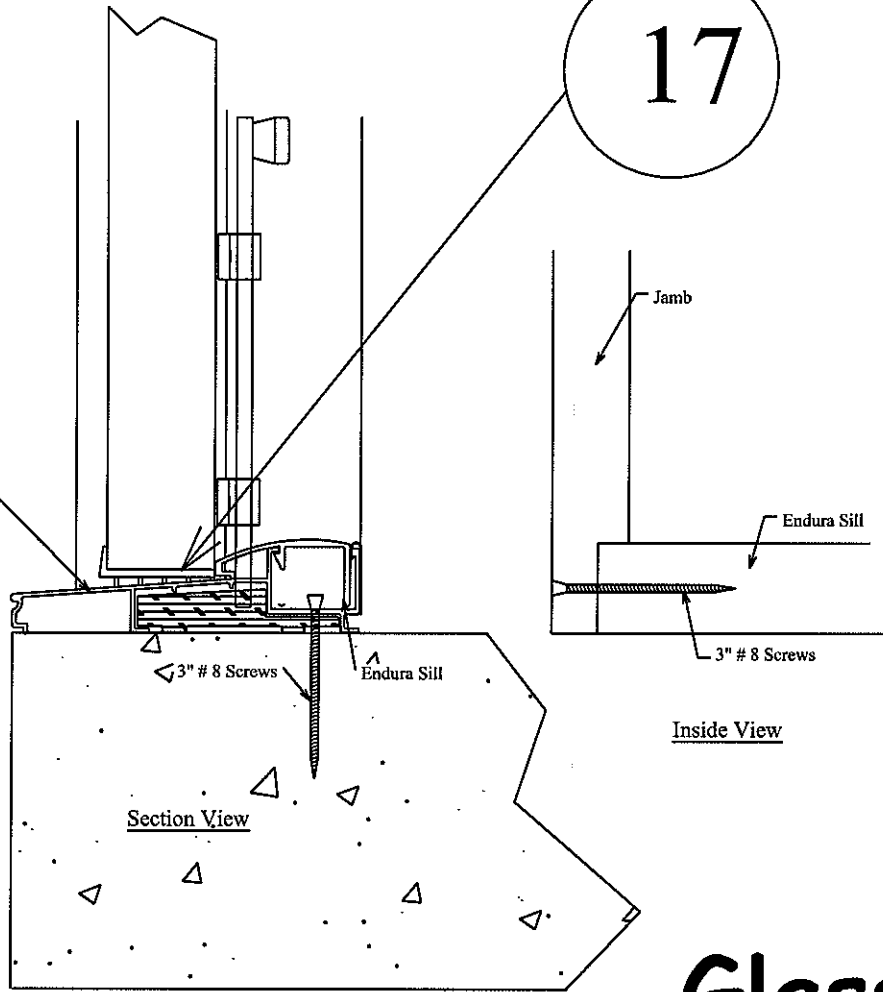
(A) Threshold Out Swing

Endura Sill  
 ZAIL 5866 / O/S

**Frame Construction:** The door frame was constructed of 4-5/8" by 1-1/4" hardwood head and jambs, and 3-5/8" by 2-5/8" mullions and included an adjustable extruded aluminum and composite threshold. The head and jambs were kerfed to accept the weatherstripping. The corners were coped, butted and secured with two #8 x 1-1/2" and five #8 x 3" screws at the threshold and with four #8 x 1-1/2" and two #8 x 3" screws at the head. The mullions were attached with five #8 x 3" screws through the head and the threshold.
