ASTM E330 PERFORMANCE TESTING
HARWOOD GLAZED WIDE MUNTIN TDL PANEL WOOD DOORS (IN - SWING)
REPORT #CCLI-18-027

CONSTRUCTION
CONSULTING
LABORATORY,
INTERNATIONAL
1601 Luna Road
Carrollton, Texas 75006
Phone (972) 242-0556
Report# CCLI-18-027, Date 3-21-2018
Reviewed BY EA

Hardwood Glazed Wide Muntin TDL Doors

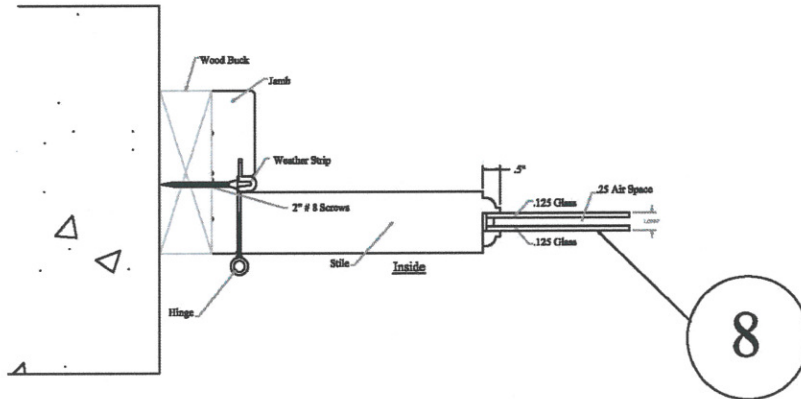
April 10, 2018
Drawing Pg. 13

Ⓒ Anchor Section

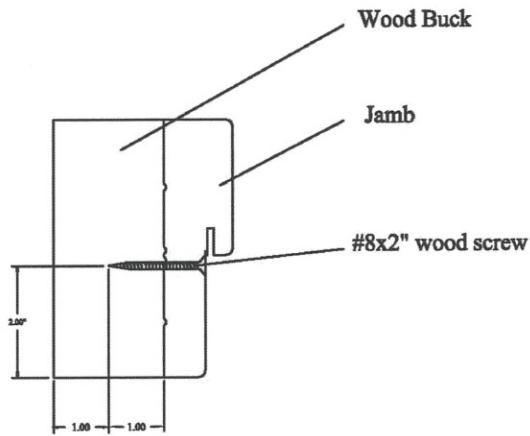
April 10, 2018
 Drawing Pg. 14

Ⓒ1 Anchor Detail

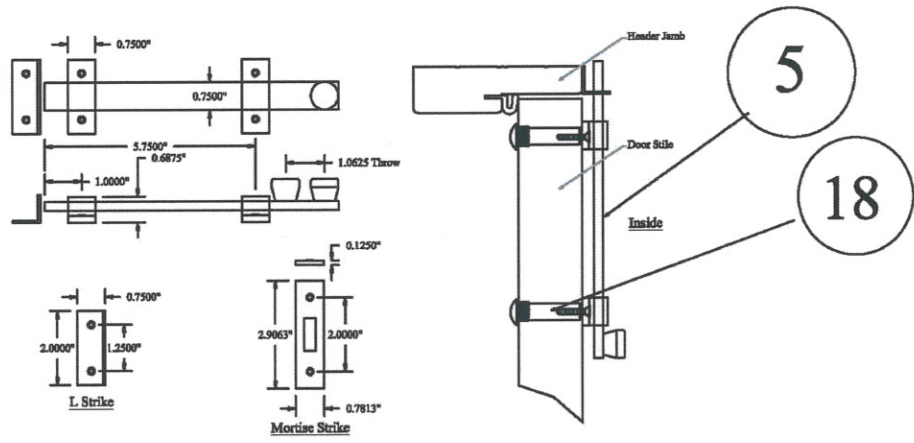
April 10, 2018
 Drawing Pg. 16

(F) Surface Bolt

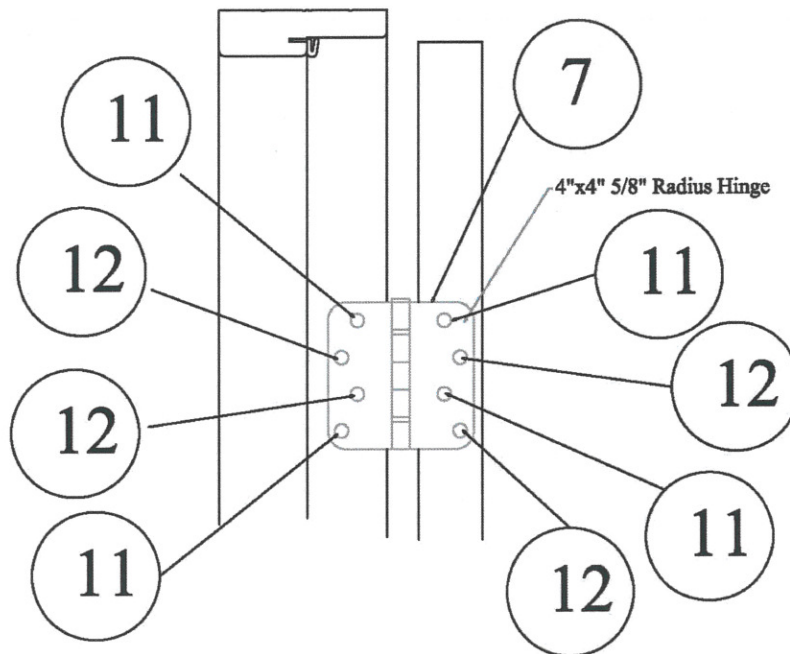
April 10, 2018
Drawing Pg. 18

Ⓓ Door Hinge

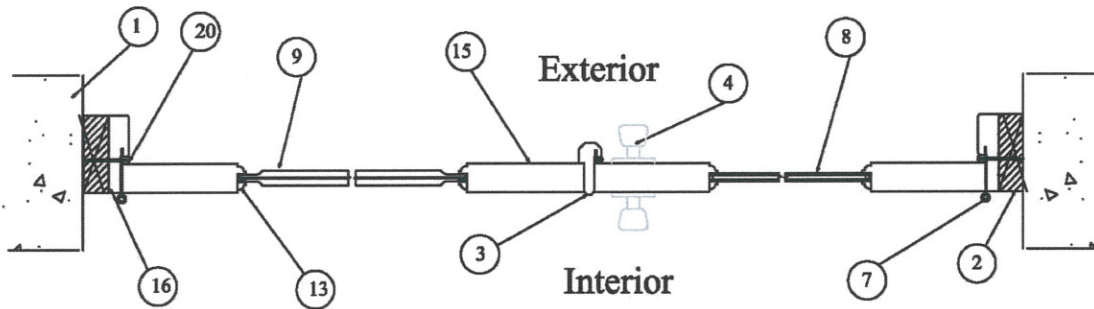
April 10, 2018
Drawing Pg. 20

Horizontal Cross Section

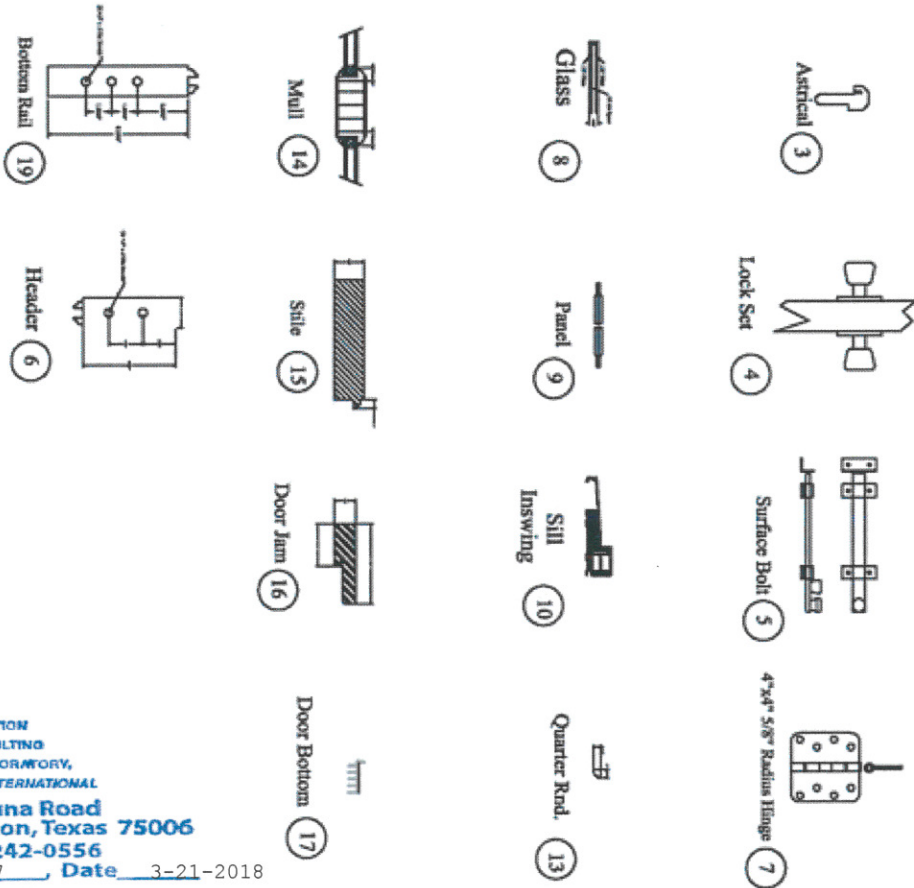
April 10, 2018
 Drawing Pg. 21

List of Material

Item #	Description	Material
1	Masonry	CONC.
2	2x Back	Wood
3	Astrical	Wood
4	Lock Set	Metal
5	Surface Bolt	Metal
6	Top Header	Wood
7	4"x4" 5/8" Radius Hinge	Metal
8	Panel	Glass
9	Panel	Wood
10	Sill Inswing	Alum.
11	2" x #8 Wood Screw	Metal
12	1" x #9 PFH Wood Screw	Metal
13	Quarter Round Trim	Wood
14	Mull	Wood
15	Stile	Wood
16	Door Jamb	Wood
17	Door Bottom	Rubber
18	10-32 Sex Bolt	Metal
19	Bottom Rail	Wood
20	Weather Strip	Foam

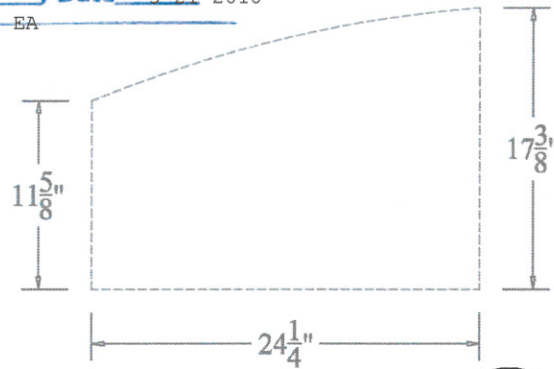
8

Glass Panel

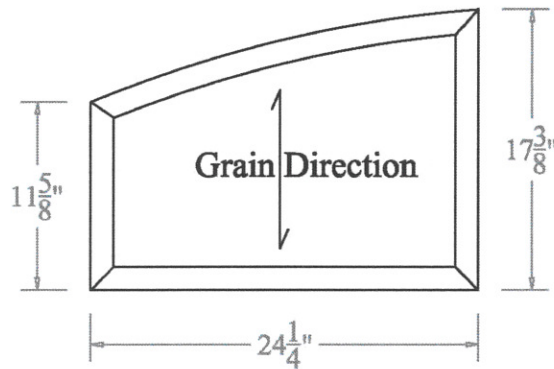
9

Wood Panel

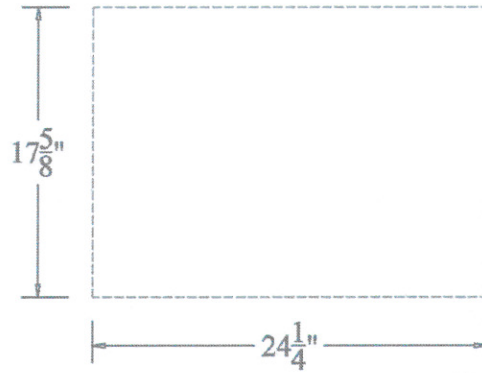
8

Glass Panel

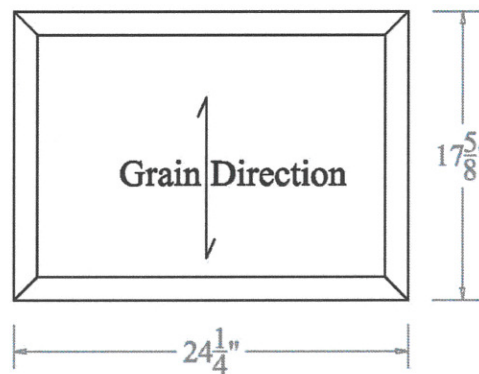
9

Wood Panel
