# **GLICK METALS LLC**

## **TEST REPORT**

TAS 100(A) TESTING ON SNAP-Z, RIDGE VENT

K8029.01-109-18

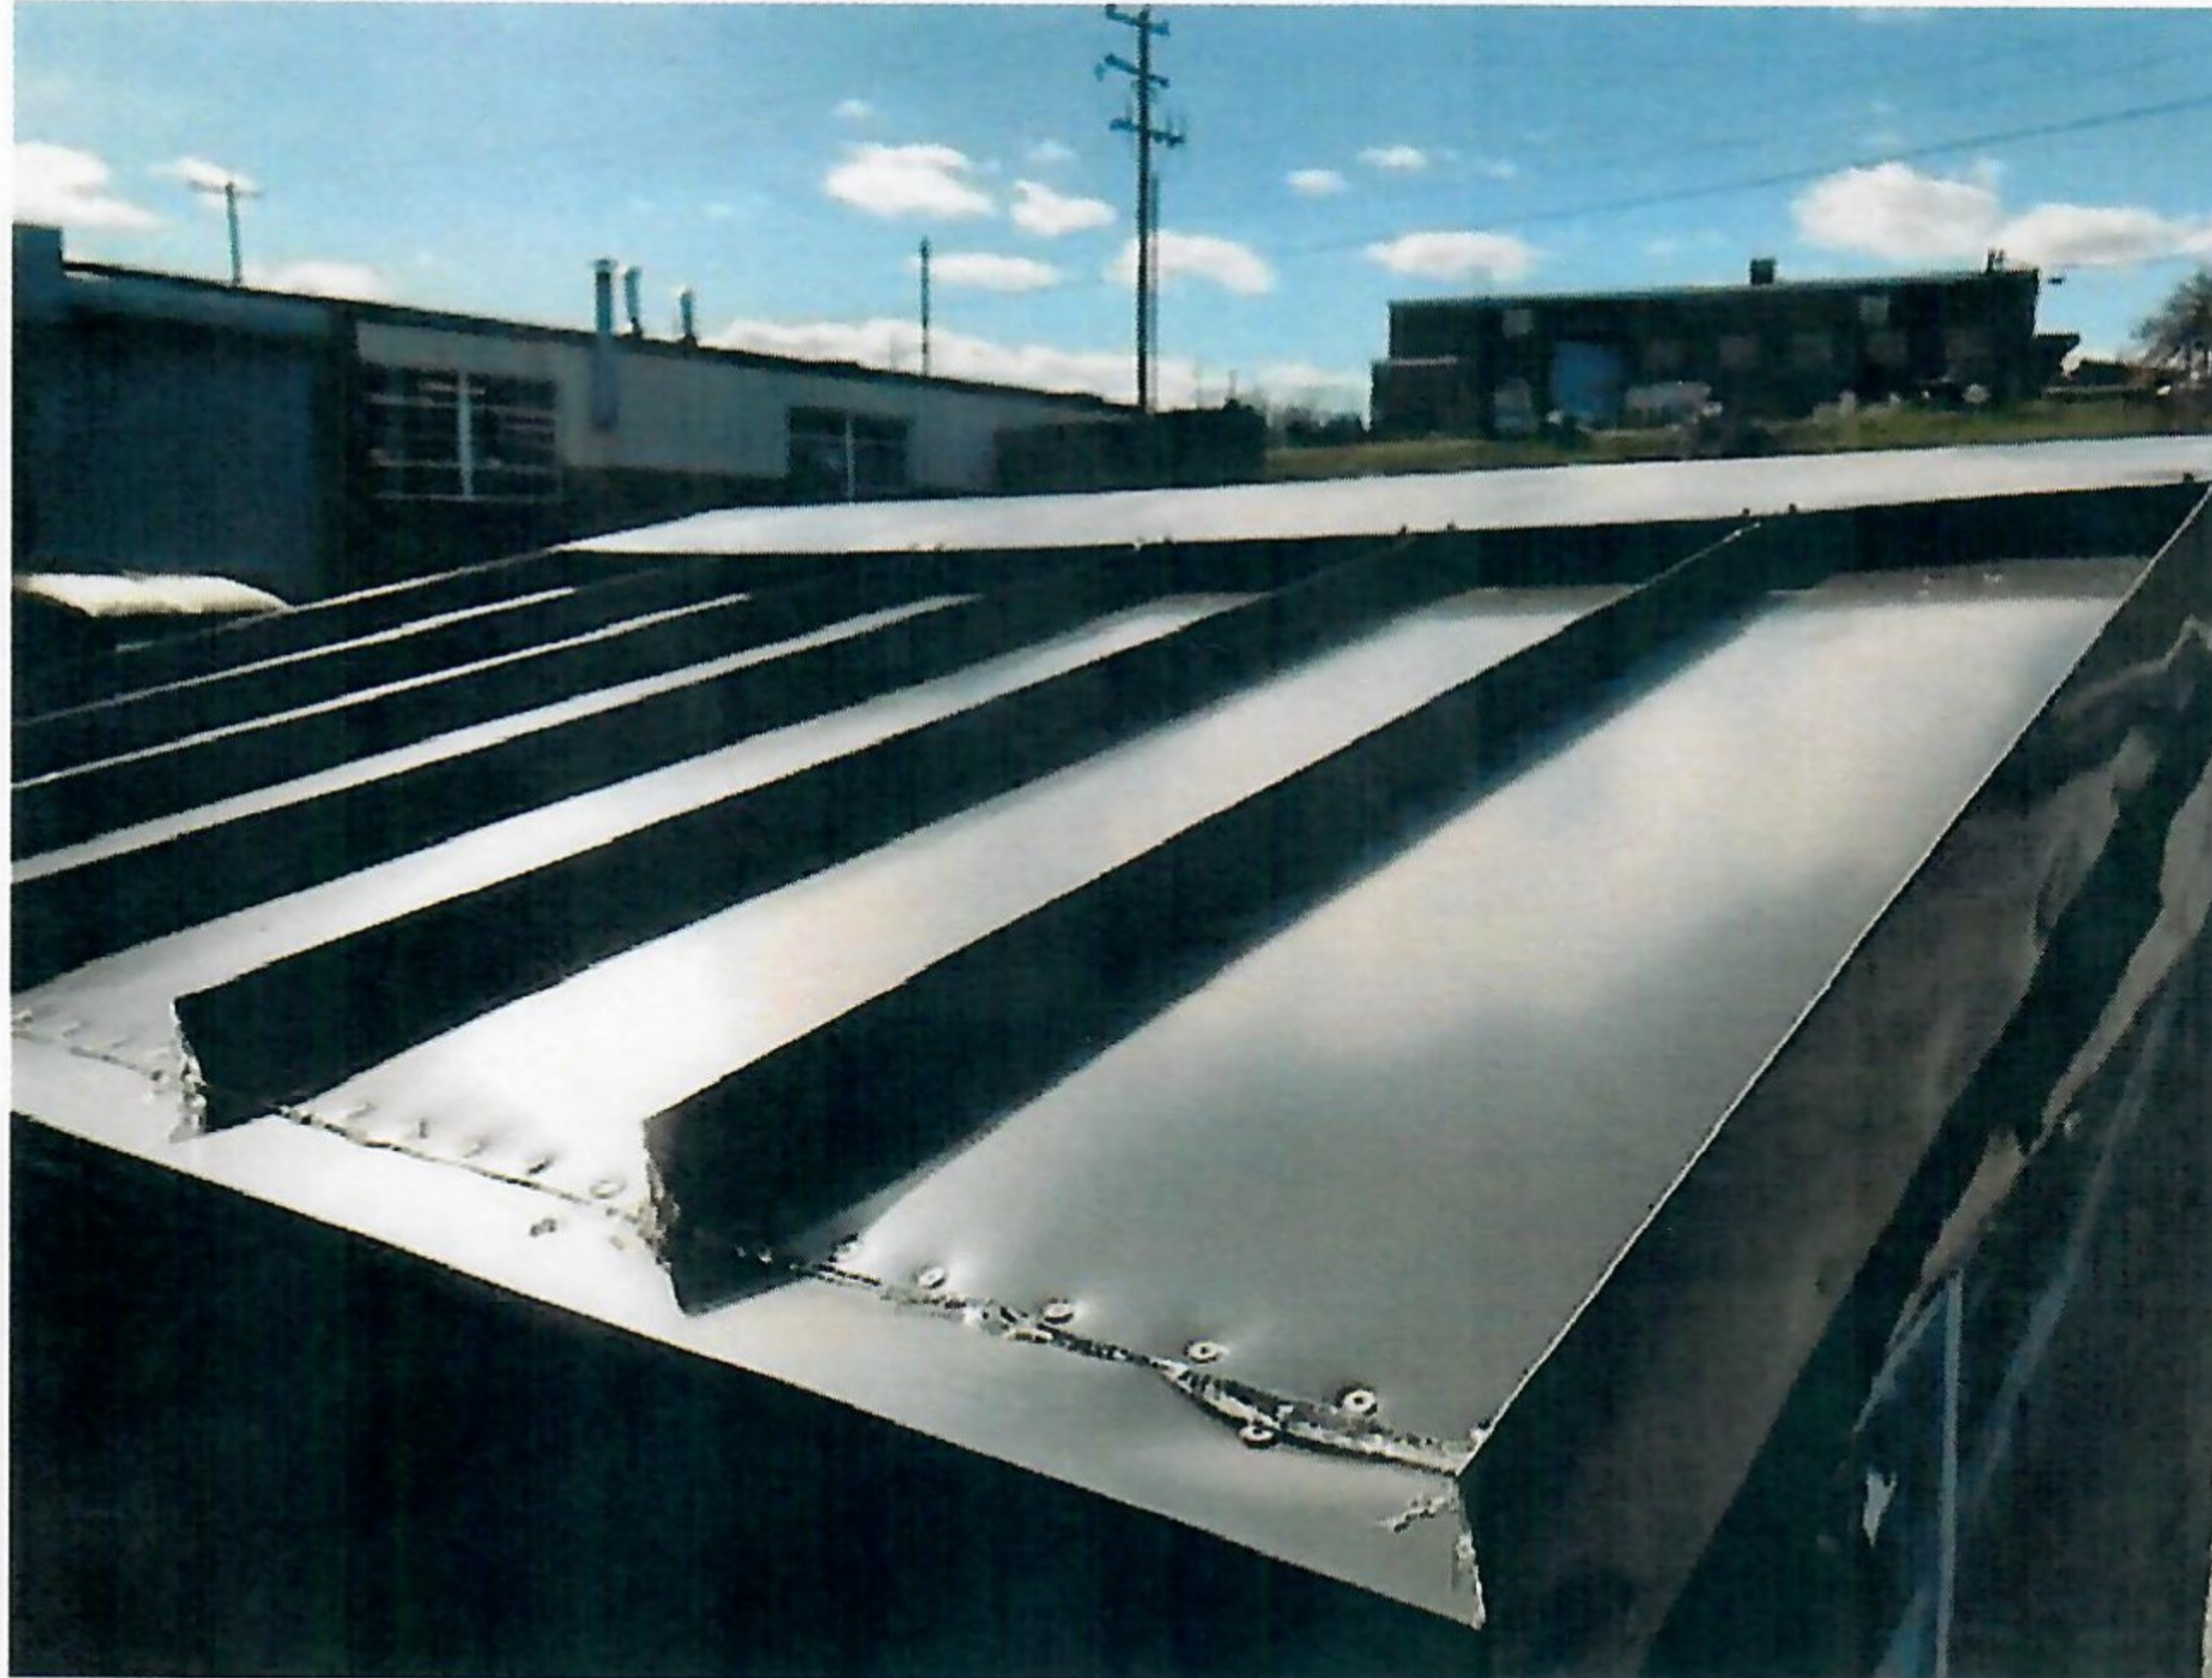
**Photo No. 1**  
**Top Side Before Testing**

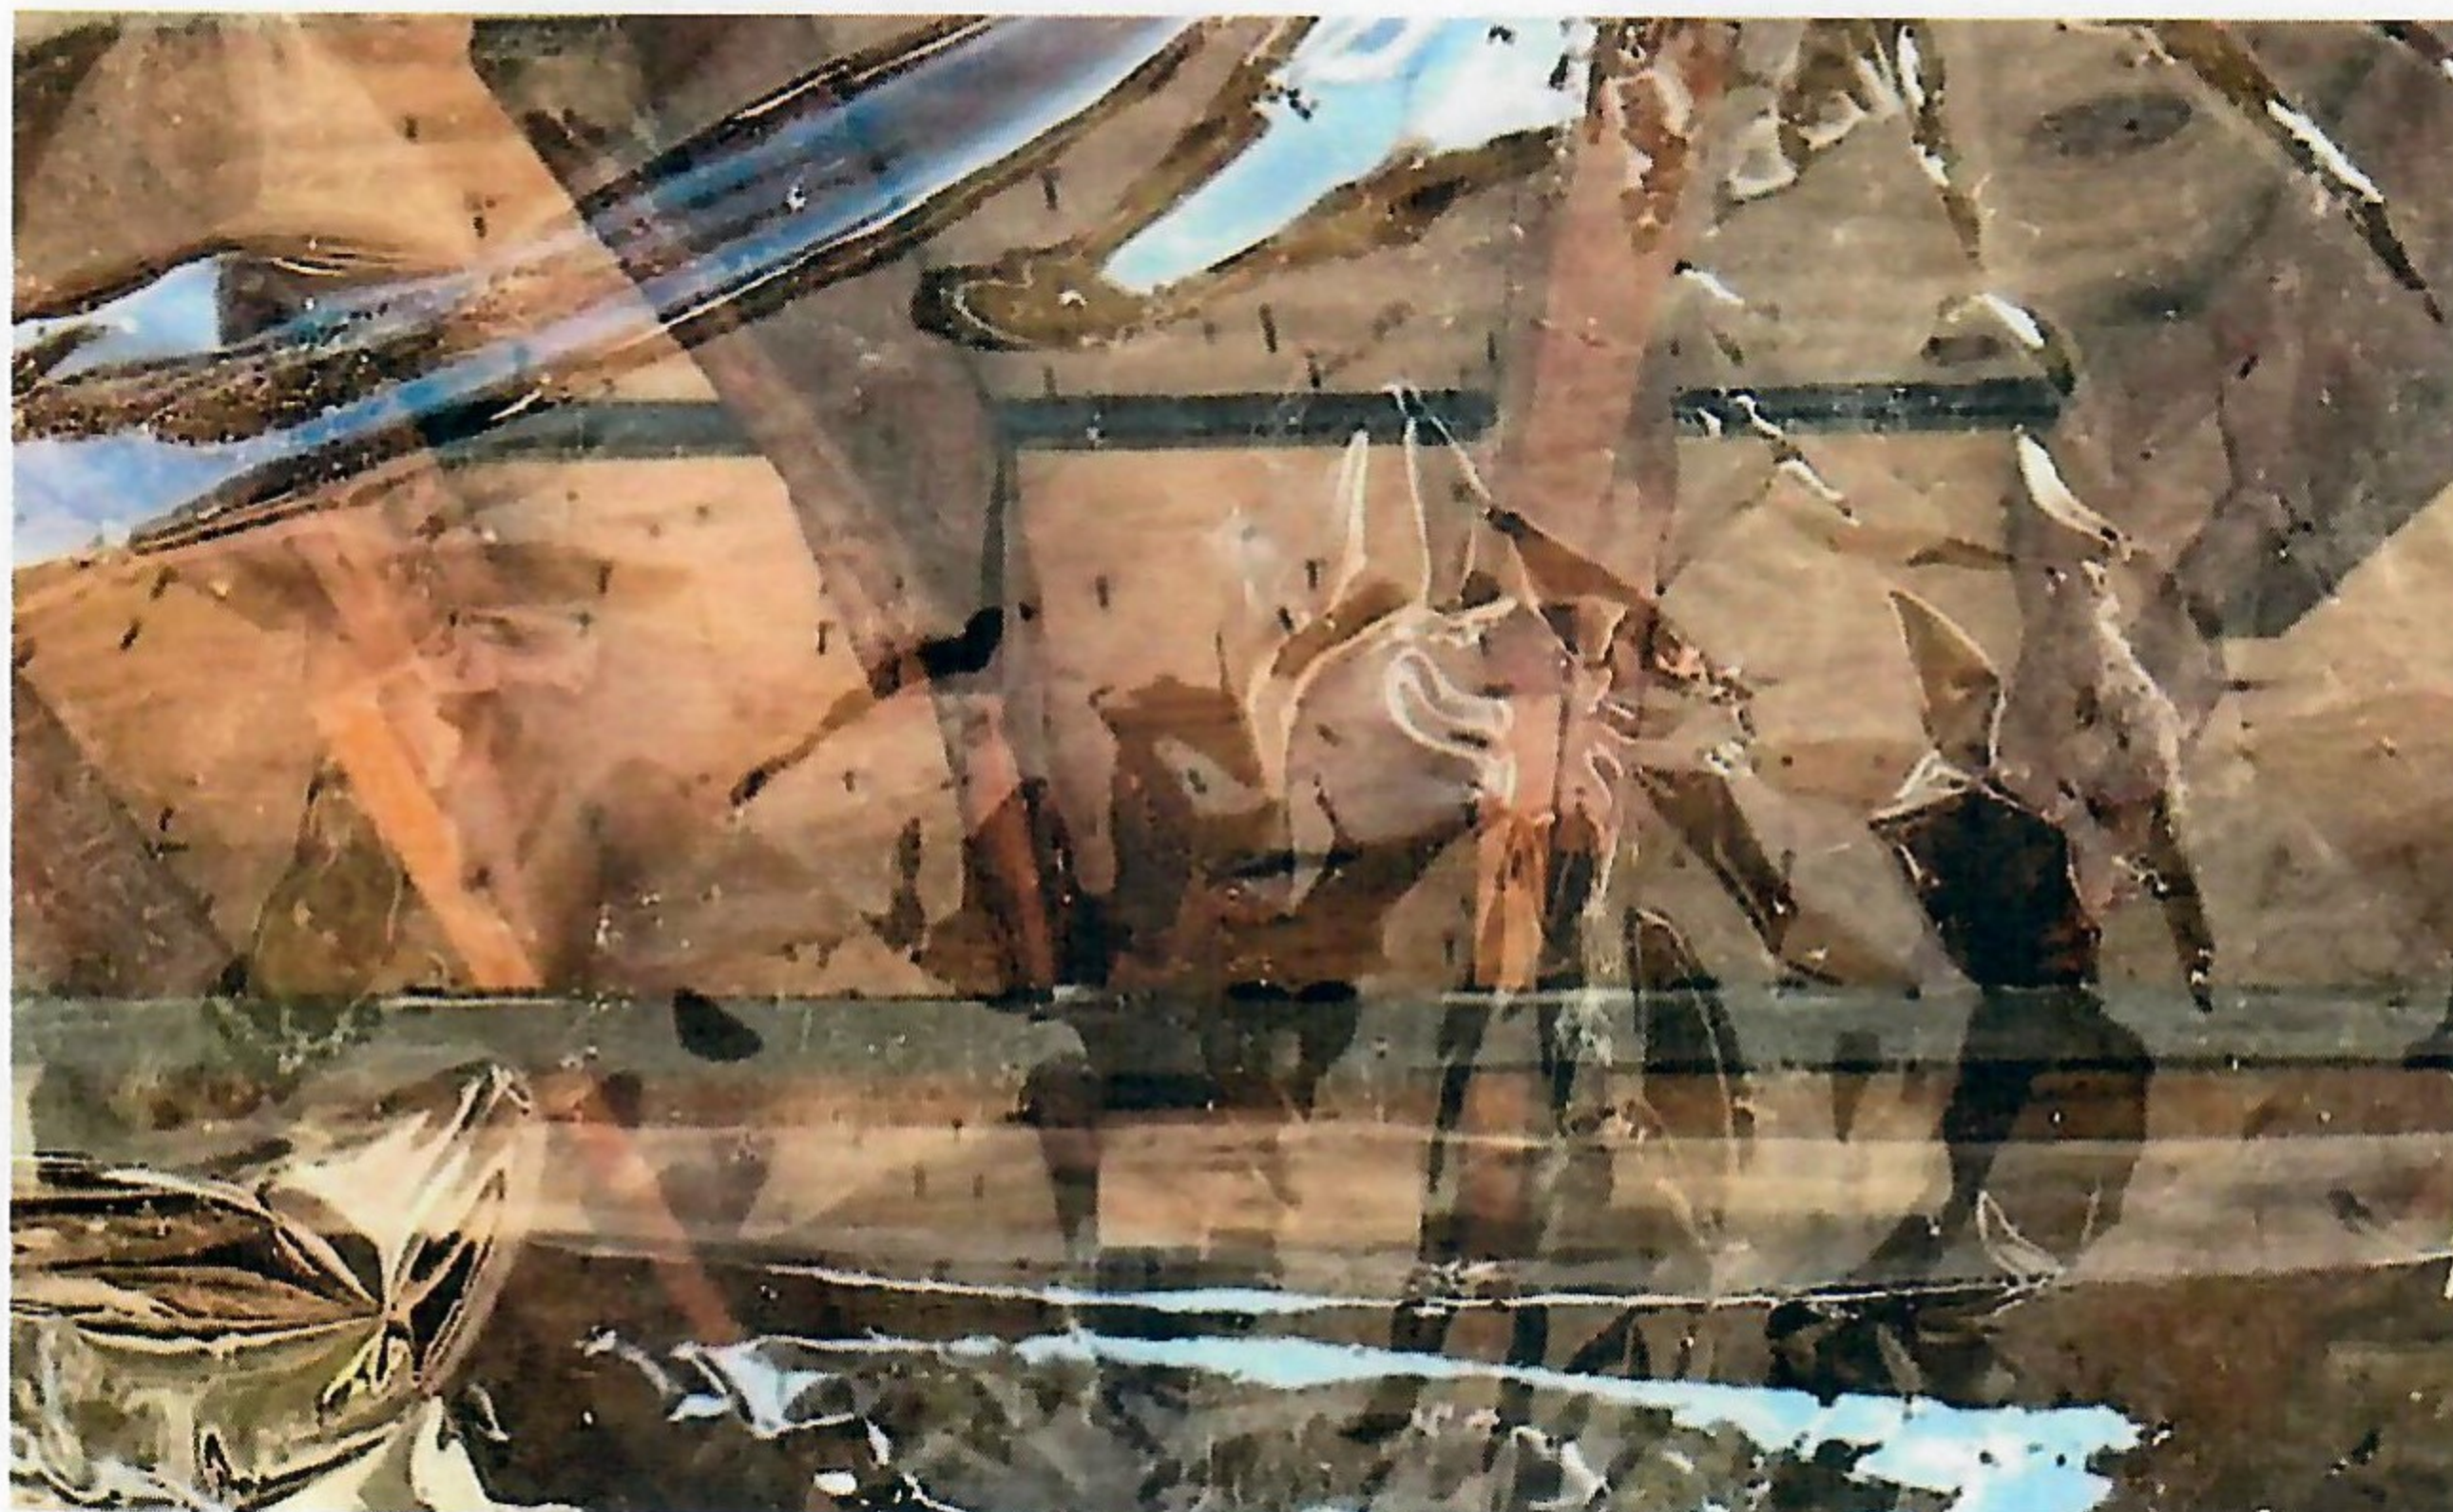
**Photo No. 2**  
**Underside Before Testing**

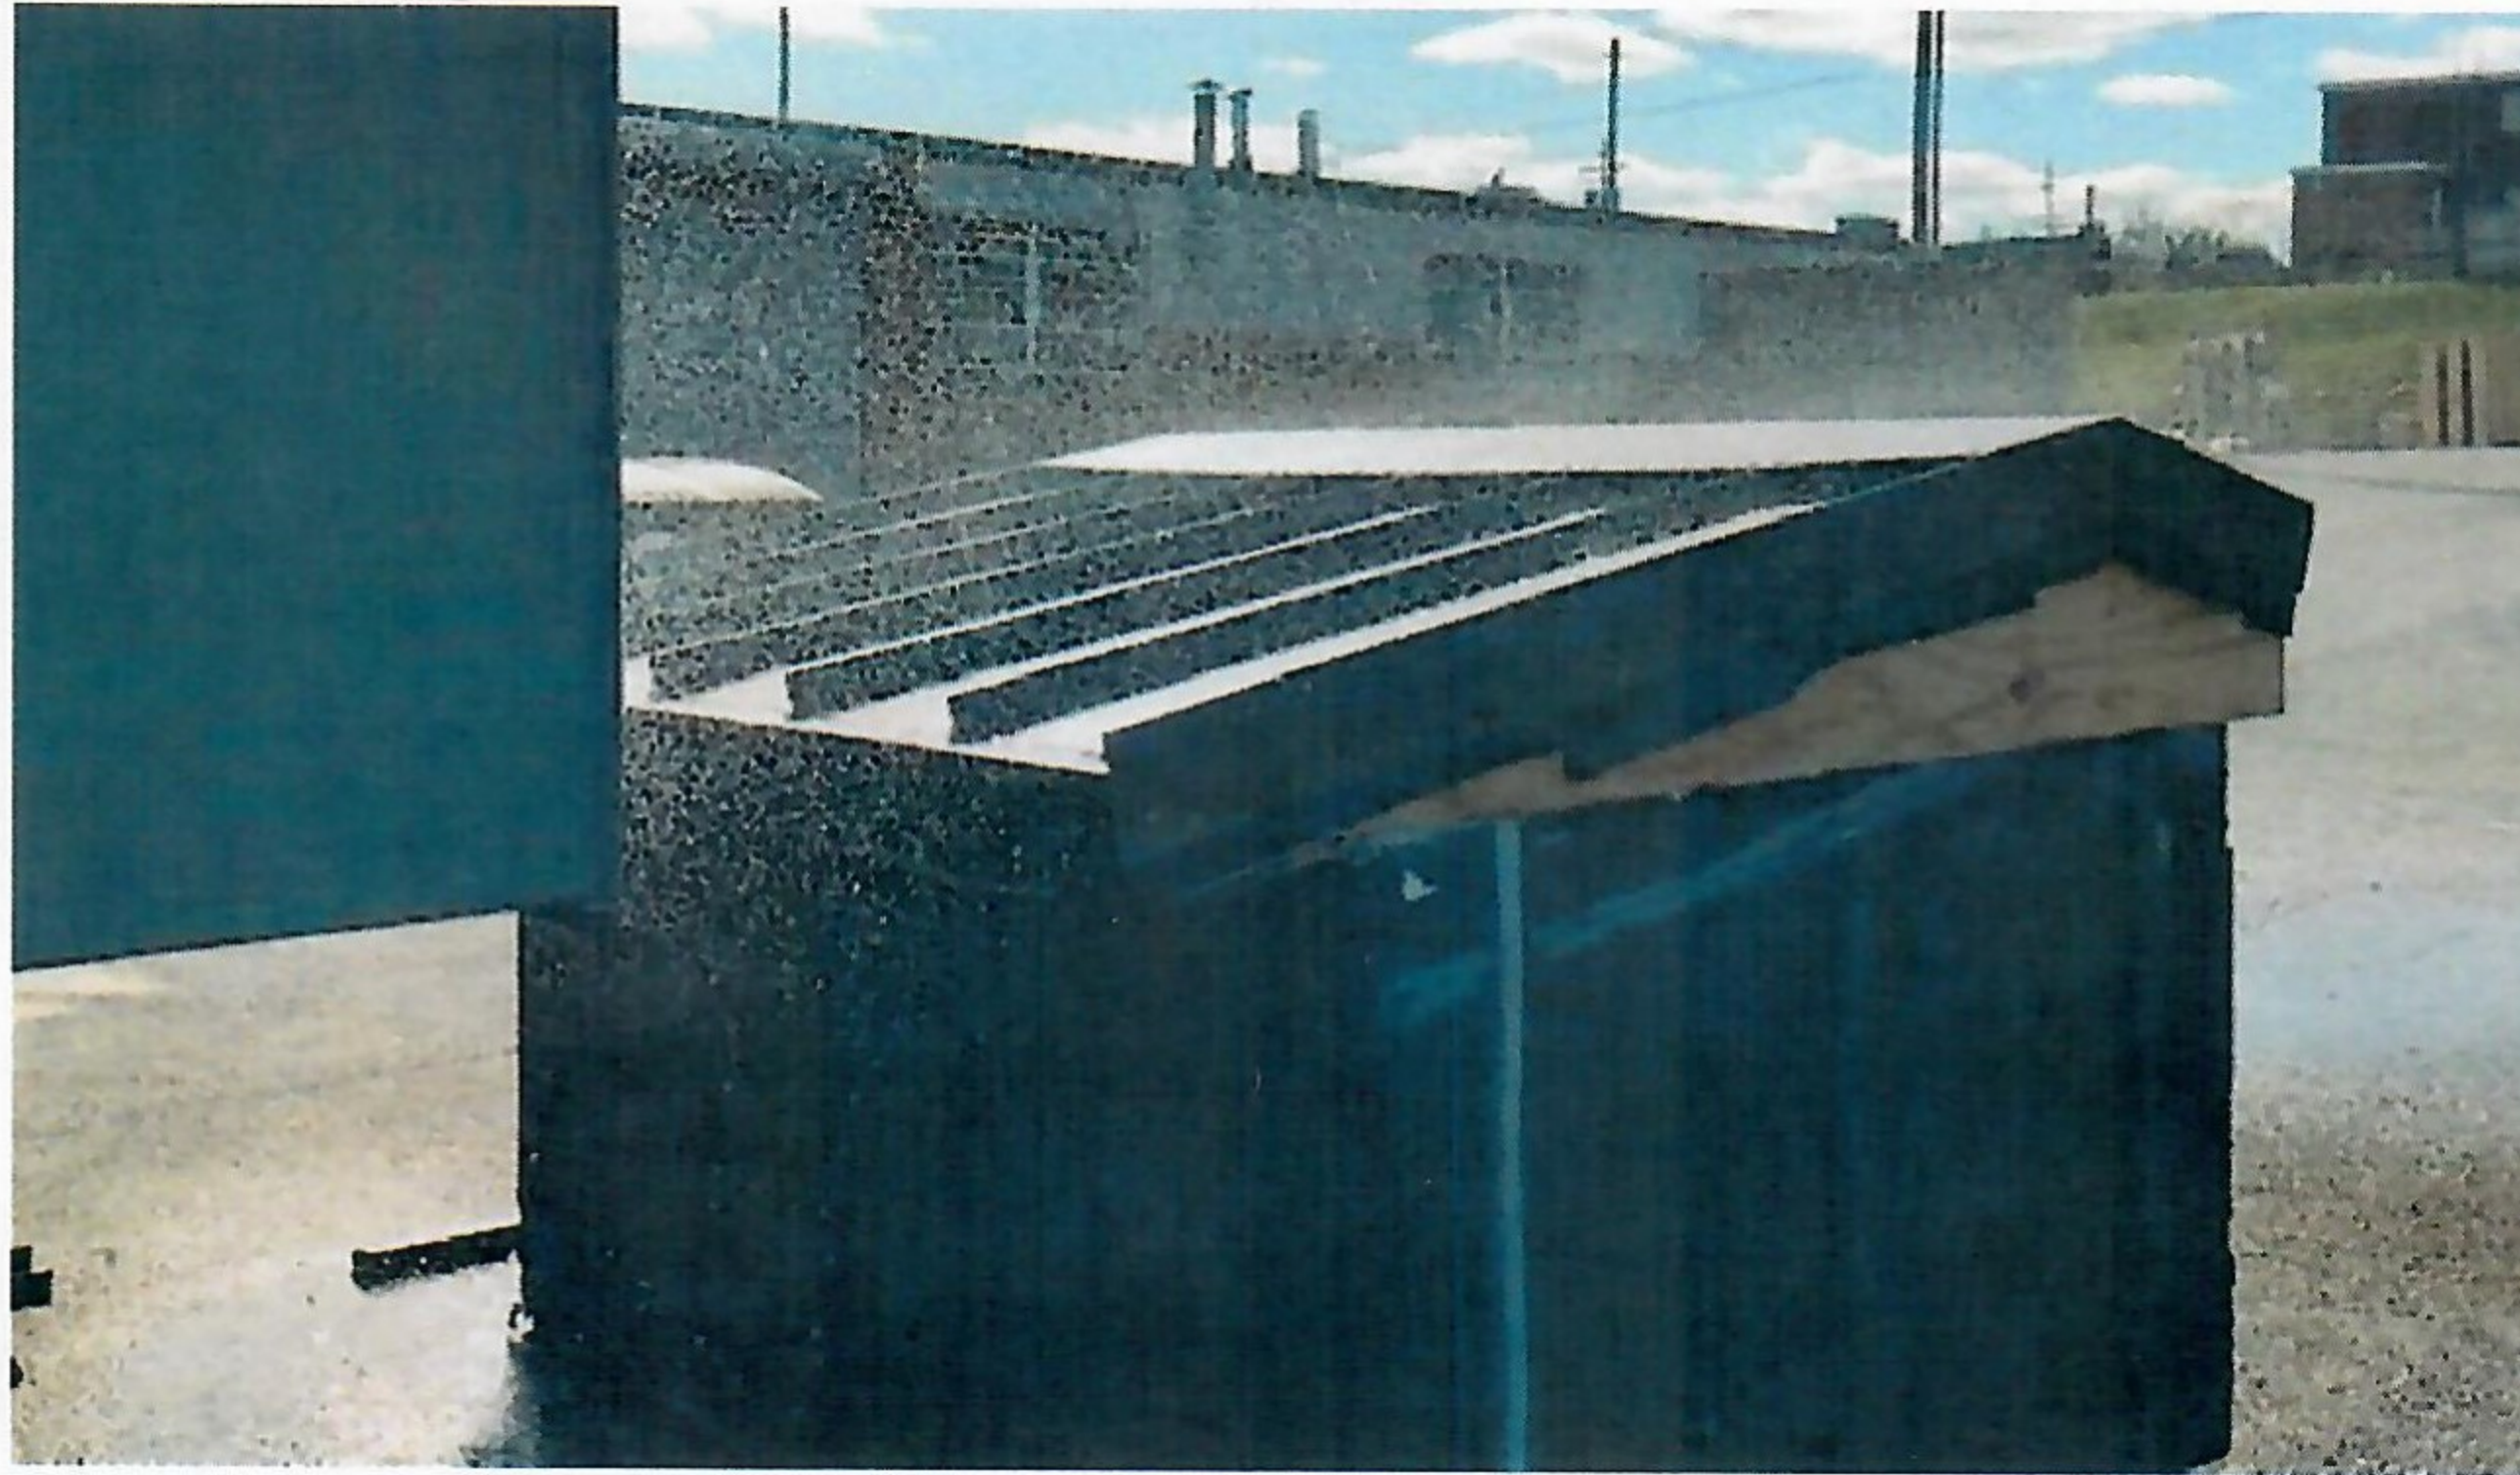
**Photo No. 3**  
**35 MPH Top Side**

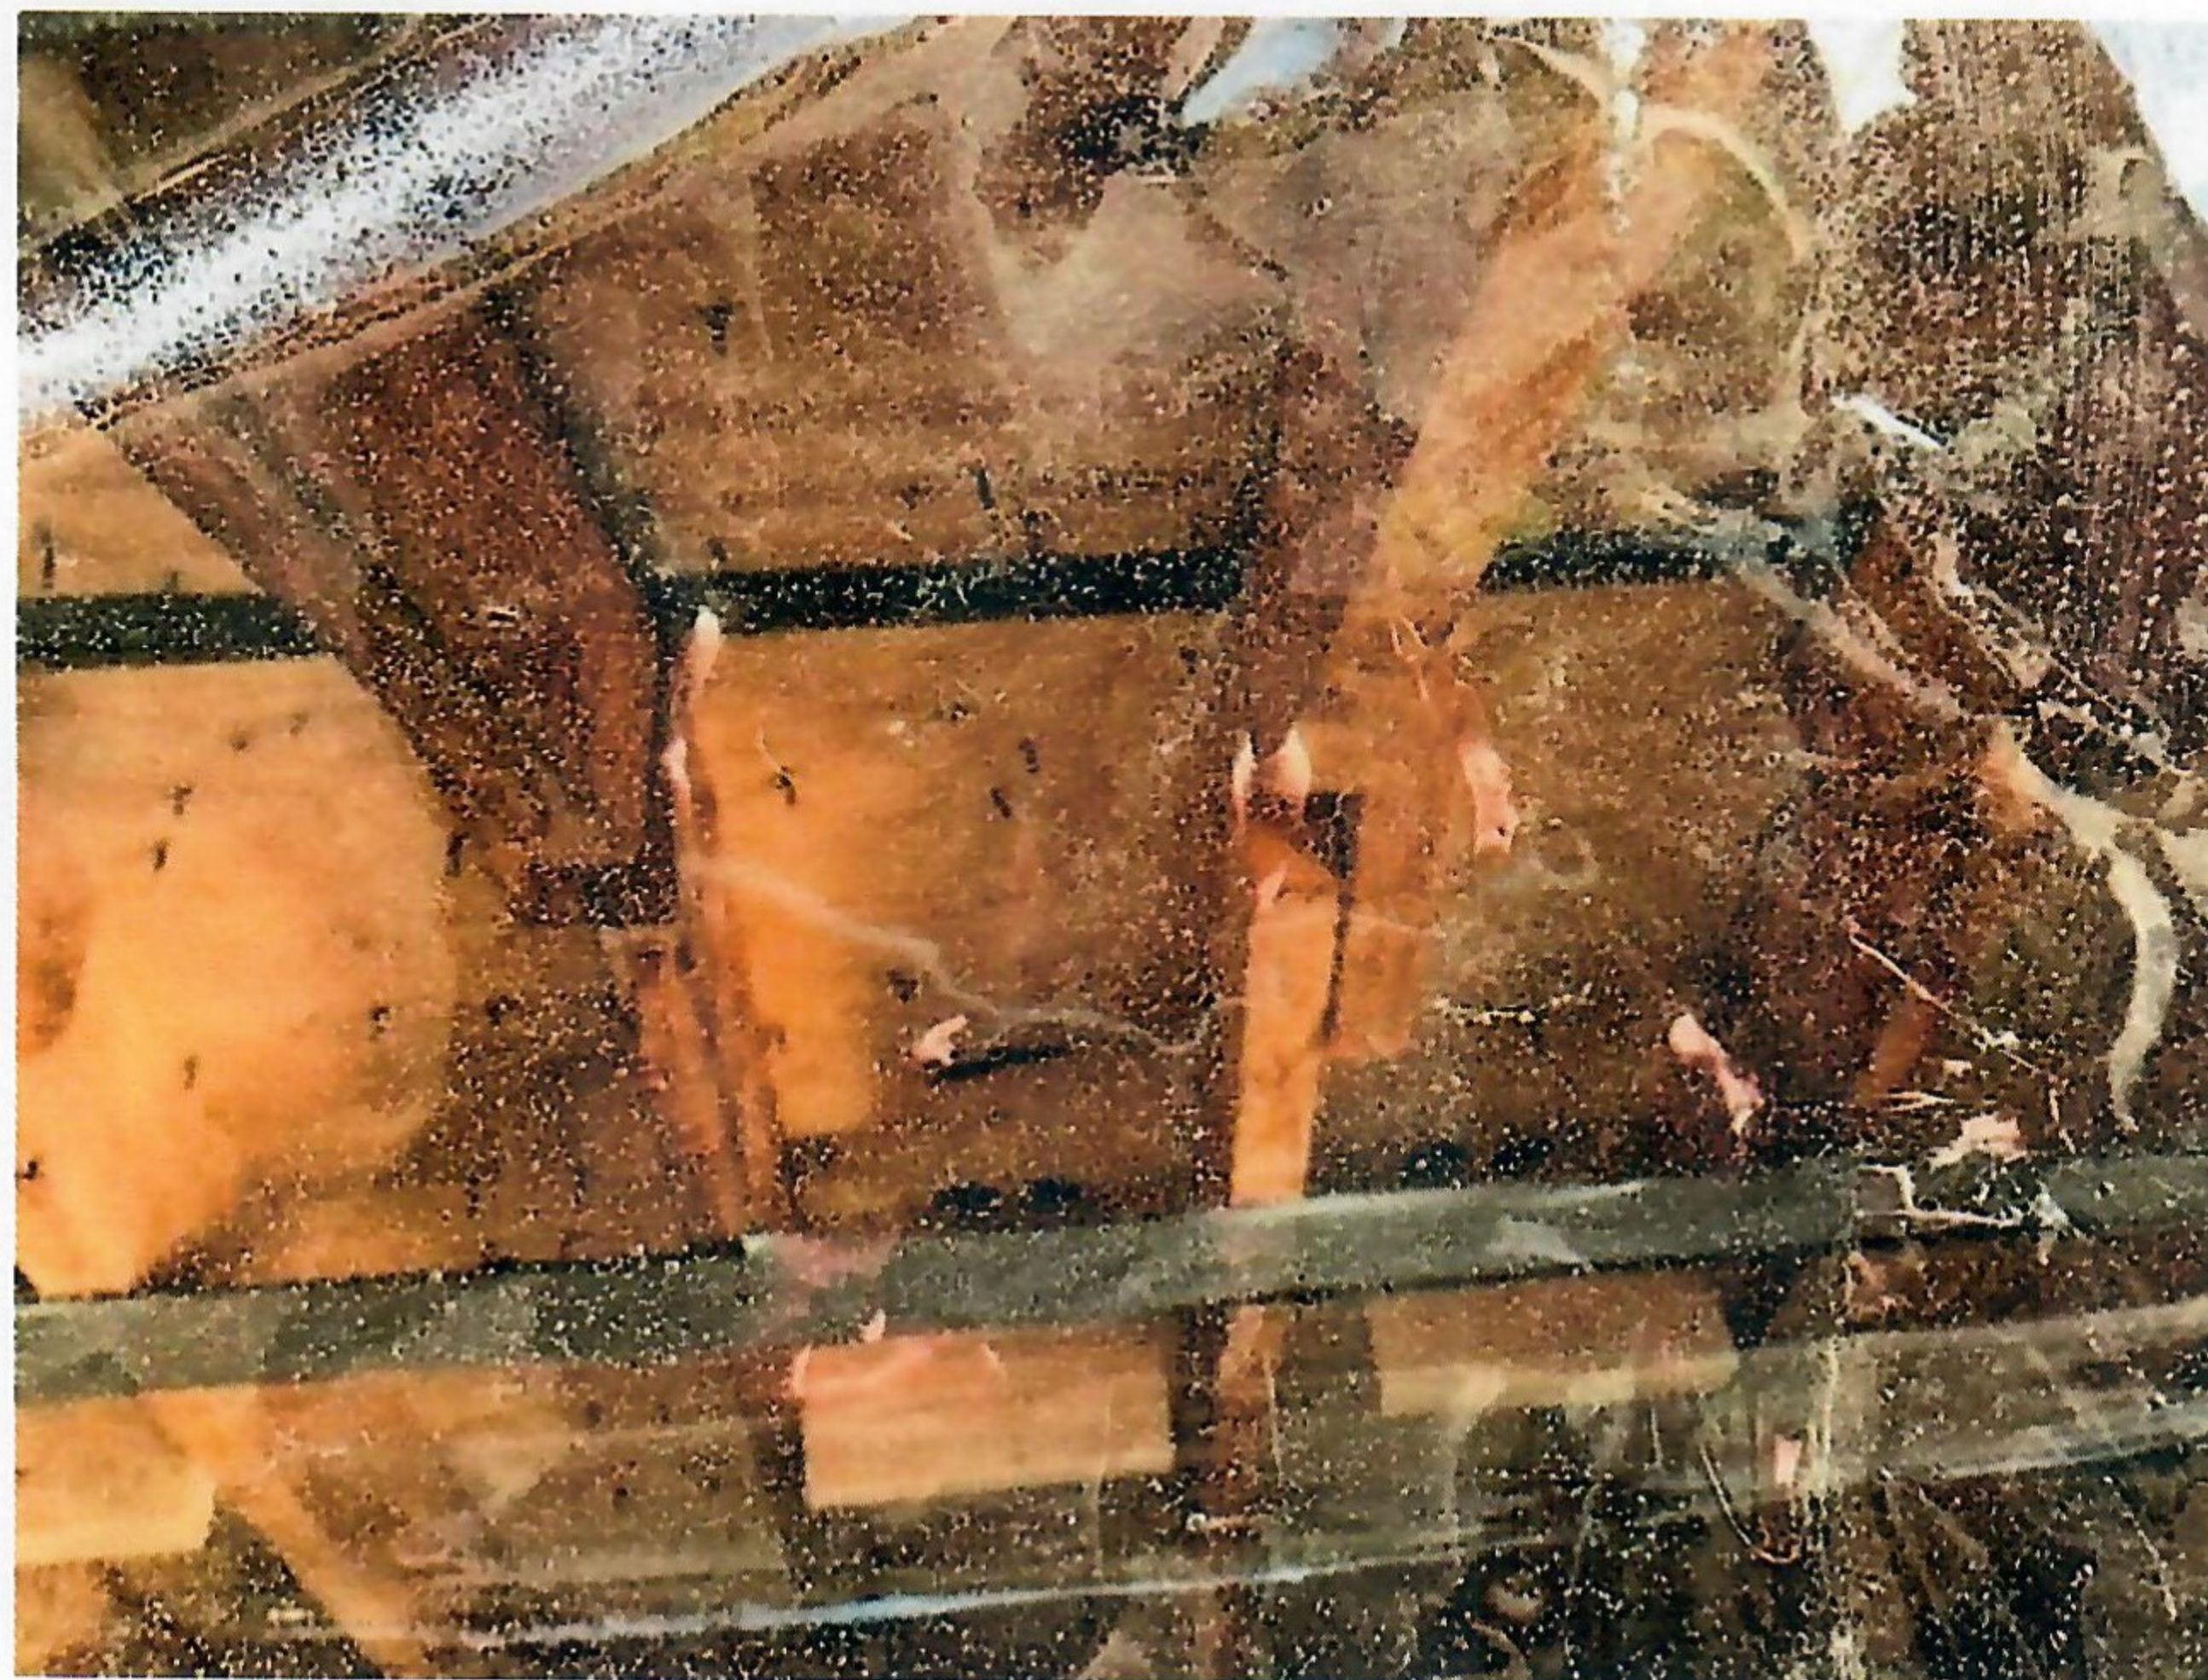
**Photo No. 4**  
**35 MPH Underside**

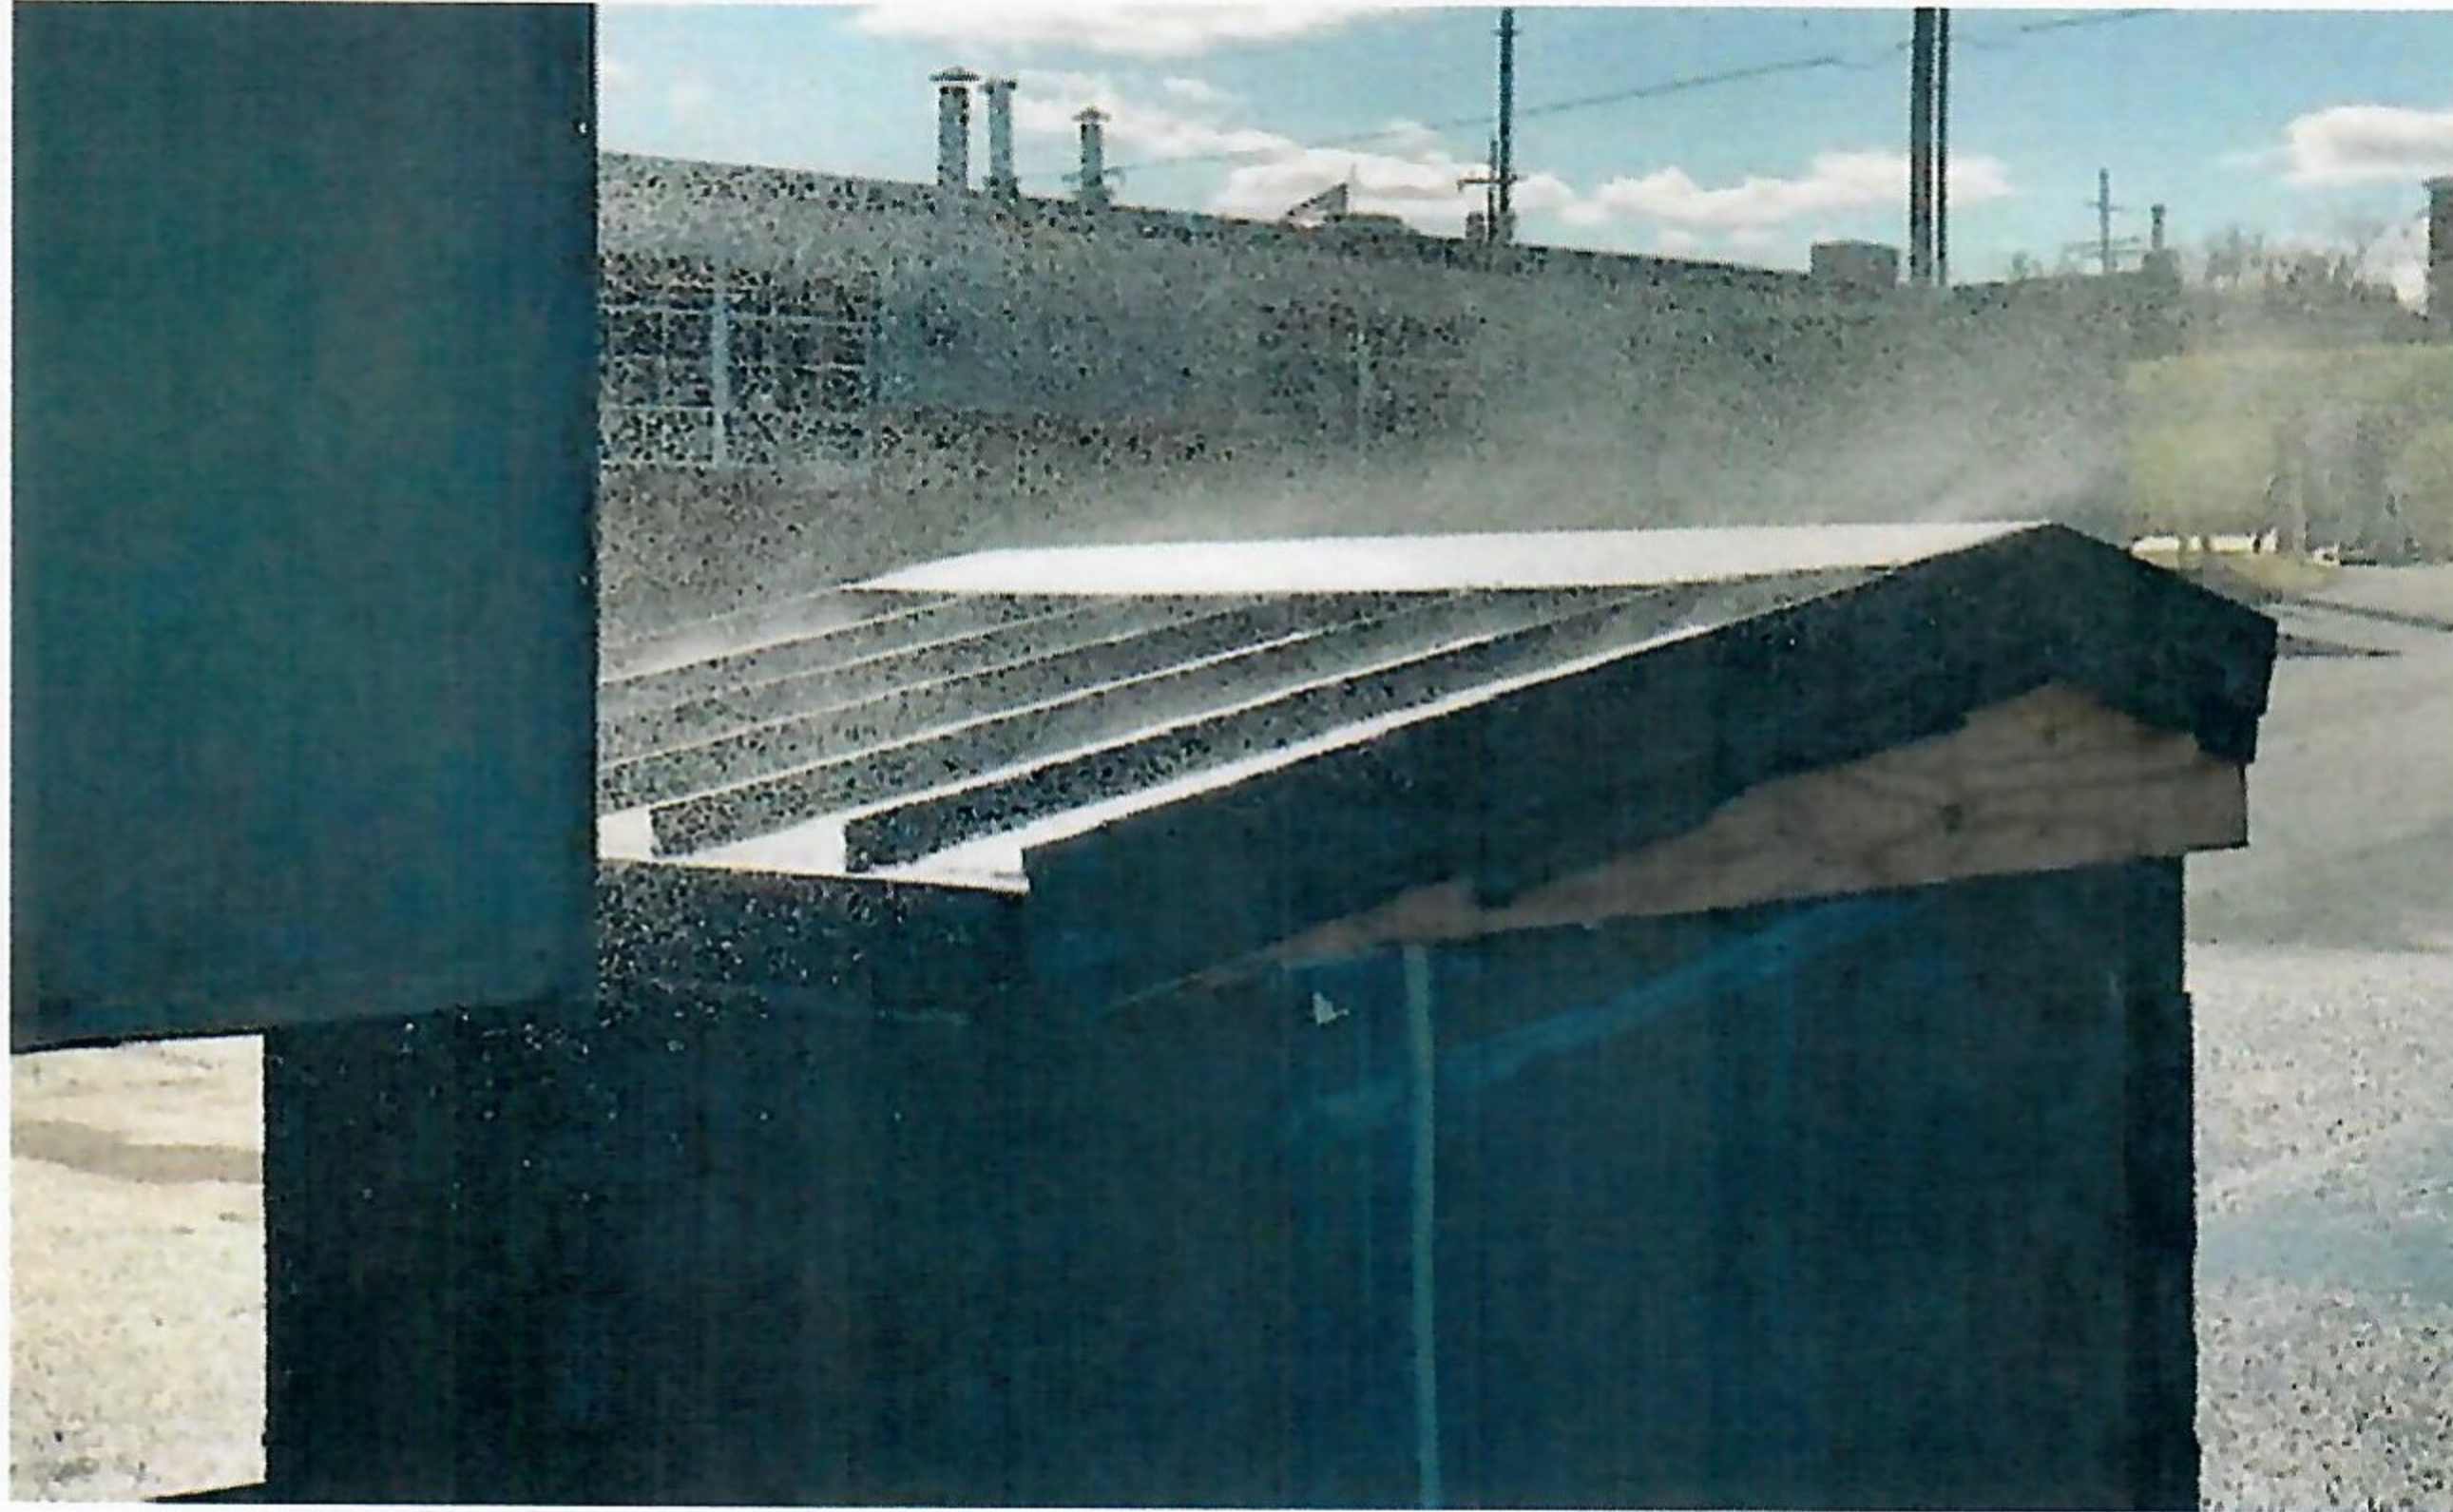
**Photo No. 5**  
**70 MPH Top Side**

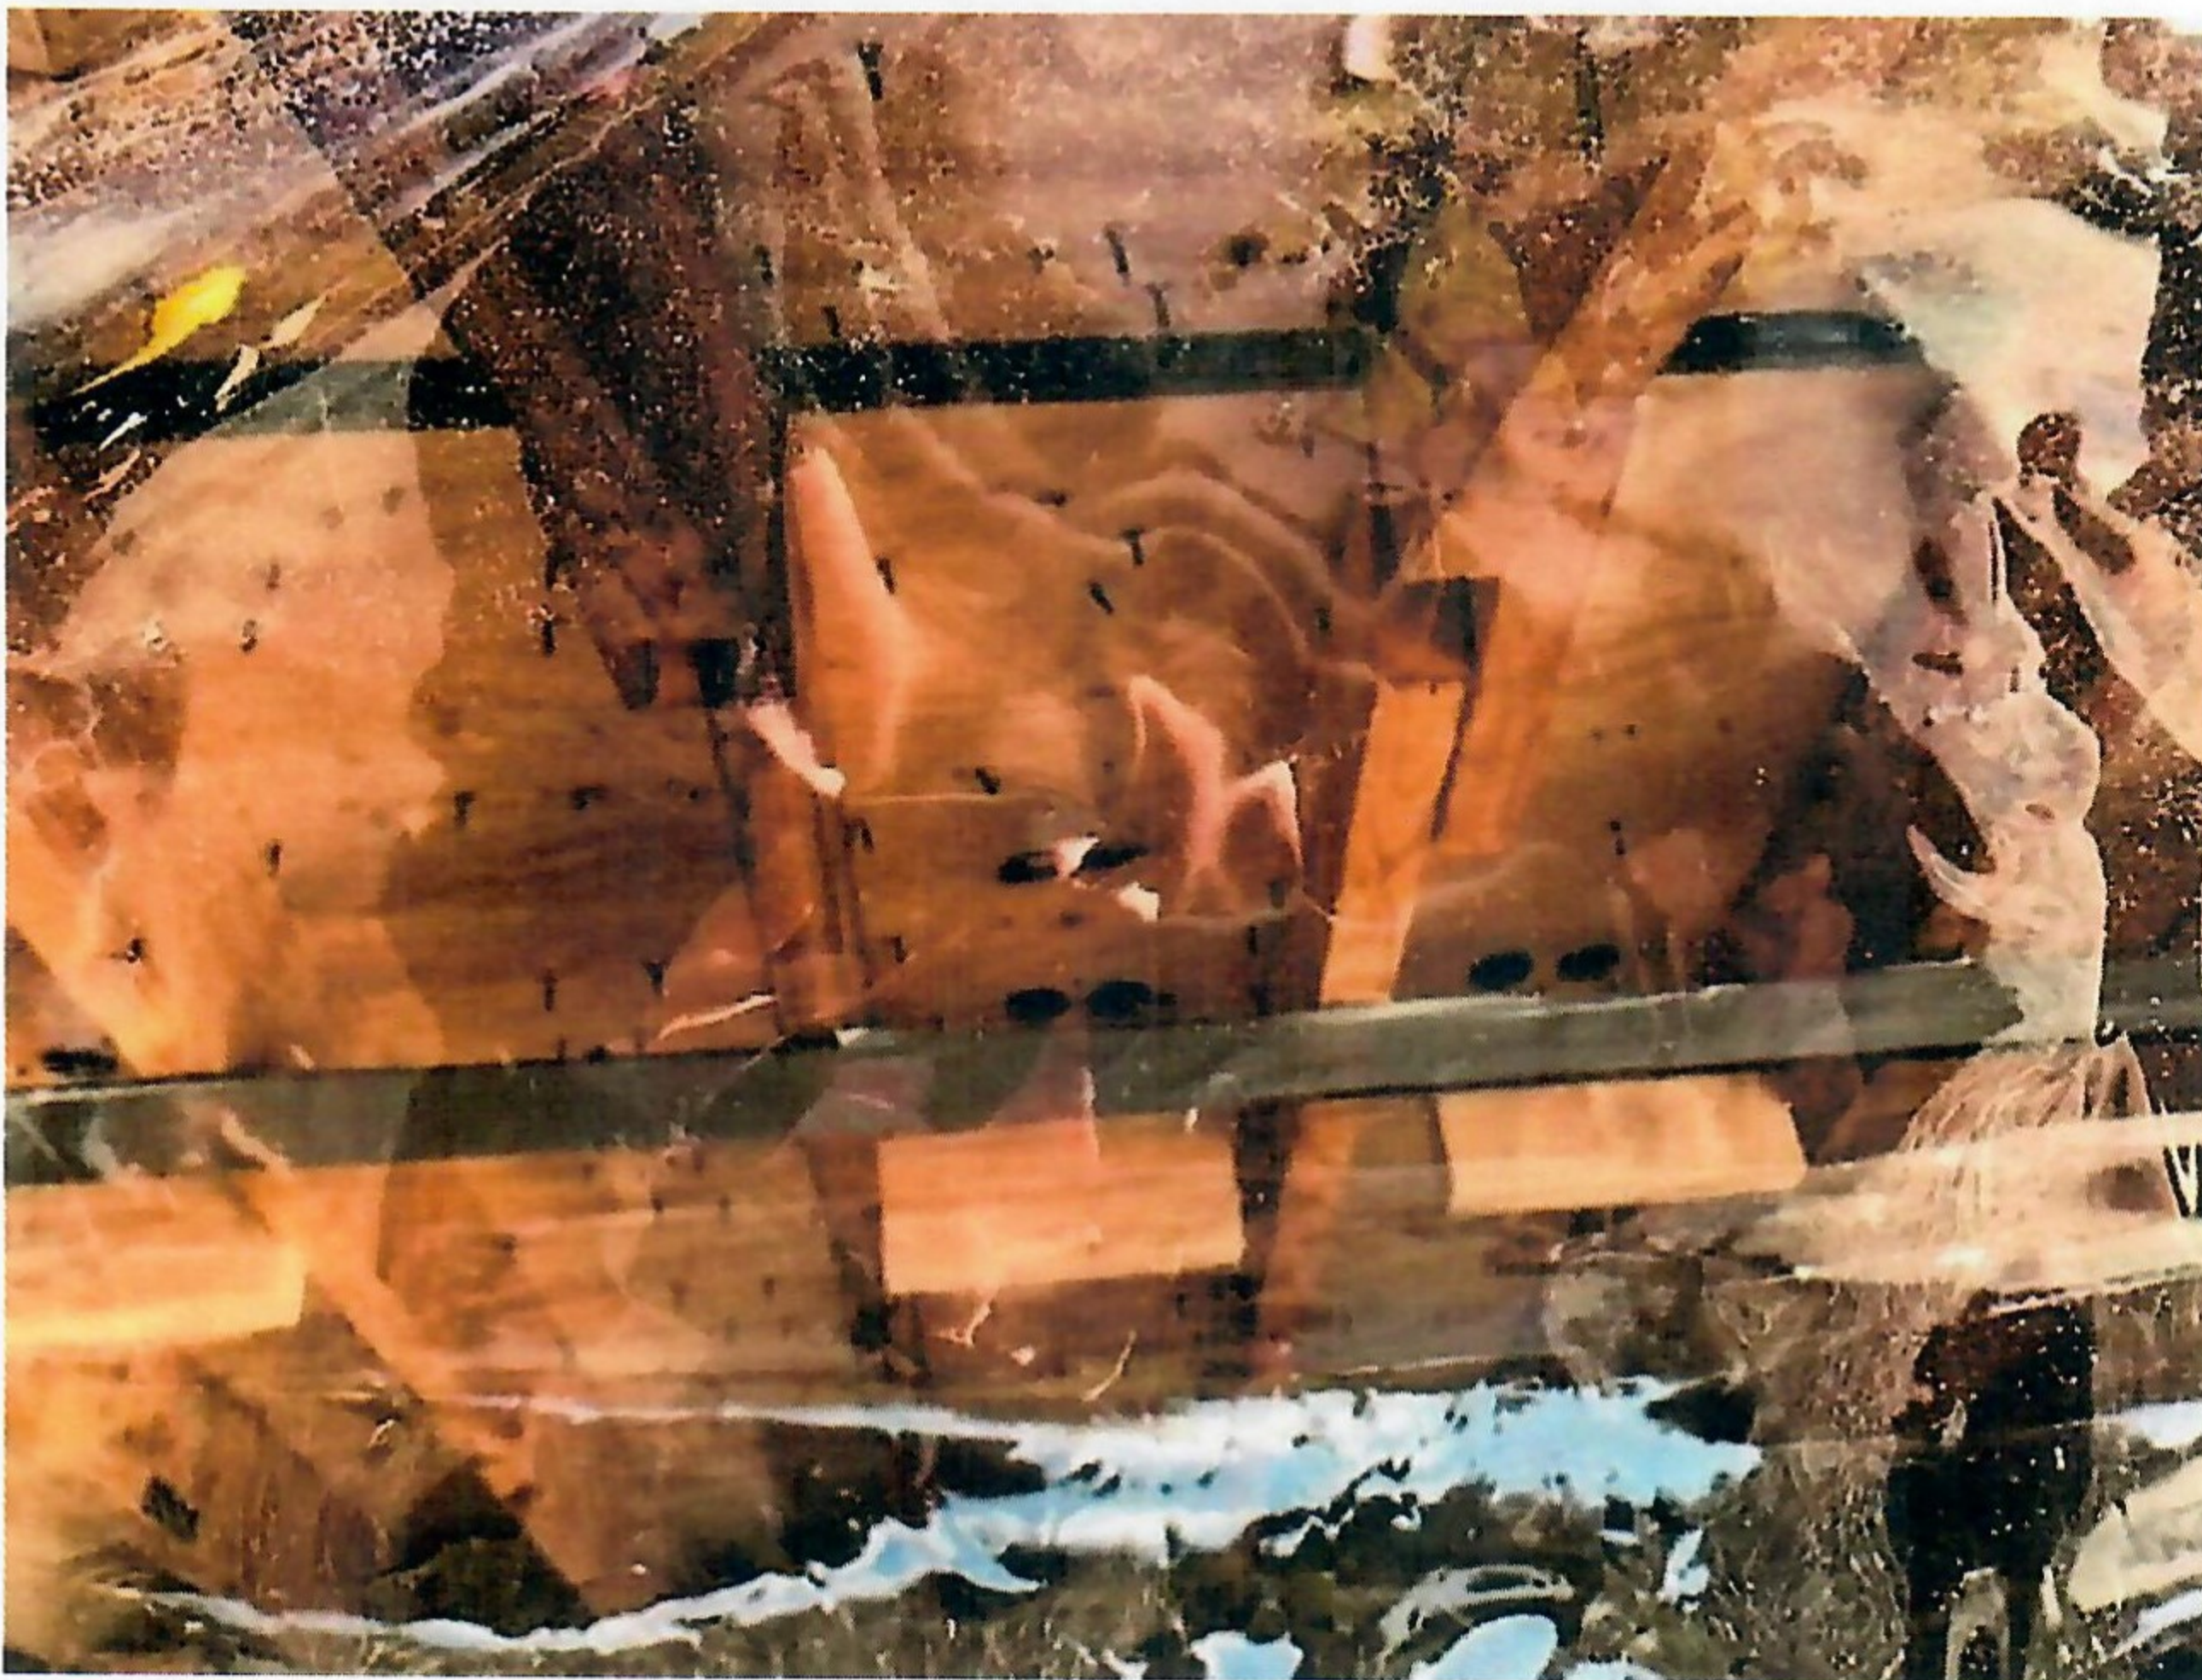
**Photo No. 6**  
**70 MPH Underside**
