# **GLICK METALS LLC**

## **TEST REPORT**

TAS 100(A) TESTING ON SNAP-Z, RIDGE VENT

K8029.01-109-18

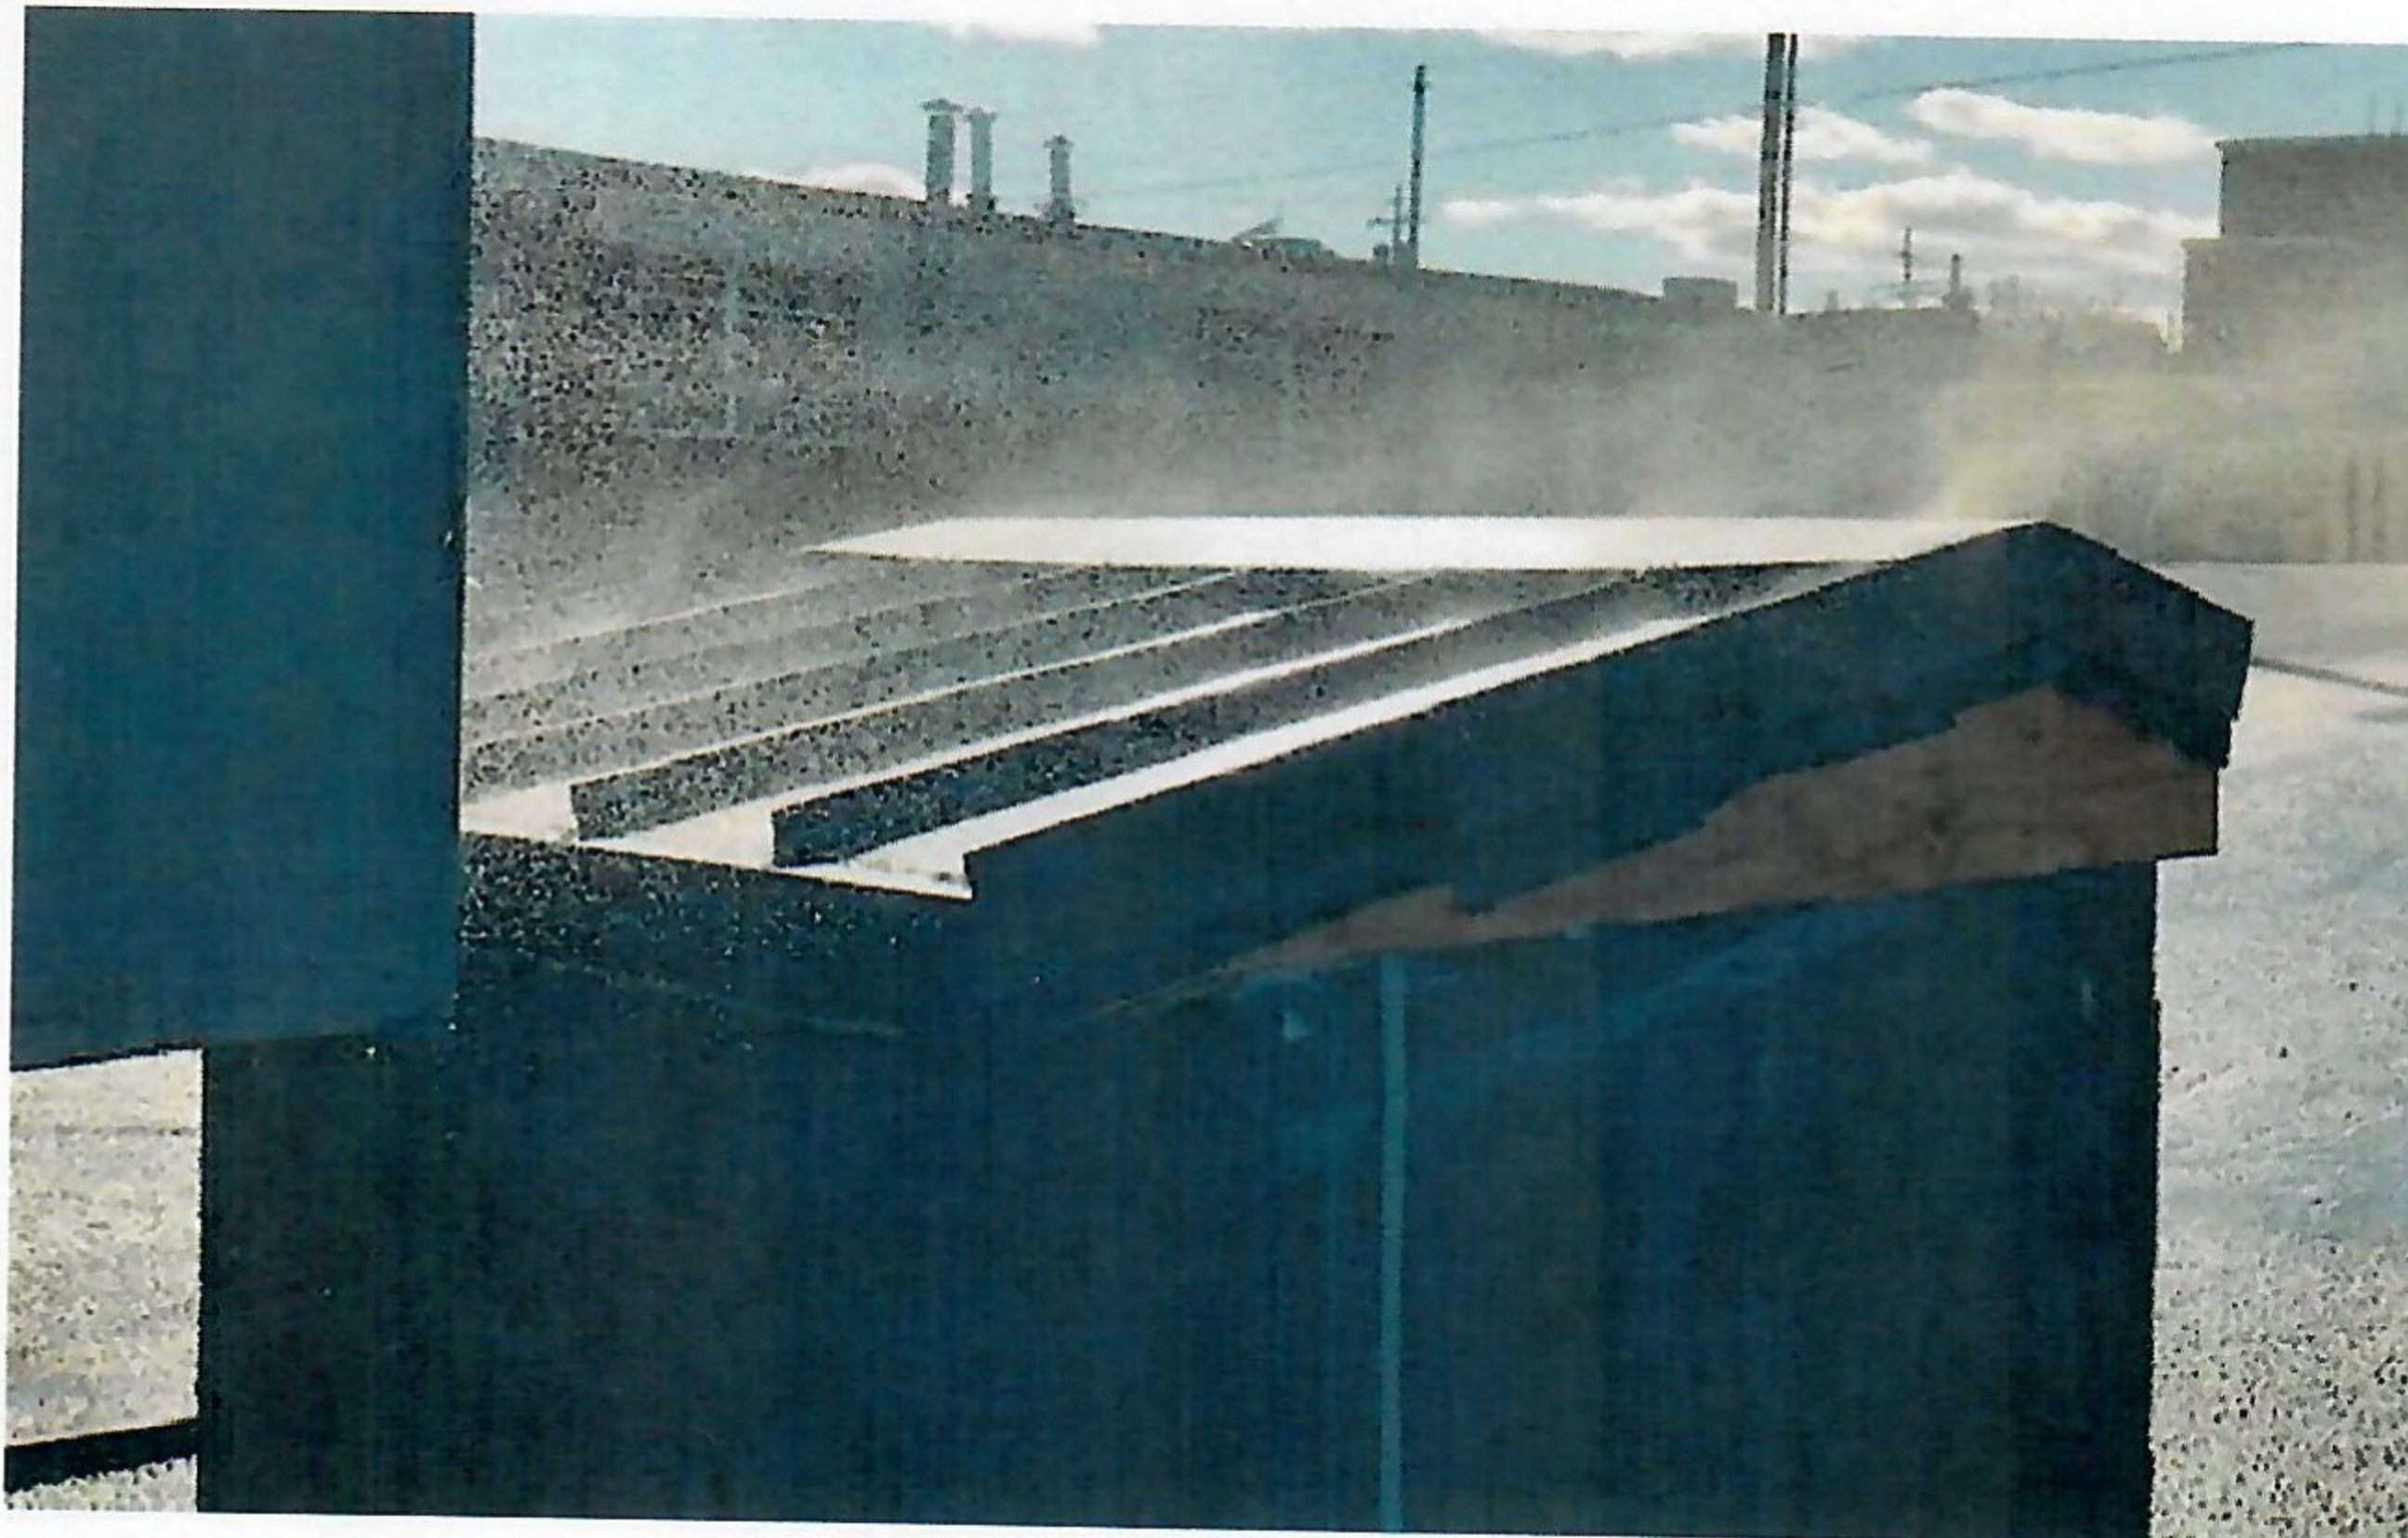
**Photo No. 7**  
**90 MPH Top side**

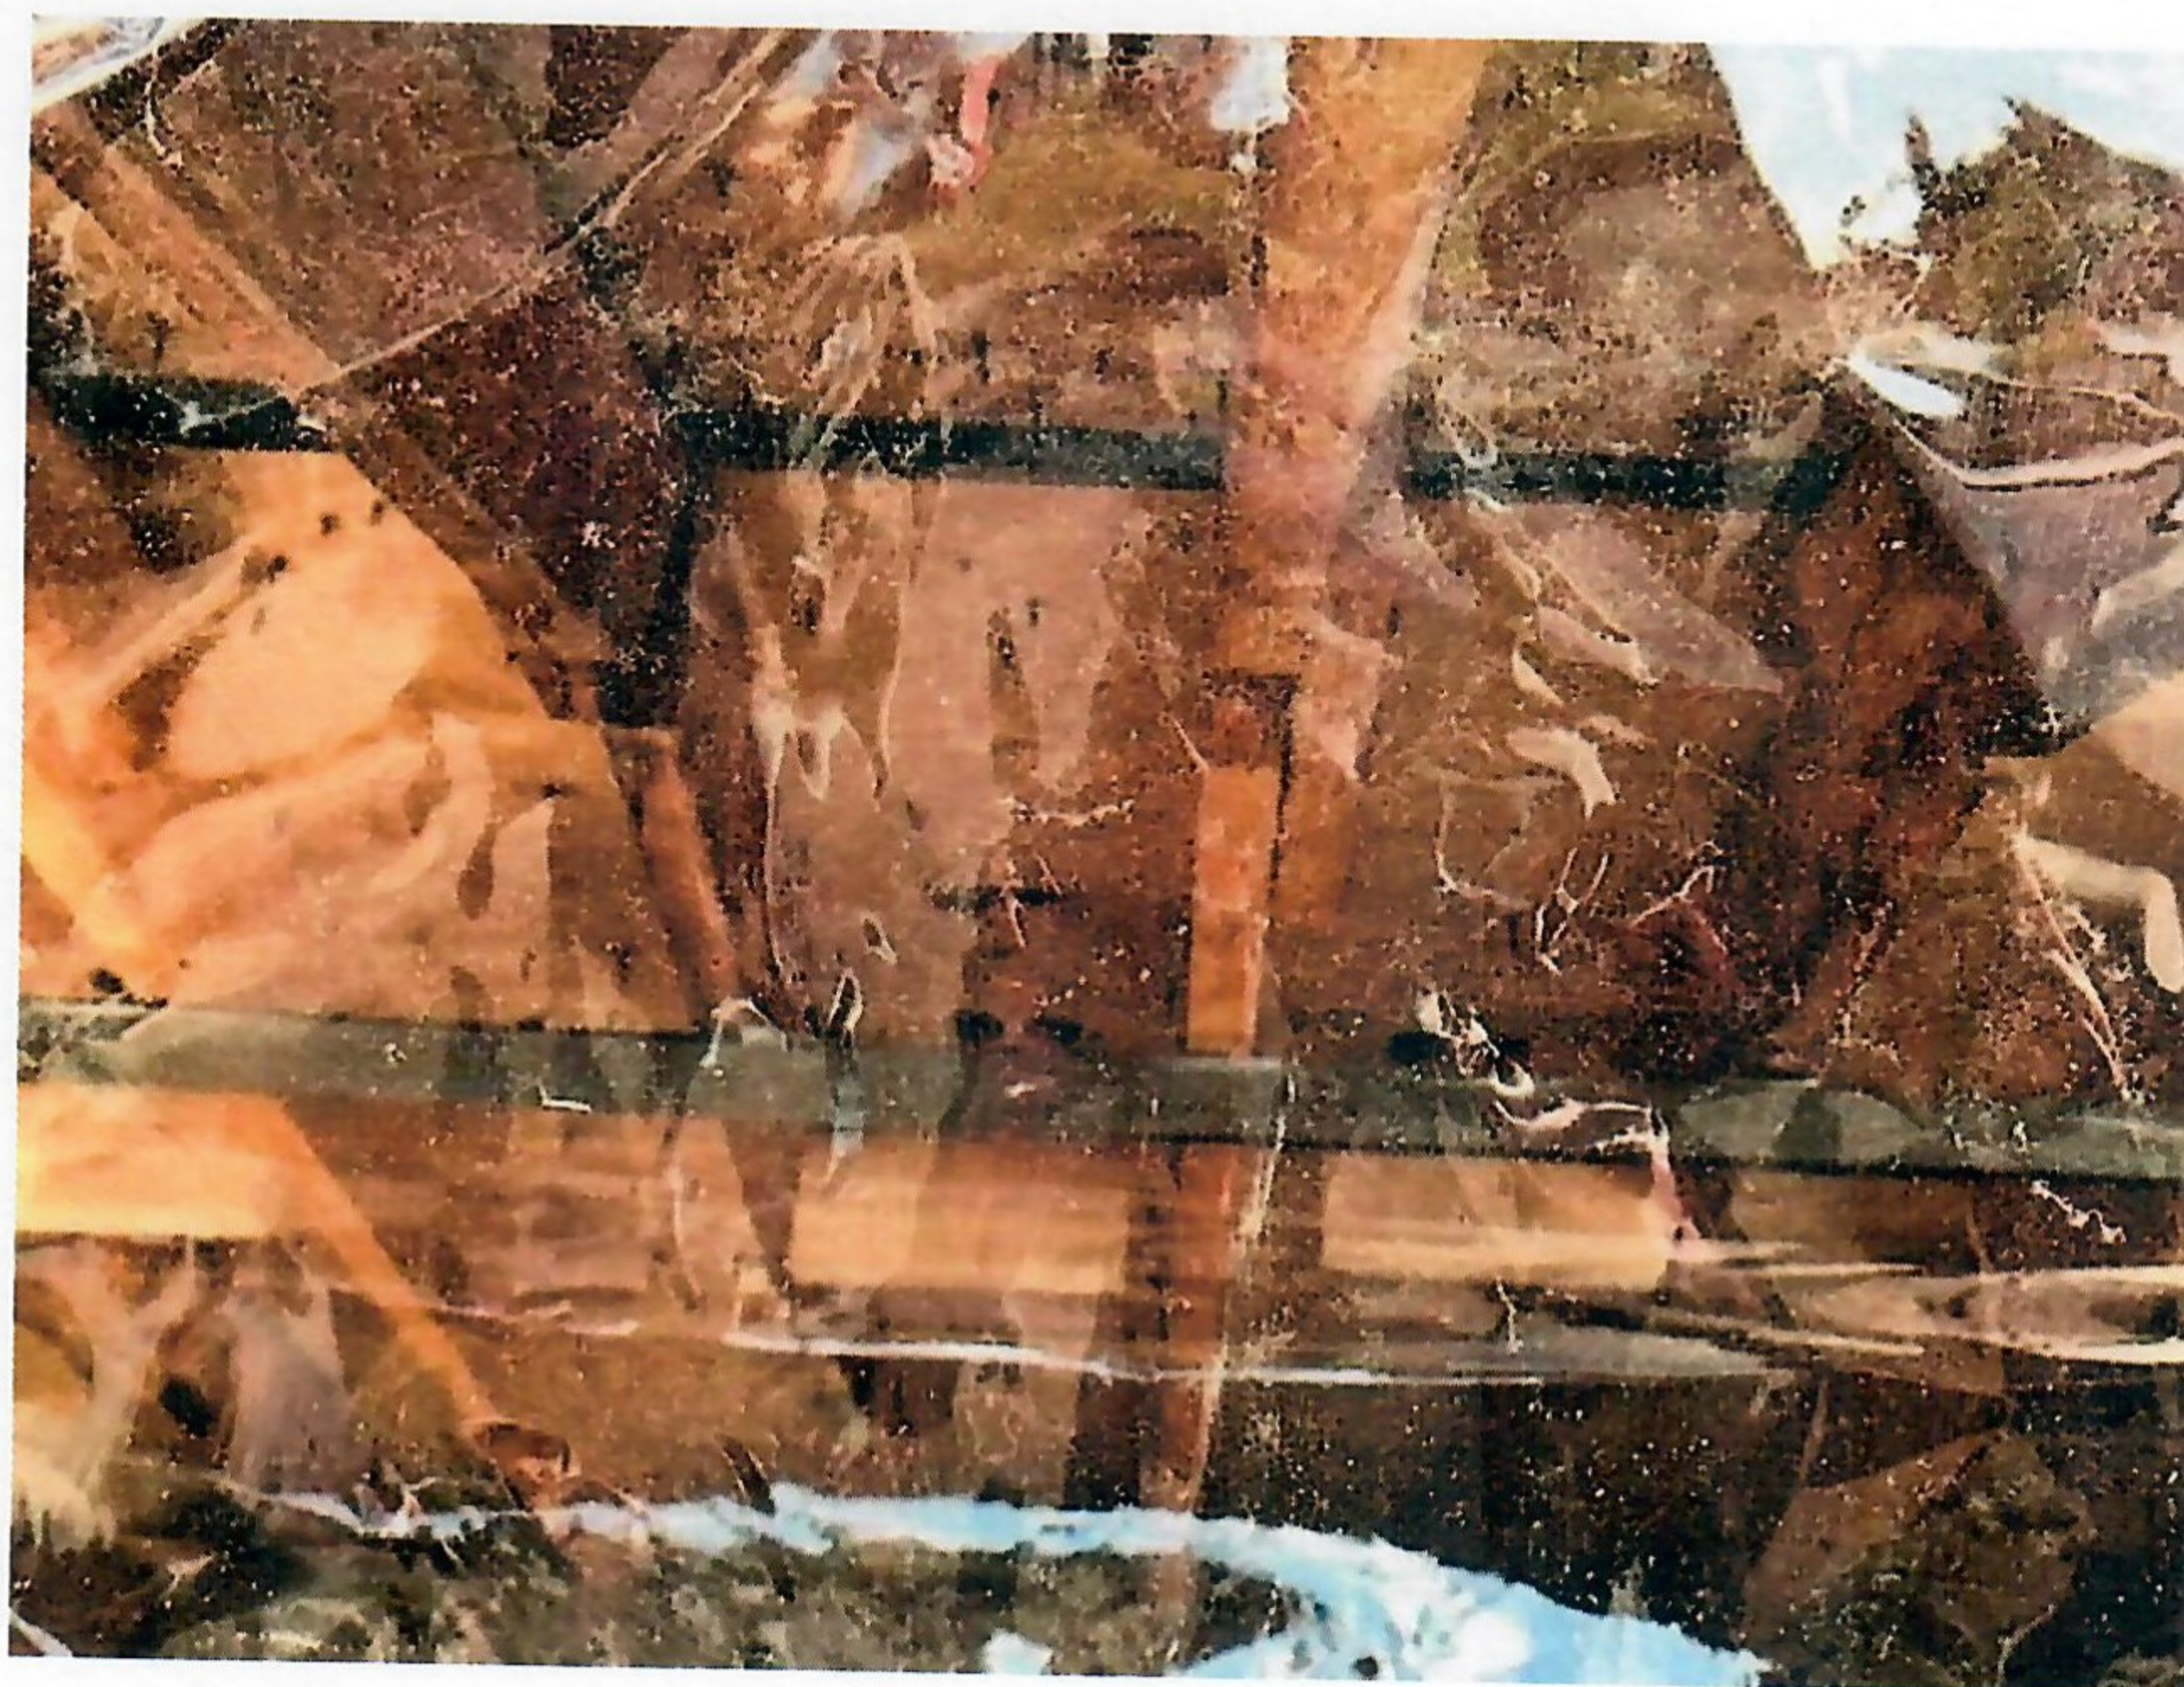
**Photo No. 8**  
**90 MPH Underside**

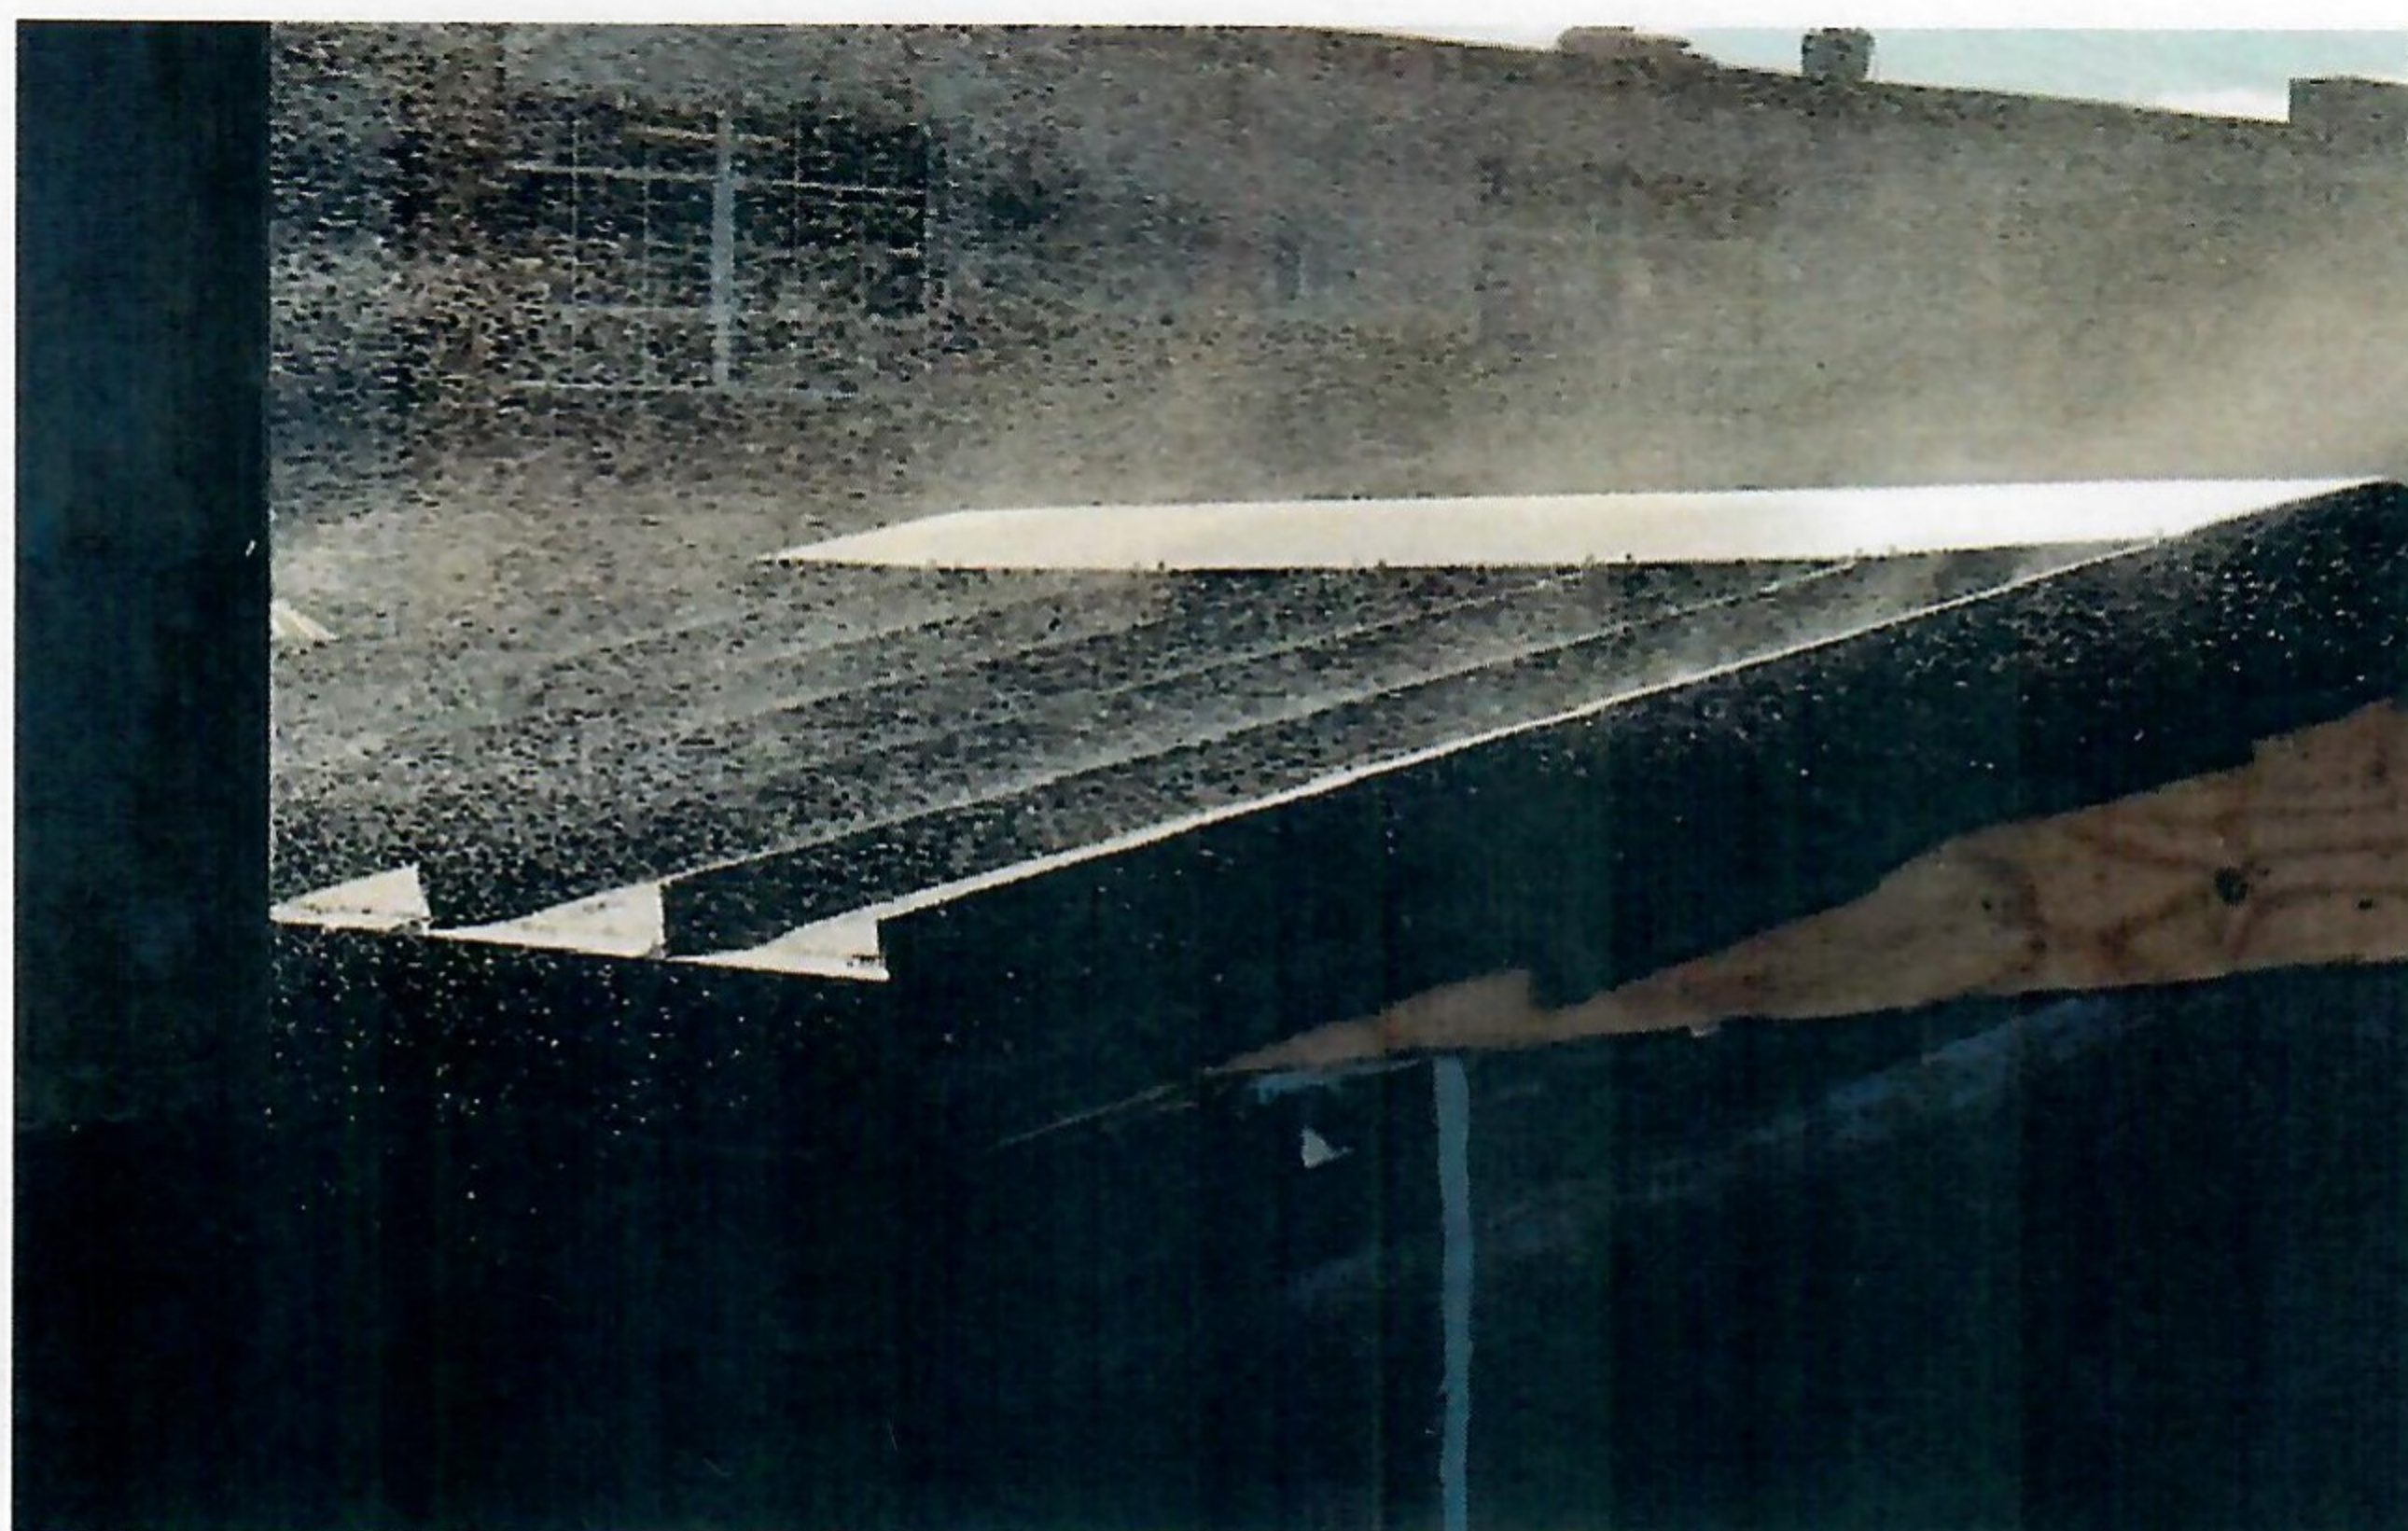
**Photo No. 9**  
**110 MPH Top Side**

*During the 110 mph wind speed interval, droplets of water were observed on the collection bag that were not measurable.*

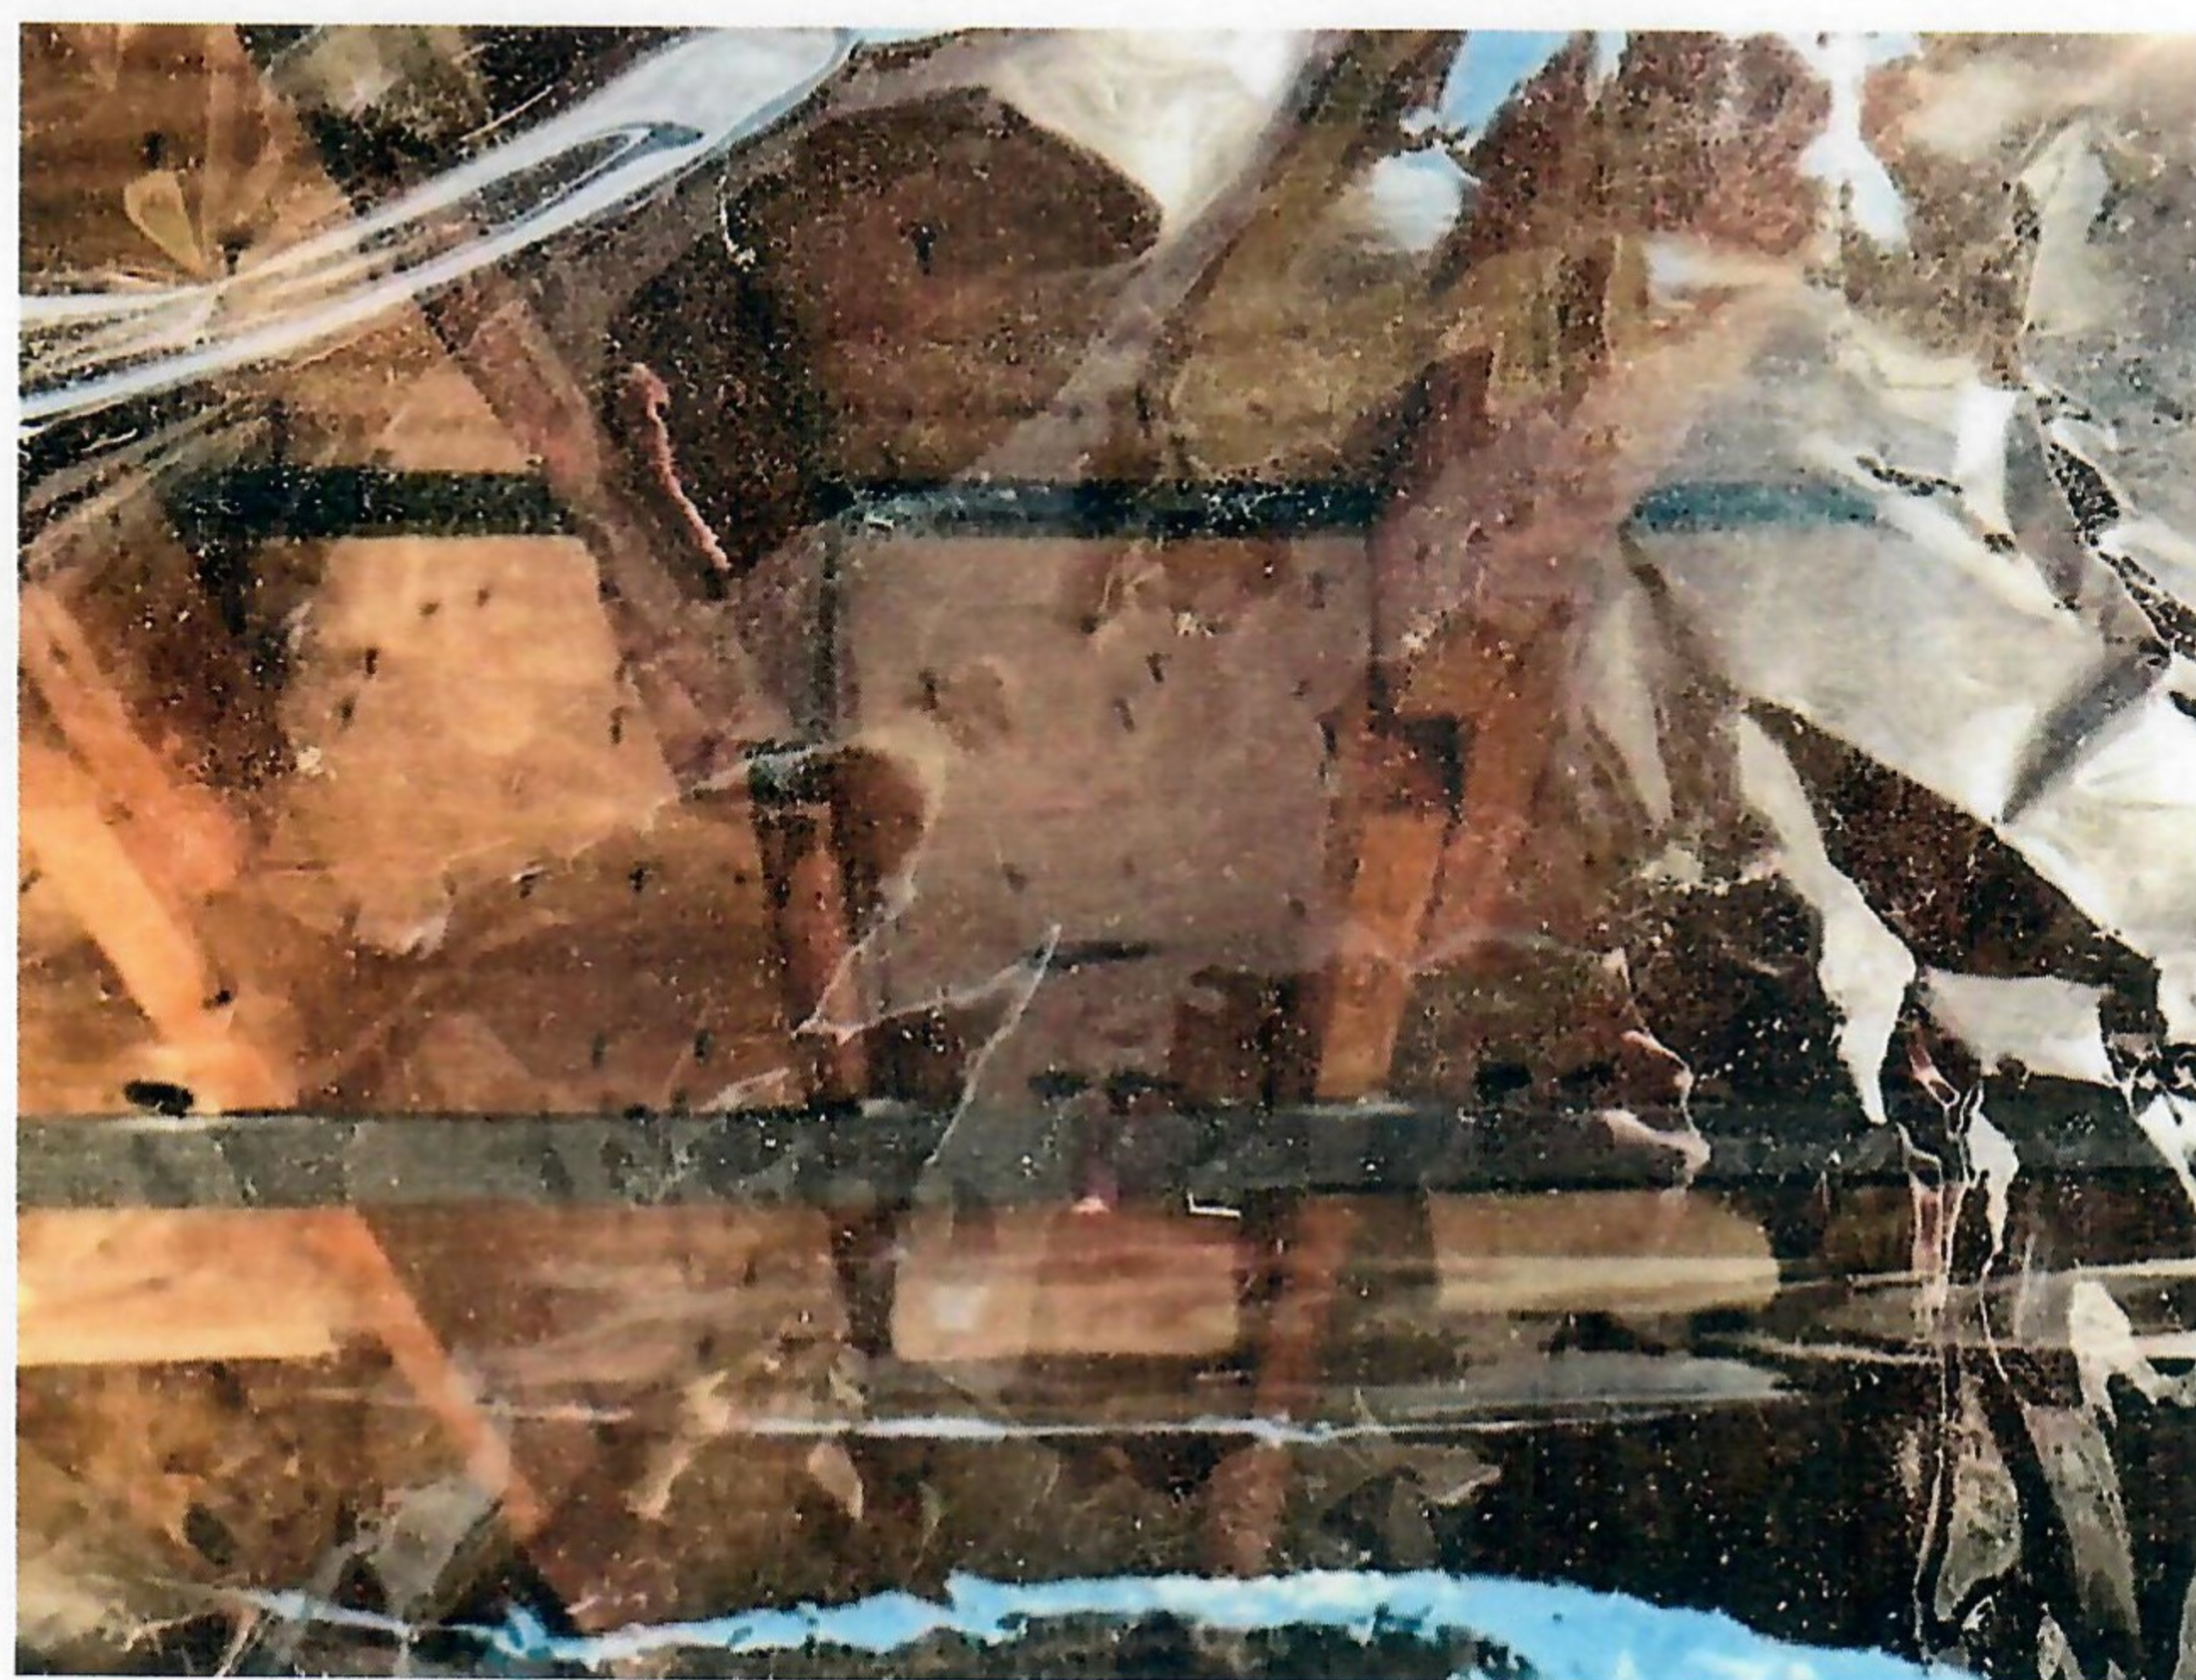
**Photo No. 10**  
**110 MPH Underside**

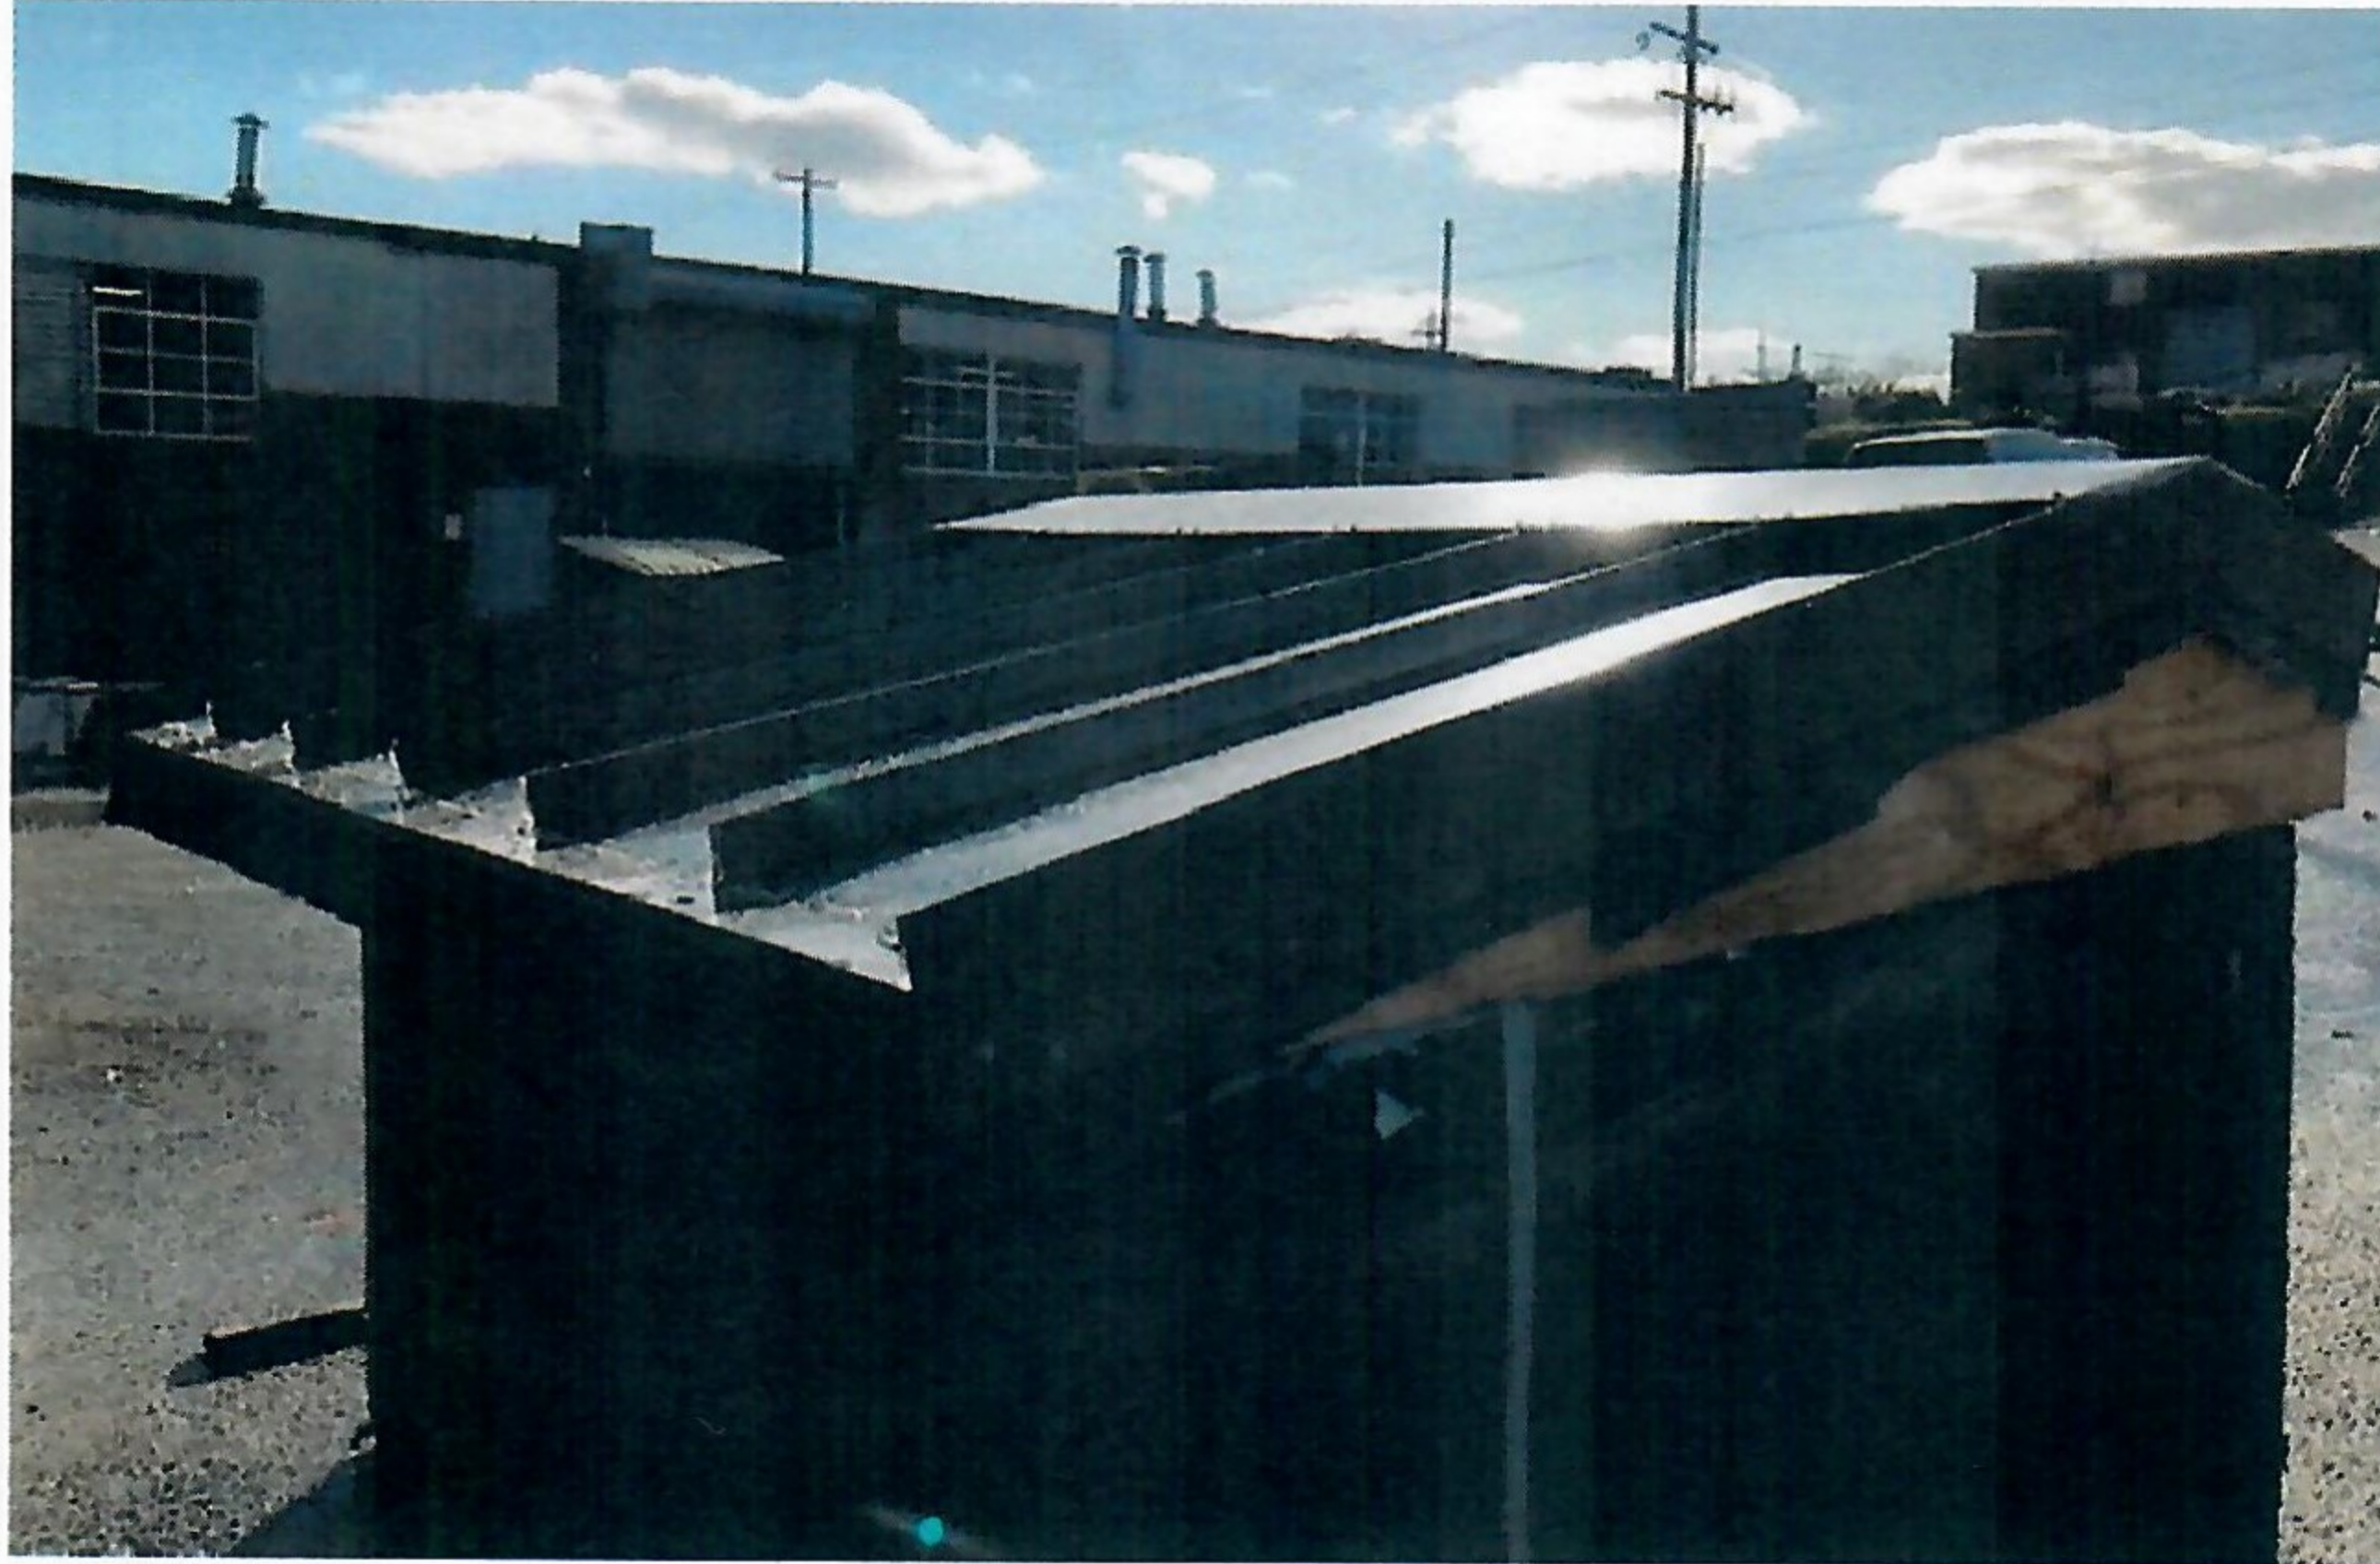
**Photo No. 11**  
**Post Test Top Side**

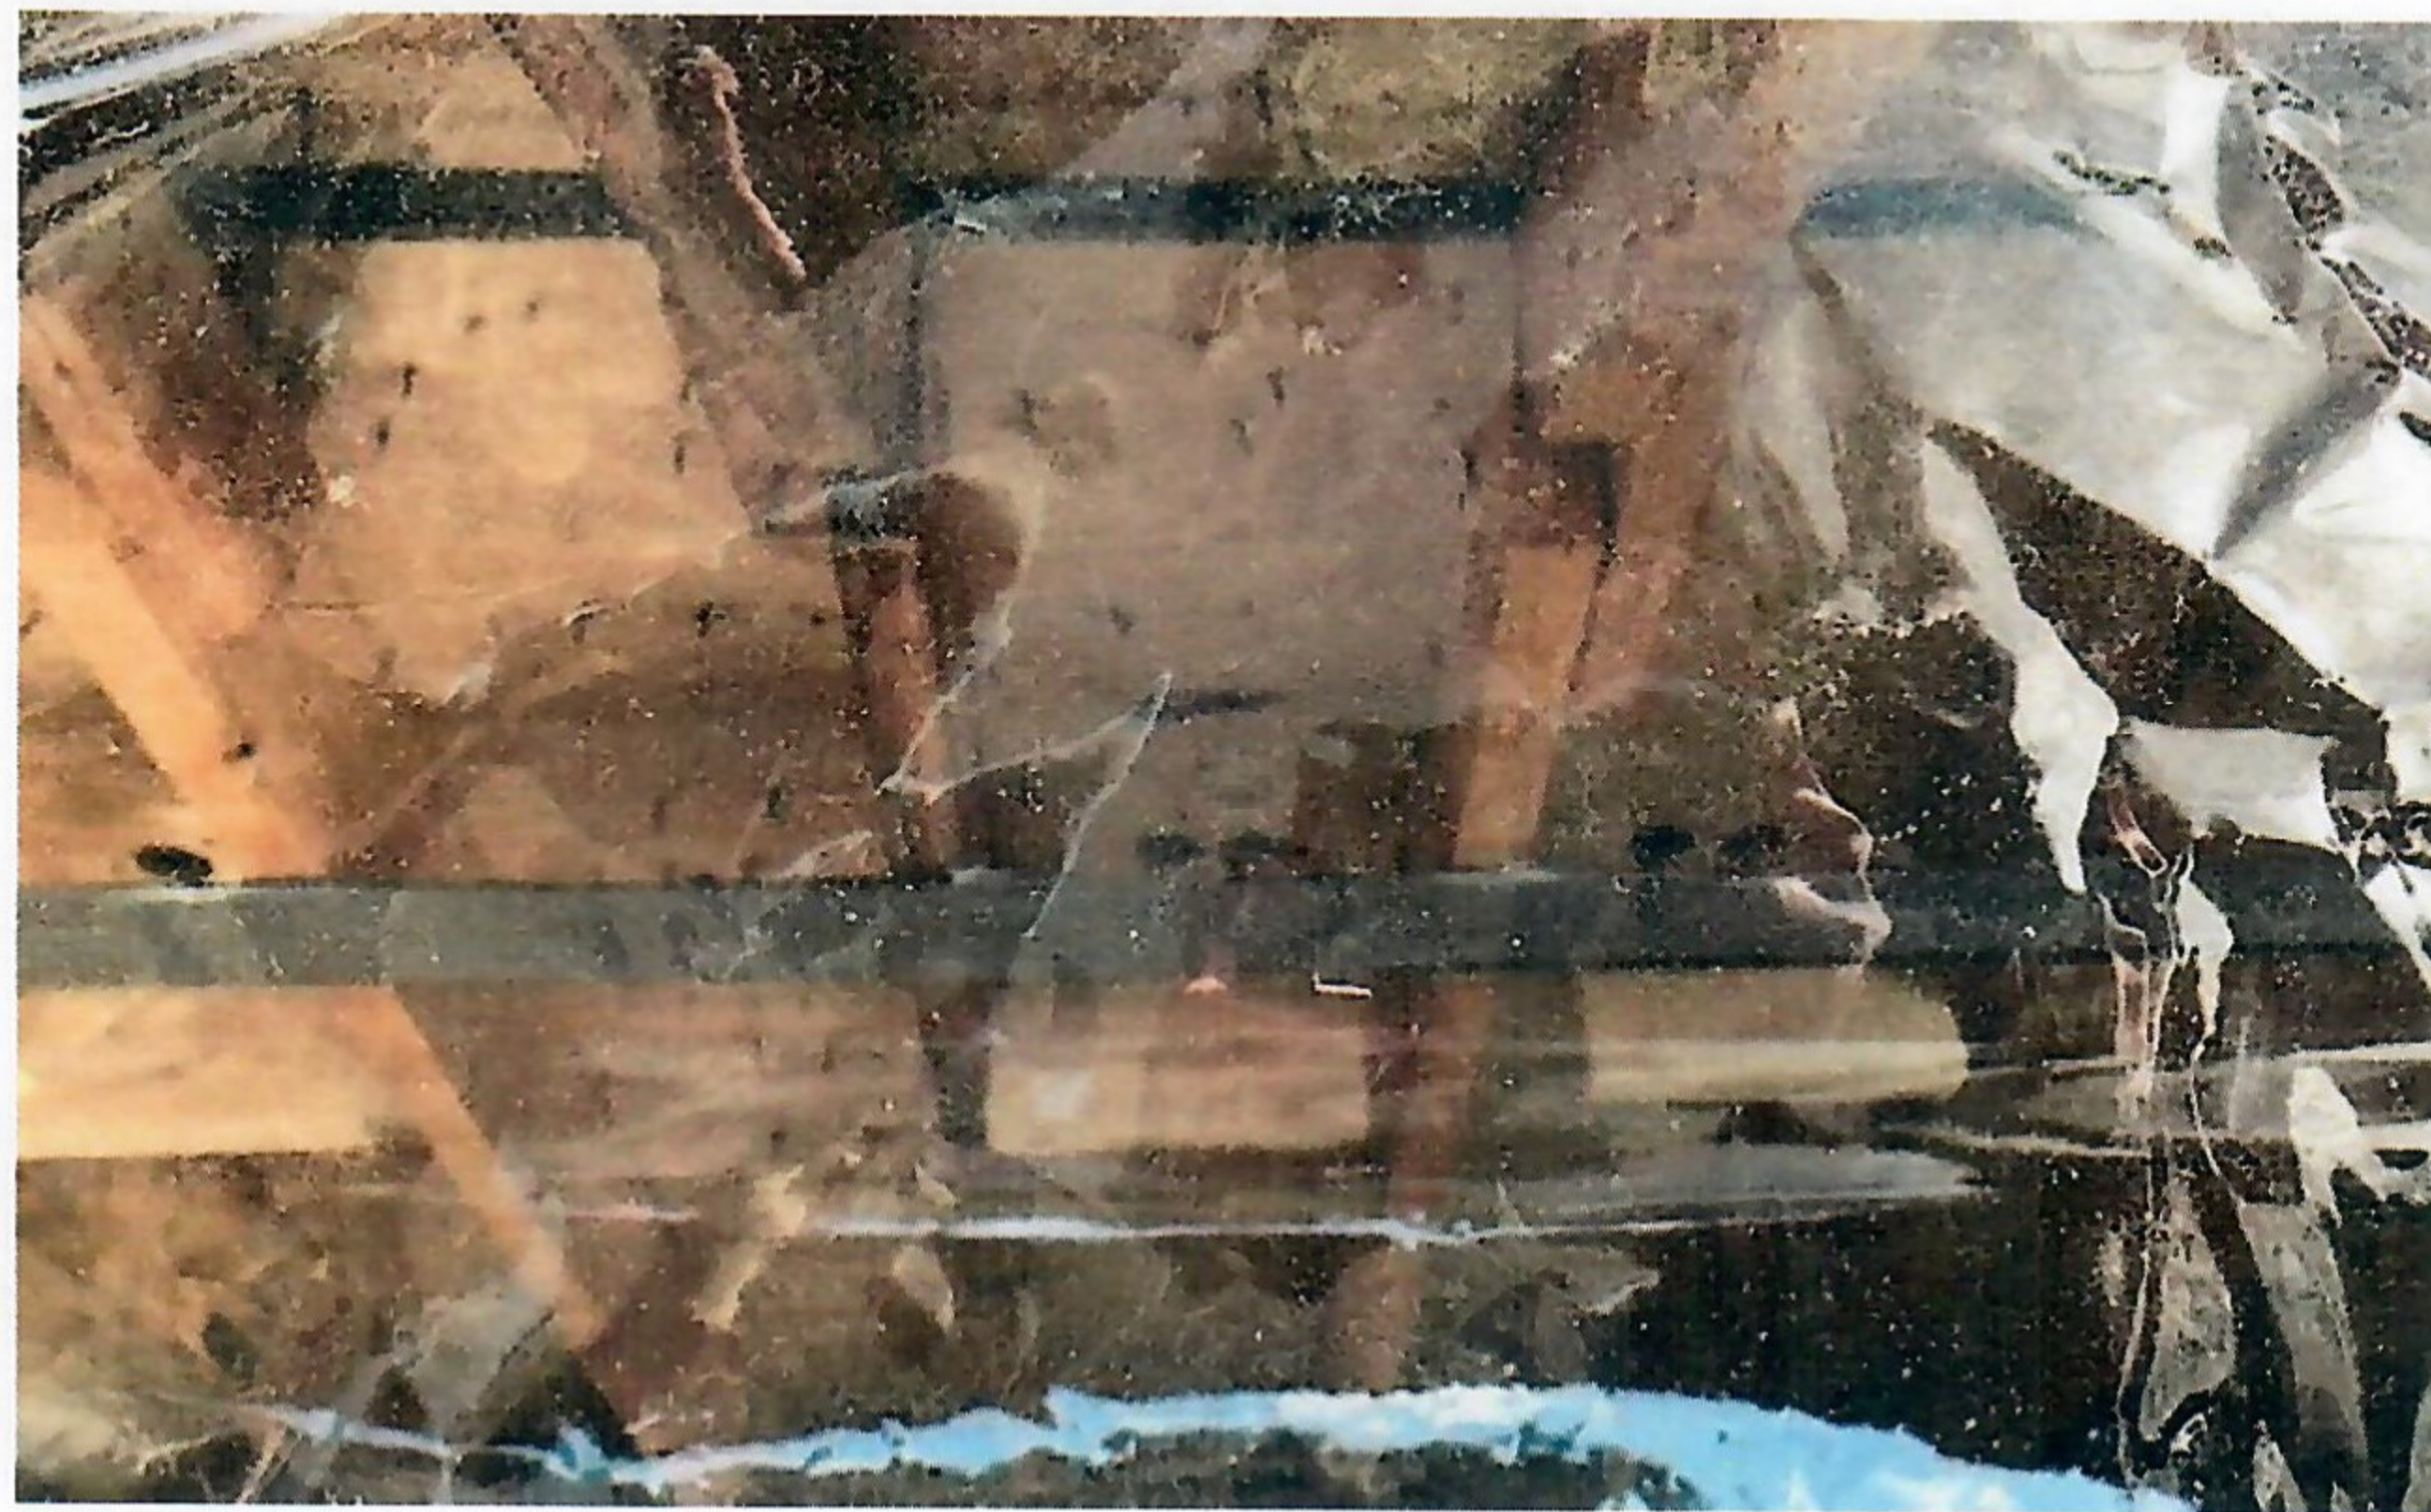
**Photo No. 12**  
**Post Test Underside**
