# **GLICK METALS LLC**

## **TEST REPORT**

TAS 100(A) TESTING ON SNAP-Z, RIDGE VENT

K8029.01-109-18

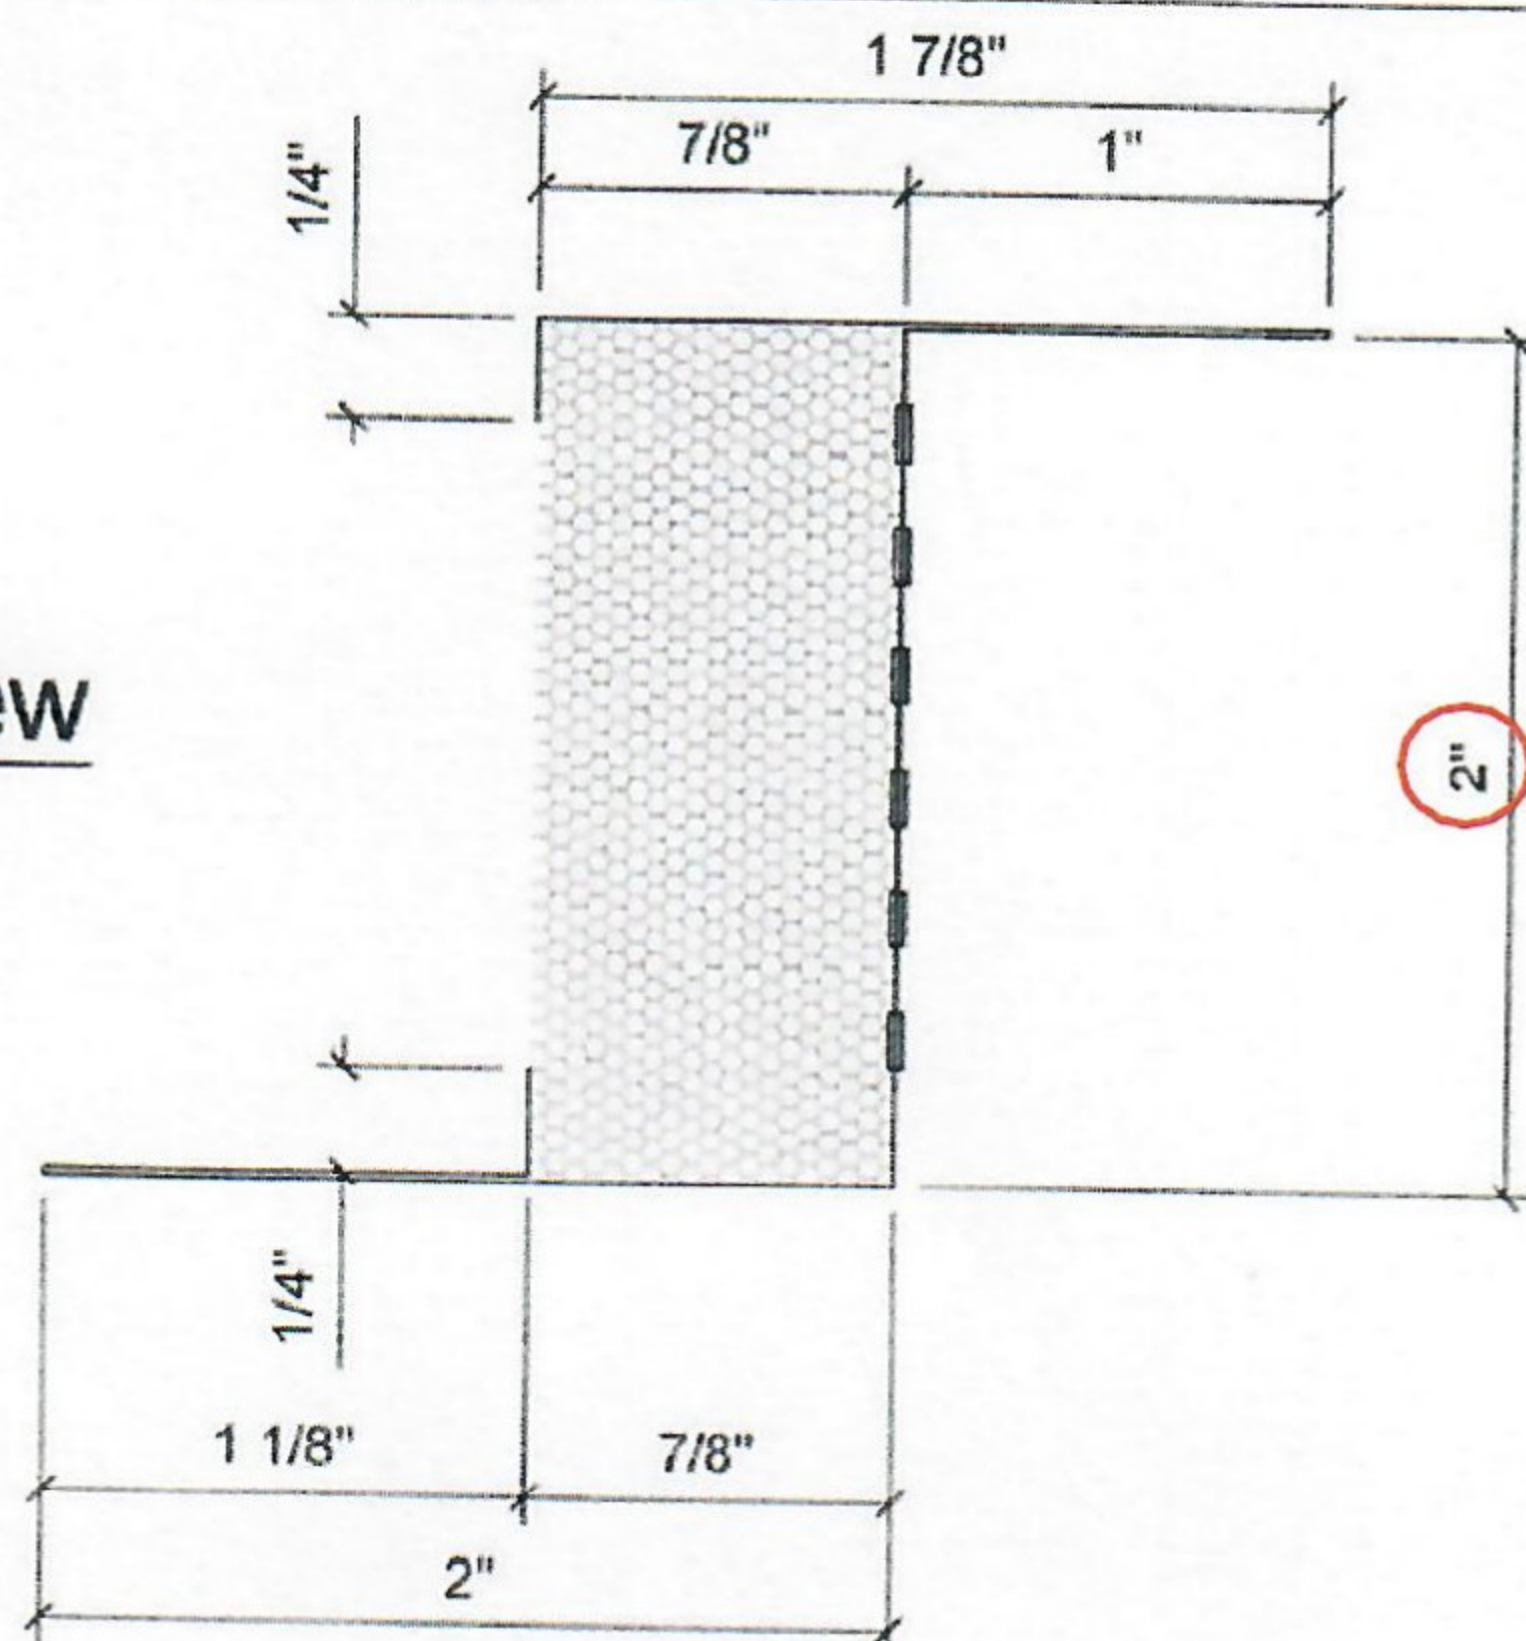
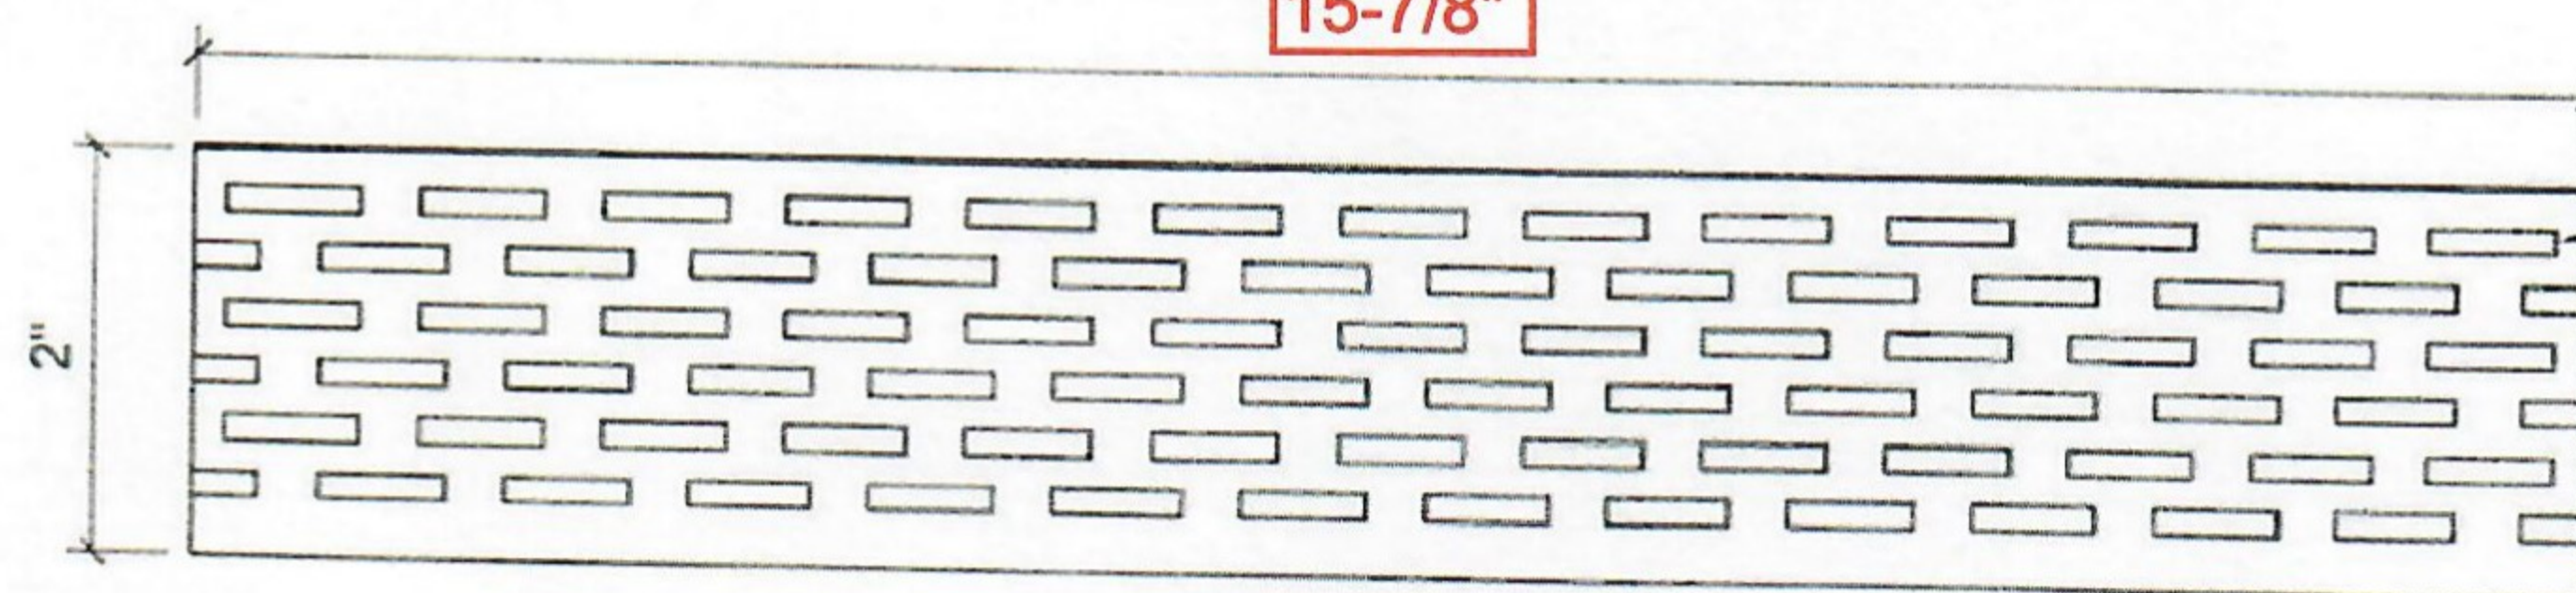
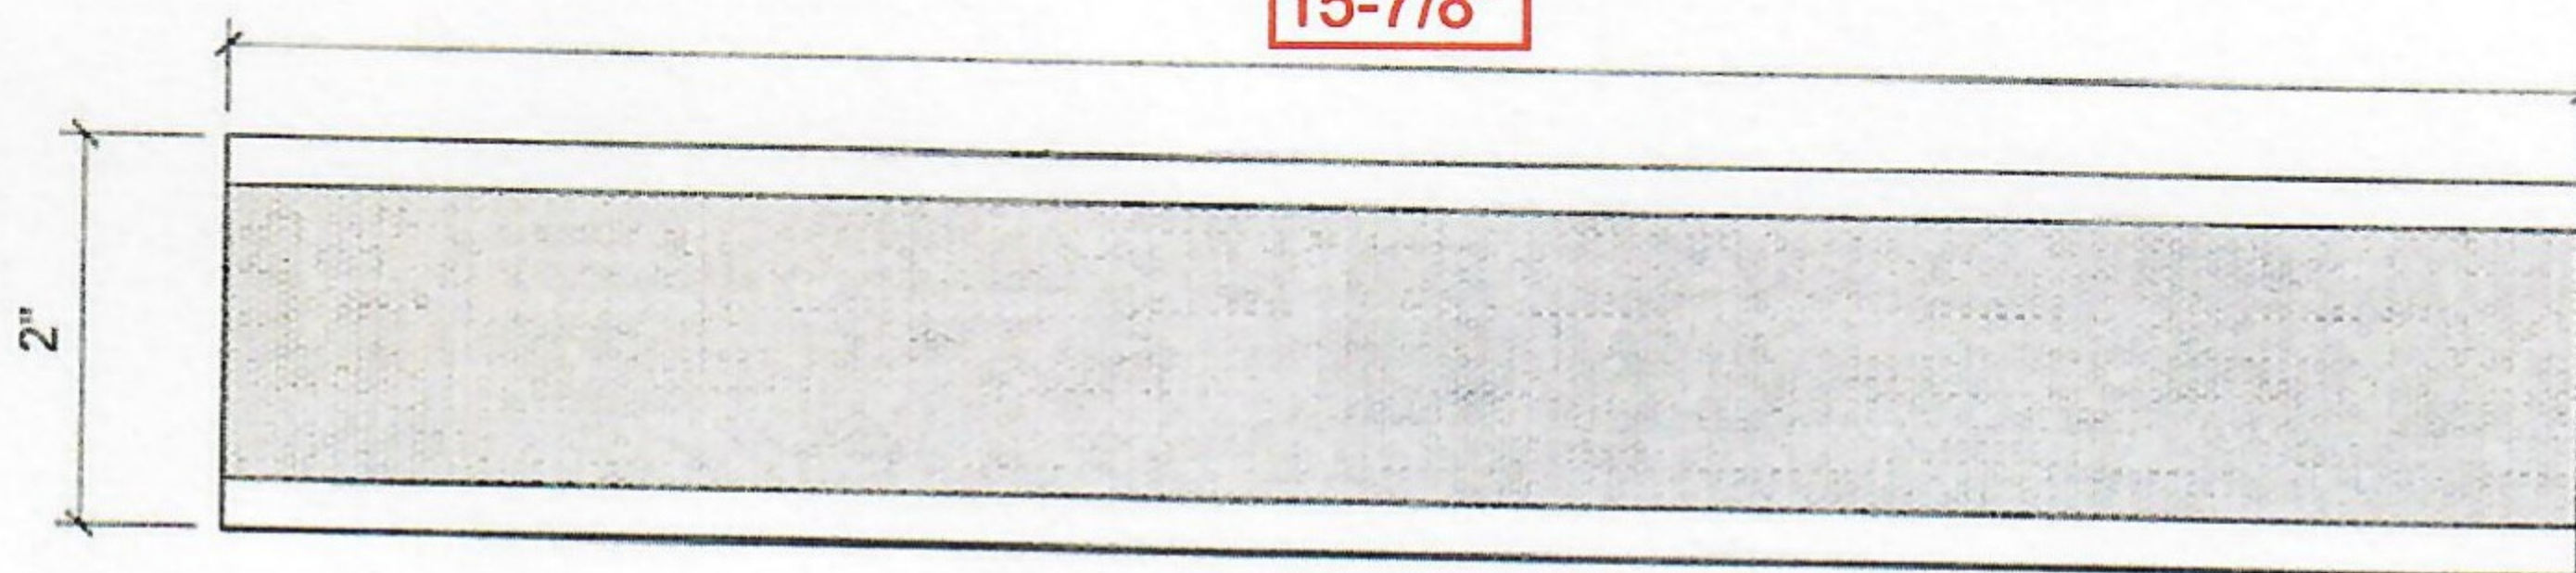
Snap-Z 2000 Detail  
Not To Scale

End View

13 lances per row (6 rows)  
78 lances per lin ft  
12.168 sq in net free area per lin ft

Front Side

Back Side

**Ridge Vent Description:** The ridge vent was composed of 15-7/8" long sections of formed 24-gauge steel sheet and open cell foam. The leading face of the vent sections were punched to allow airflow through the foam. The foam measured 1" thick by 1-3/4" tall and was pressed into the formed vent section. The vent was secured to the test deck with #10 x 1" screws spaced at 3" on center. A strip of butyl tape was utilized under the attachment leg sealing to the roof deck. The leading edge and each end of the vent sections were sealed with silicone. An aluminum sheet ridge cap was then secured over the ridge with #10 x 3/4" hex head screws with sealing washers.
