# MODERN MILL, INC FLORIDA BUILDING CODE TEST REPORT

TAS 202 AND TAS 203 TESTING ON 1 X 6 ACRE, SHIPLAP SIDING

Q0770.01-109-18

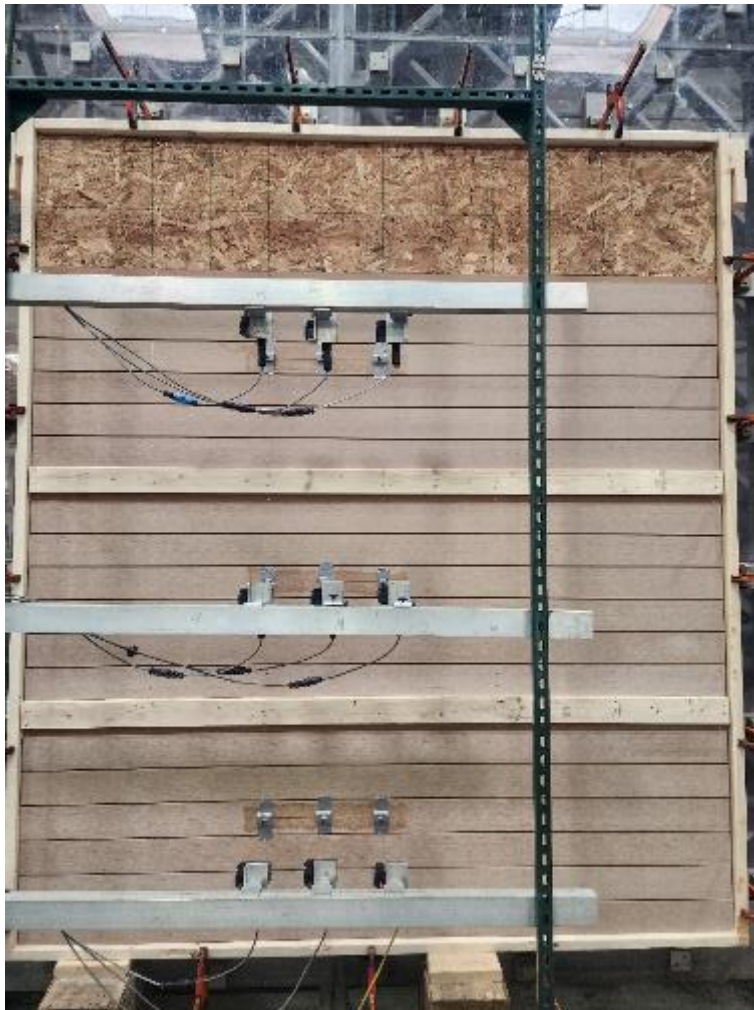
**Photo No. 1**  
**Horizontal TAS202 Specimens 1-3**

Each specimen consisted of six horizontal courses of siding with a female interlock on the bottom and a male interlock on the top. Each course consisted of a panel that was 3/4" thick and composed of compressed rice husk.

The specimen was installed onto a test wall measuring 8' 0" wide by 9' 2" high constructed of #2 Spruce-Pine Fir nominal 2x4 lumber. Five studs were spaced 16" on center (six spans) and were attached to the top and bottom plates with 3" long drywall screws. A sheet of nominal 5/8" thick 5-ply plywood, with six 4" diameter holes to allow pressure to transfer to the siding, was secured to the studs with #8 x 1-5/8" drywall screws. The stud to plate connection was reinforced with 3" wide by 1-1/2" high by 4-3/4" long by 5/16" thick aluminum angles secured with #8 x 1-5/8" drywall screws. Silicone was utilized on the backside of the test panel to seal the perimeter. A 2-mil thick plastic film was loosely draped over the interior of the siding to enable attainment of pressure.

The siding was mounted with 2-1/2" x 0.099 ring shank siding nails, spaced 16" on center, through the nail hem, sheathing and into the studs.

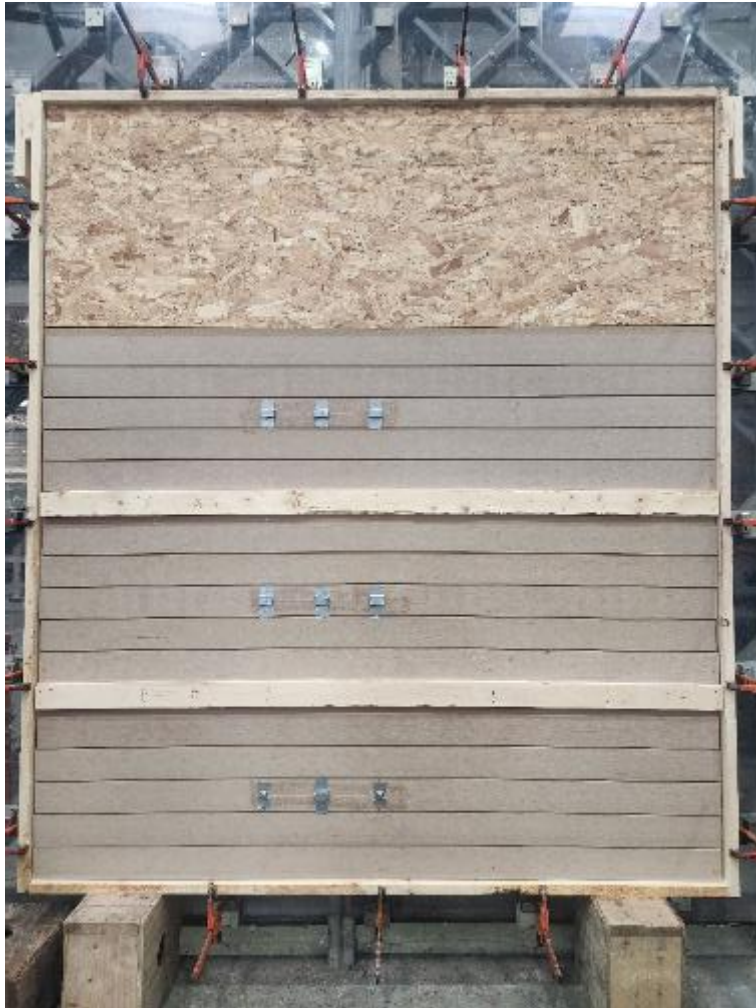
**Photo No. 2**  
**Horizontal TAS203 Specimens 4-6**

Each specimen consisted of five horizontal courses of siding with a female interlock on the bottom and a male interlock on the top. Each course consisted of a panel that was 3/4" thick and composed of compressed rice husk.

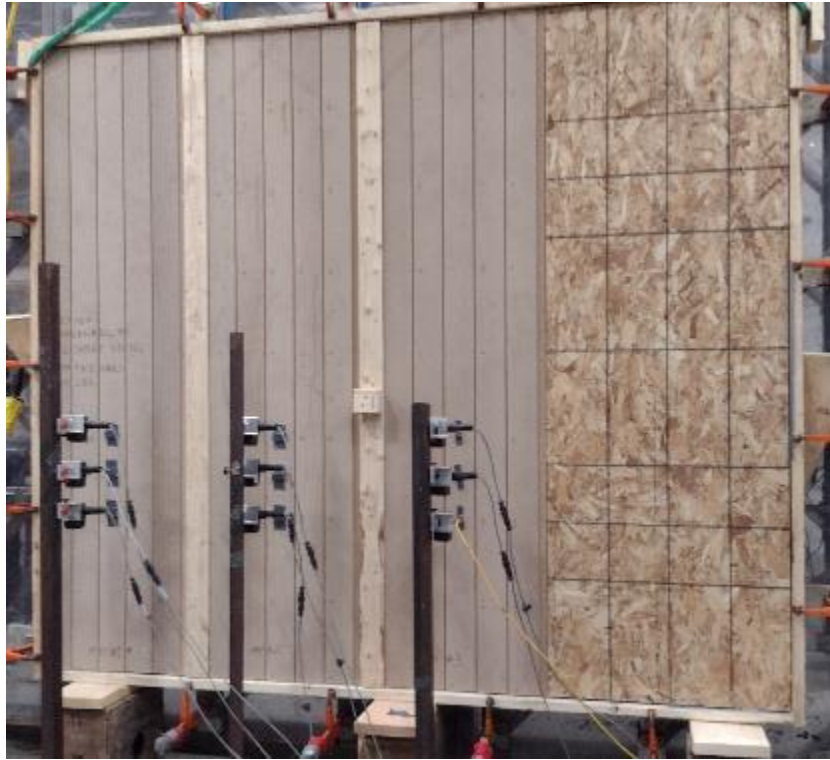
**Photo No. 3**  
**Vertical TAS202 Specimens 7-9**

Each specimen consisted of five vertical courses of siding with a female interlock on the left side and a male interlock on the right side. Each course consisted of a panel that was 3/4" thick and composed of compressed rice husk.

The specimen was installed onto a test wall measuring 9' 2" wide by 8' 0" high constructed of #2 Spruce-Pine Fir nominal 2x4 lumber. Eight studs were spaced 16" on center (nine spans) and were attached to the top and bottom plates with 3" long drywall screws. A sheet of nominal 5/8" thick 5-ply plywood, with six 4" diameter holes to allow pressure to transfer to the siding, was secured to the studs with #8 x 1-5/8" drywall screws. The stud to plate connection was reinforced with 3" wide by 1-1/2" high by 4-3/4" long by 5/16" thick aluminum angles secured with #8 x 1-5/8" drywall screws. Silicone was utilized on the backside of the test panel to seal the perimeter. A 2-mil thick plastic film was loosely draped over the interior of the siding to enable attainment of pressure.

The siding was mounted with 2-1/2" x 0.099 ring shank siding nails, spaced 12" on center, through the nail hem, and face of the siding into the sheathing.

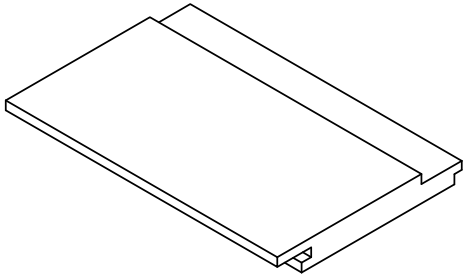
TITLE:  
T&G SHIPLAP 1/4" GAP  
SP-75061XT&G SHIPLAP 1/4" GAP  
SP-7506

The test specimen drawings have been reviewed by Intertek B&C and are representative of the test specimen(s) reported herein. Test specimen construction was verified by Intertek B&C per the drawings included in this report. Any deviations are documented herein or on the drawings.
