MODERN MILL, INC FLORIDA BUILDING CODE TEST REPORT

TAS 202 AND TAS 203 TESTING ON 1 X 10 ACRE, SHIPLAP SIDING

Q0775.01-109-18 R0

TEST REPORT FOR MODERN MILL, INC

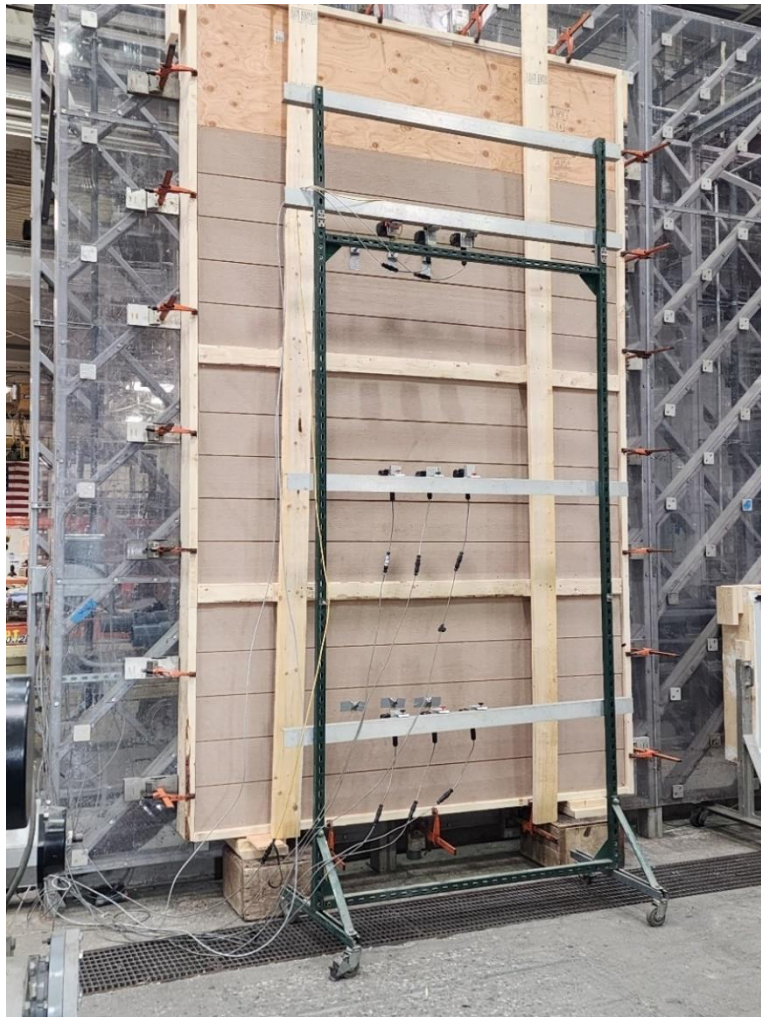
Photo No. 1
Horizontal TAS 202 Specimens 1-3

Test Wall Description: Test Specimens #1- #6 (Horizontal Installation)

The specimen was installed onto a test wall measuring 8' 0" wide by 13' 4" high constructed of #2 Spruce-Pine Fir nominal 2x4 lumber. Five studs were spaced 16" on center (six spans) and were attached to the top and bottom plates with 3" long drywall screws. A sheet of nominal 5/8" thick 5-ply plywood, with six 4" diameter holes to allow pressure to transfer to the siding, was secured to the studs with #8 x 1-5/8" drywall screws. The stud to plate connection was reinforced with 3" wide by 1-1/2" high by 4-3/4" long by 5/16" thick aluminum angles secured with #8 x 1-5/8" drywall screws. Silicone was utilized on the backside of the test panel to seal the perimeter. A 2-mil thick plastic film was loosely draped over the interior of the siding to enable attainment of pressure.

The siding was mounted with 2-1/2" x 0.099 ring shank siding nails, spaced 16" on center, through the nail hem, sheathing and into the studs.

Test Specimen Description: Test Specimens #1 - #6 (Horizontal Installation)

Each specimen consisted of five horizontal courses of siding with a female interlock on the bottom and a male interlock on the top. Each course consisted of a panel that was 3/4" thick and composed of compressed rice husk.

Test Specimen #1: Preload and Design Load per TAS 202

INDICATOR LOCATION	Deflection at -82.50 psf	DEFLECTION (in.)		Permanent Set at -82.50 psf	PERMANENT SET (in.)	
		MEASURED	ALLOWED		MEASURED	ALLOWED
1	1.18	0.06	N/A	0.15	0.01	N/A
2	1.32			0.16		
3	1.34			0.15		
INDICATOR LOCATION	Deflection at -110.00 psf	DEFLECTION (in.)		Permanent Set at -110.00 psf	PERMANENT SET (in.)	
		MEASURED	ALLOWED		MEASURED	ALLOWED
1	1.79	0.08	0.09	0.22	0.02	N/A
2	2.00			0.24		
3	2.06			0.22

Test Specimen #1: Structural Overload Load per TAS 202

INDICATOR LOCATION	Deflection at -165.00 psf	DEFLECTION (in.)		Permanent Set at -165.00 psf	PERMANENT SET (in.)	
		MEASURED	ALLOWED		MEASURED	ALLOWED
1	3.26	0.15	N/A	0.46	0.05	0.06
2	3.64			0.48		
3	3.73			0.40

No signs of failure were observed in any area of the test specimen during the TAS 202 testing; as such, the test specimen satisfies the requirements of TAS 202. Upon completion of testing, specimens tested for TAS 202-94 met the requirements of Section 1620 of the Florida Building Code, Building.

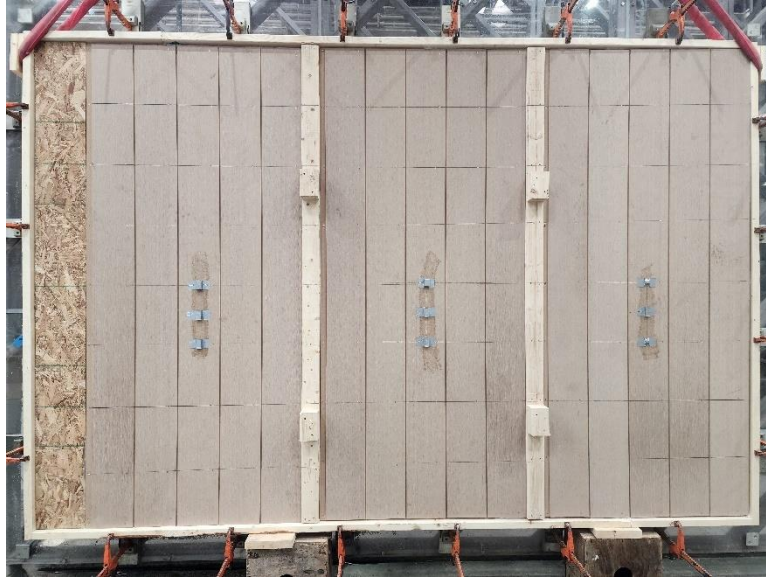
Photo No. 3
Vertical TAS 202 Specimens 7-9

Test Wall Description: Test Specimens #7- #12 (Vertical Installation)

The specimen was installed onto a test wall measuring 12' 0-1/2" wide by 8' 0" high constructed of #2 Spruce-Pine Fir nominal 2x4 lumber. Eight studs were spaced 16" on center (nine spans) and were attached to the top and bottom plates with 3" long drywall screws. A sheet of nominal 5/8" thick 5-ply plywood, with six 4" diameter holes to allow pressure to transfer to the siding, was secured to the studs with #8 x 1-5/8" drywall screws. The stud to plate connection was reinforced with 3" wide by 1-1/2" high by 4-3/4" long by 5/16" thick aluminum angles secured with #8 x 1-5/8" drywall screws. Silicone was utilized on the backside of the test panel to seal the perimeter. A 2-mil thick plastic film was loosely draped over the interior of the siding to enable attainment of pressure.

The siding was mounted with 2-1/2" x 0.099 ring shank siding nails, spaced 12" on center, through the nail hem, and face of the siding into the sheathing.

Test Specimen Description: Test Specimens #7 - #12 (Vertical Installation)

Each specimen consisted of five vertical courses of siding with a female interlock on the right side and a male interlock on the left side. Each course consisted of a panel that was 3/4" thick and composed of compressed rice husk.

Test Specimen #7: Preload and Design Load per TAS 202

INDICATOR LOCATION	Deflection at -75.00 psf	DEFLECTION (in.)		Permanent Set at -75.00 psf	PERMANENT SET (in.)	
		MEASURED	ALLOWED		MEASURED	ALLOWED
1	0.34	0.01	N/A	0.03	0.01	N/A
2	0.33			0.04		
3	0.31			0.03		
INDICATOR LOCATION	Deflection at -100.00 psf	DEFLECTION (in.)		Permanent Set at -100.00 psf	PERMANENT SET (in.)	
		MEASURED	ALLOWED		MEASURED	ALLOWED
1	0.51	0.01	0.07	0.05	<0.01	N/A
2	0.50			0.05		
3	0.48			0.05

Test Specimen #7: Structural Overload Load per TAS 202

INDICATOR LOCATION	Deflection at -150.00 psf	DEFLECTION (in.)		Permanent Set at -150.00 psf	PERMANENT SET (in.)	
		MEASURED	ALLOWED		MEASURED	ALLOWED
1	0.96	0.01	N/A	0.09	<0.01	0.05
2	0.94			0.09		
3	0.90			0.09

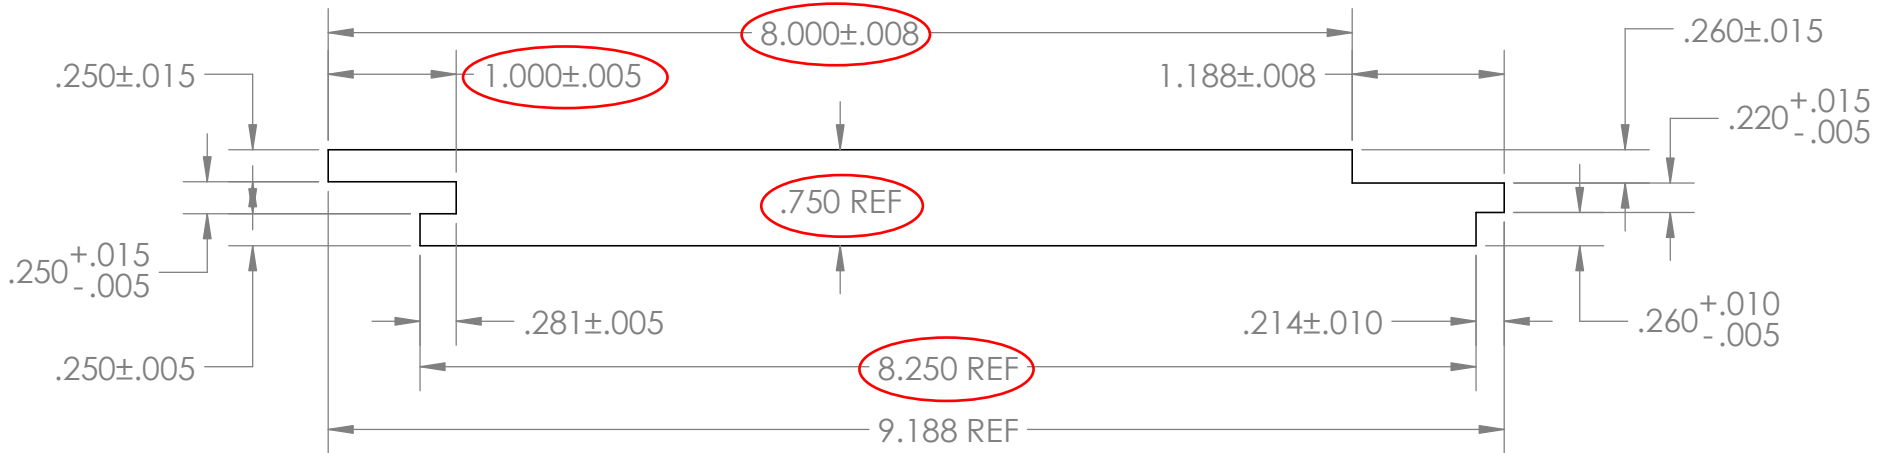
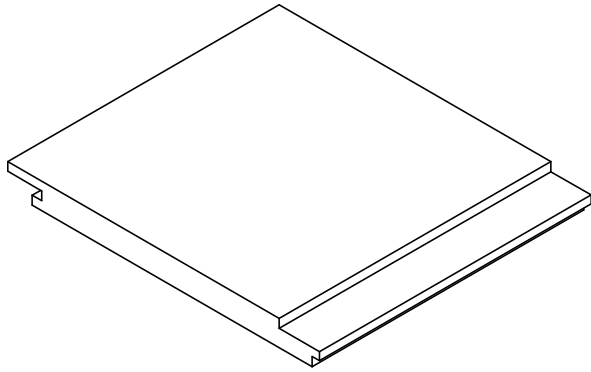
The test specimen drawing has been reviewed by Intertek B&C and is representative of the test specimen(s) reported herein. Test specimen construction was verified by Intertek B&C per the drawing included in this report. Any deviations are documented herein or on the drawing.

UNLESS OTHERWISE SPECIFIED:	NAME	DATE	TITLE: 1x10 SHIPLAP T&G 1/4" SP-7510	
		DIMENSIONS ARE IN INCHES	DRAWN	SMK		220508
		TOLERANCES:	CHECKED	MYM		2221005
		FRACTIONAL ±	ENG APPR.			
		ANGULAR: MACH ± BEND ±	MFG APPR.			
		TWO PLACE DECIMAL ±	Q.A.			
		THREE PLACE DECIMAL ±	COMMENTS:			
		INTERPRET GEOMETRIC TOLERANCING PER:				
		MATERIAL				
		FINISH				
NEXT ASSY	USED ON					
APPLICATION		DO NOT SCALE DRAWING				
SIZE	DWG. NO.	REV				
A	MM-003	1B				
SCALE: 1:1.5		WEIGHT:	SHEET 1 OF 1
