Report No: 04-009 FE FBC

Testing : Polycarbonate Hurricane Shutter Panels

Transparent Protection Systems, Inc.

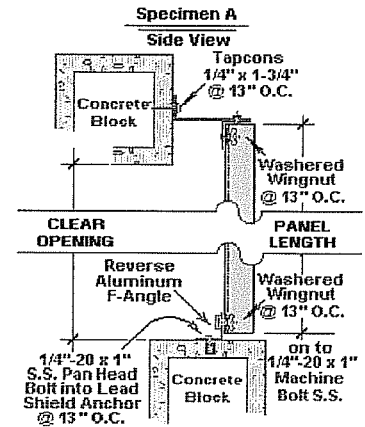
Specimen A : Build Out / Floor, Mount : 144" Panels : 140" C.O. Impacts & Cyclic Wind Loading

Head: Panels were mounted at 13" on center (O.C.) with washered wing nuts onto a studded aluminum angle. This angle was secured with #14 x 3/4" stainless steel (S.S.), self drilling self tapping (SDST) screws at 13" O.C. to the 5" leg of a 2" x 5" aluminum angle, forming a 3" build out. This 2" x 5" angle was in turn secured to a concrete block beam with standard 1/4" x 1-3/4" ELCO Tapcon masonry screws at 13" O.C. by it's 2" leg which was turned away from the opening. **Sill:** Panels were mounted at 13" O.C. with washered wing nuts onto stainless steel, 1/4"-20 x 1" machine bolts trapped into an aluminum reverse f-track. This reverse f-angle was secured to a concrete block beam at 13" on center with S.S. 1/4"-20 x 1" pan head bolts (9/16" head and combination slot & phillips drive) into RAWL, Caulk-In, machine bolt, masonry anchors.

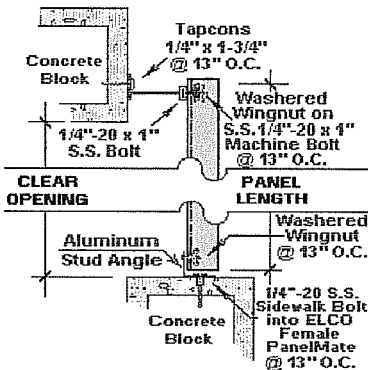
Specimen B
Side View

Specimen B : Build Out / Floor, Mount : 144" Panels : 140" C.O. Impacts & Cyclic Wind Loading

Head: Panels were mounted at 13" O.C. with washered wing nuts onto stainless steel, 1/4"-20 x 1" machine bolts trapped into a build out F-track extrusion. This extrusion was secured to a concrete block beam at 13" O.C. with ELCO Maxi Set 1/4" x 1-3/4" Tapcon masonry screws. **Sill:** Panels were mounted at 13" O.C. with washered wing nuts onto a studded aluminum angle. This angle was secured at 13" O.C. with S.S. 1/4"-20 x 1/2" side walk bolts (3/4" head and combination slot & phillips drive) into ELCO PanelMate, Female, wood & masonry anchors secured to a concrete block beam.

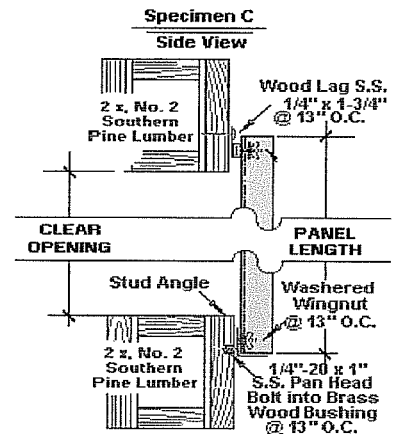
Specimen C : Wall / Wall, Mount : 144" Panels : 140" C.O. Impacts & Cyclic Wind Loading

Head: Panels were mounted at 13" O.C. with washered wing nuts onto stainless steel, 1/4"-20 x 1" machine bolts trapped into a F-track extrusion. This extrusion was secured to a No: 2 Southern Pine lumber beam at 13 O.C. with S.S. 1/4" x 1-3/4" wood lags. **Sill:** Panels were mounted at 13" O.C. with washered wing nuts onto a studded aluminum angle. This angle was secured at 13" O.C. with S.S. 1/4"-20 x 1" pan head bolts (9/16" head and combination slot & phillips drive) into All Points, brass wood bushings secured into a No: 2 Southern Pine lumber beam.

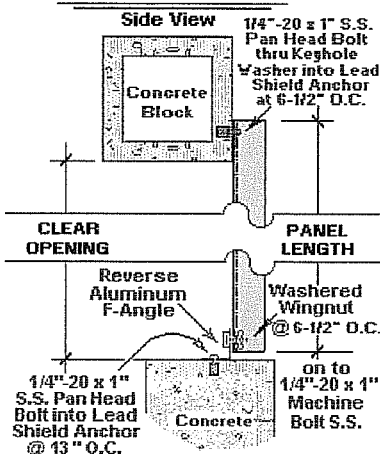
Specimen I1, I2, I3 & I4

- Specimen I1 : Wall / Floor, Mount : 120" Panels : 117" C.O. : Impacts
- Specimen I2 : Wall / Floor, Mount : 103" Panels : 100" C.O. : Impacts
- Specimen I3 : Wall / Floor, Mount : 84" Panels : 81" C.O. : Impacts
- Specimen I4 : Wall / Floor, Mount : 60" Panels : 57" C.O. : Impacts

Head: Panels were directly mounted at 6 1/2" O.C. with S.S. 1/4"-20 x 1" pan head bolts (9/16" head and combination slot & phillips drive) through an aluminum keyhole washer into All Point, Solid Set, machine bolt, masonry anchors set into a concrete block beam. **Sill:** Panels were mounted at 6 1/2" O.C. with washered wing nuts onto stainless steel, 1/4"-20 x 1" machine bolts trapped into an aluminum reverse f-track. This reverse f-angle was secured to a concrete floor slab at 13" on center with S.S. 1/4"-20 x 1" pan head bolts (9/16" head and combination slot & phillips drive) into All Point, Solid Set, machine bolt, masonry anchors.

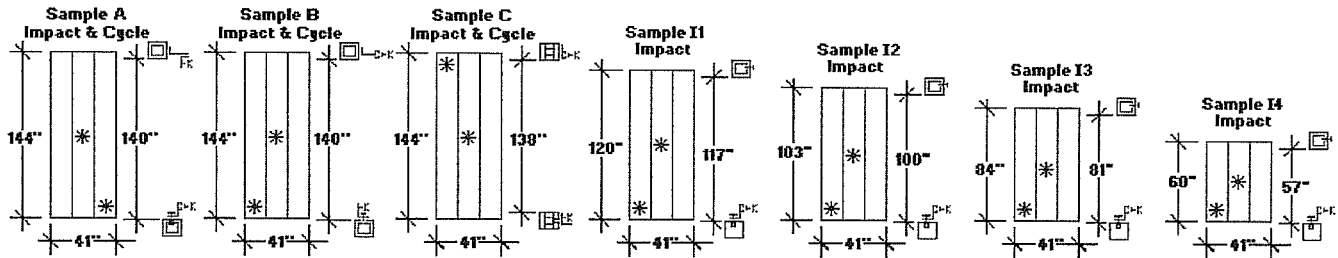
The specimens, A, B & C, as previously described, were impacted (as shown in the diagram above) with a 9.02 lb, 96" long, S4S, 2x4, of No. 2 Southern Pine lumber, in locations as directed by the client consulting engineer.
