**Study of Mitigative Techniques In Existing Houses
to Control Indoor Radon Exposure In Alachua
and Marion Counties In Florida**

Technical Publication # 71

M.E. RINKER, Sr.
SCHOOL OF BUILDING CONSTRUCTION
UNIVERSITY OF FLORIDA

July 12, 1990

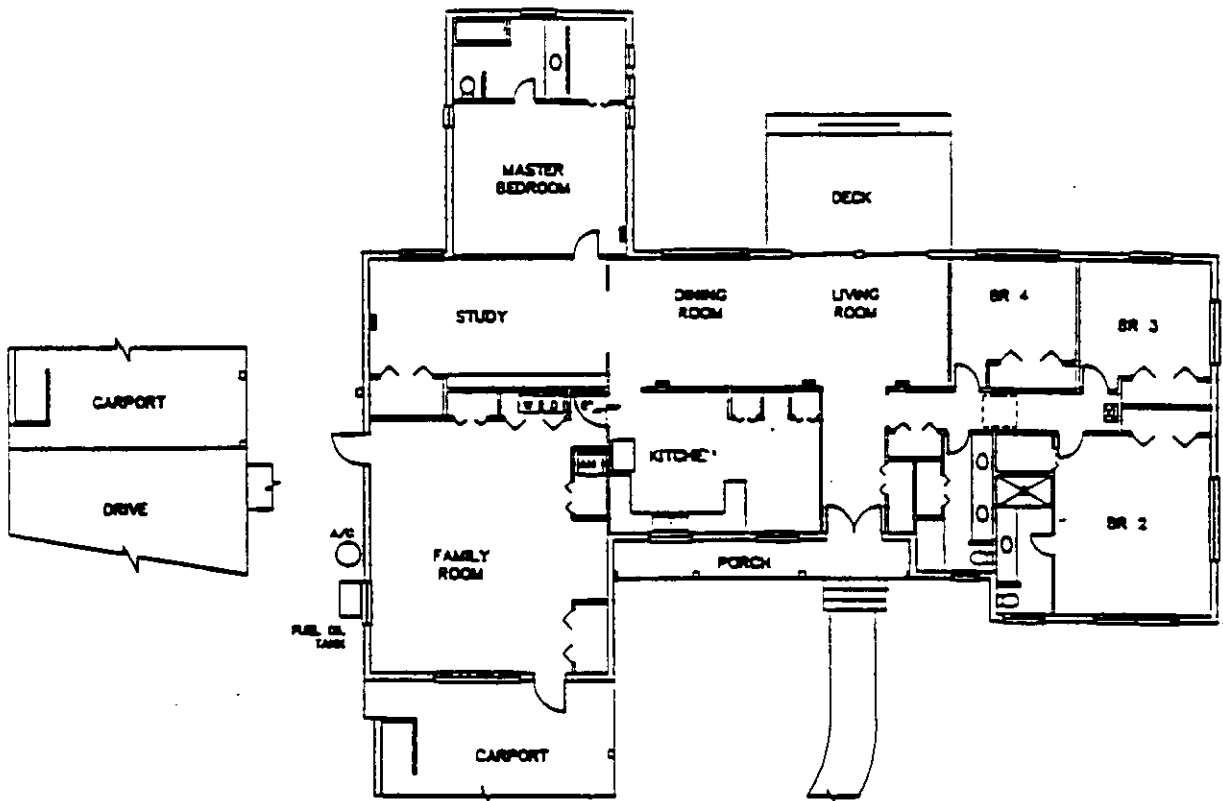
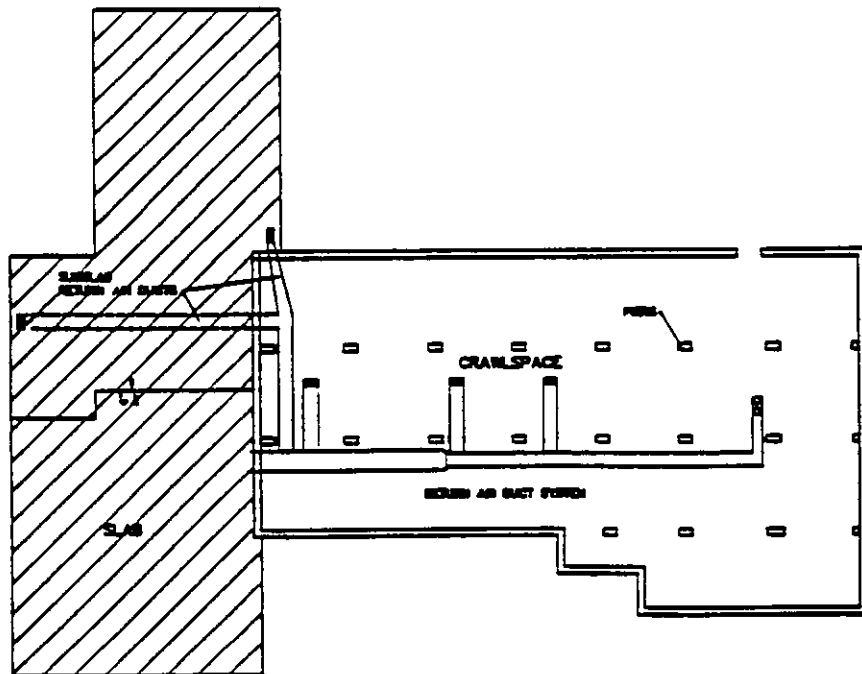
FLOOR PLAN AND FOUNDATION/FLOOR CONFIGURATION

Case Study #2 is a four bedroom, three bath residence constructed on a moderately sloping site in Gainesville, Florida (Figure 21-A). The charcoal canister screening test conducted on this house reflected a radon level of 29.6 pCi/L.

This house provided an opportunity to study a more complex structure having both concrete slab and a raised wood flooring systems (Figure 21-B). Additional areas of interest that this structure provided for study were those created by the addition of new areas of structure. The enclosing of a former garage and the addition of a new wing provided an opportunity to study a slab floor system with sub-slab partitioning. The partitioning of the sub-slab area was

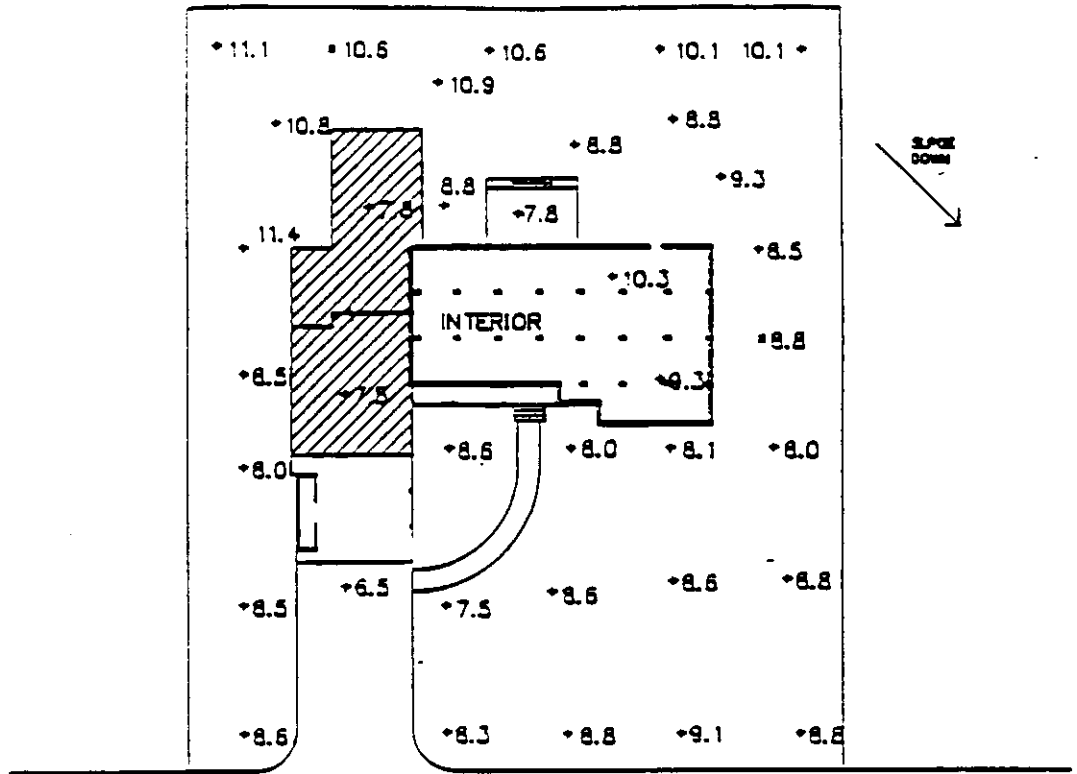
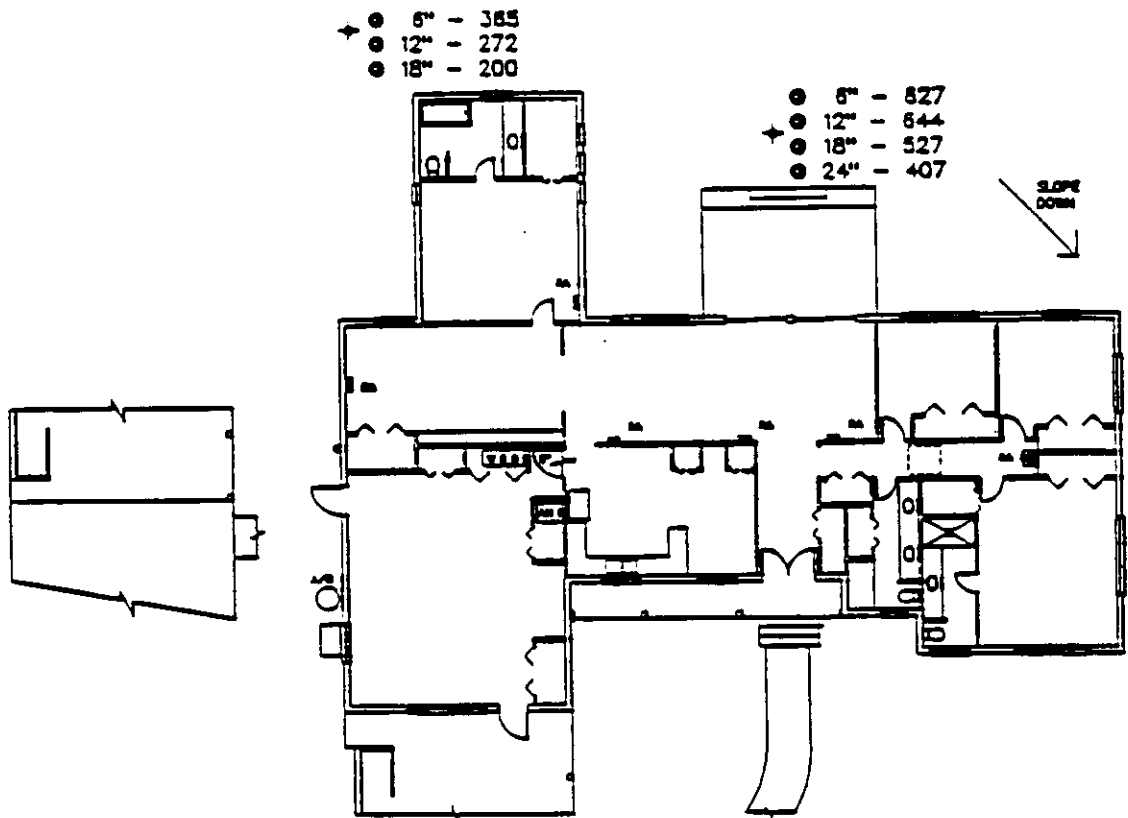
GAMMA RADIATION AND SOIL GAS RADON MEASUREMENTS

Diagnostic testing commenced with Gamma radiation measurements of the site and concluded with several measurements being taken inside the house (Figure 22-A). The levels recorded for Case Study #2 are approximately half of the magnitude of those radiation levels recorded for Case Study #1. These results, for Case Study #2, indicate a higher source potential in the northeast corner of the site than in the southwest corner which was approximately three feet lower in elevation.

A comparison of Figure 22-A with Figure 22-B does not show a direct correlation between the gamma radiation from the soil and the level of radon in the soil gas. One plausible explanation is that the soil gas is migrating through a more permeable, but less radium enriched, strata of soil.

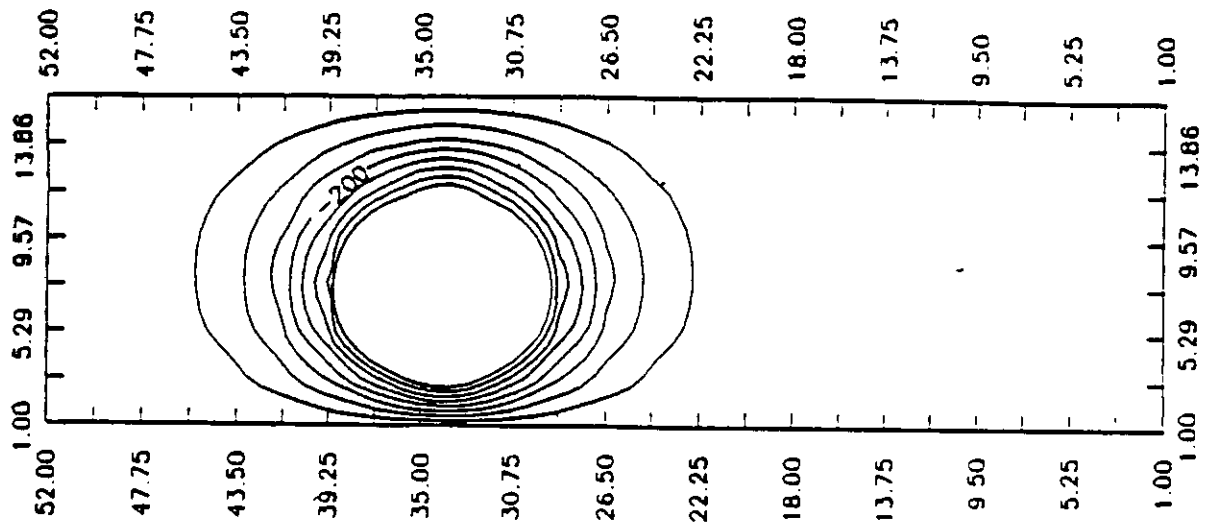
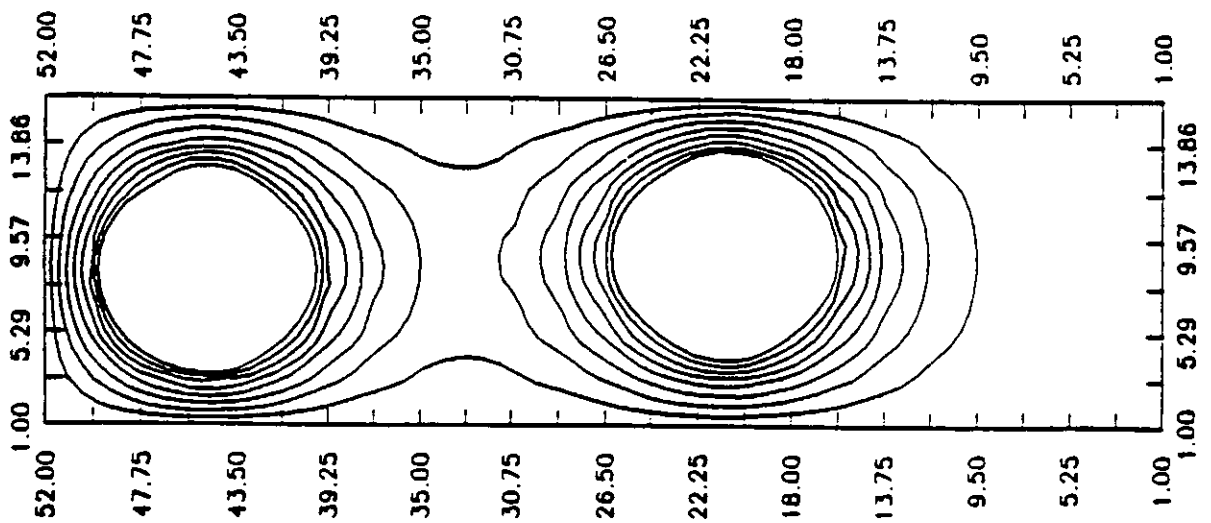
SUB-SLAB PRESSURE FIELD EXTENSIONS
 PREDICTED WITH COMPUTER MODEL

model also provided the ability to consider different slab sizes, geometries and fill characteristics. Using Case Study #4 criteria, the model was run and used to illustrate the sub-slab pressure field extensions associated with one and two suction points (Figures 39-A & 39-B). It was clear from this model that two suction points would be significantly more effective than one point in providing total coverage of the sub-slab area. From this additional analysis a two suction point sub-slab depressurization system was recommended for installation at the locations shown in Figure 40. The system would be installed as illustrated in Figure 41.

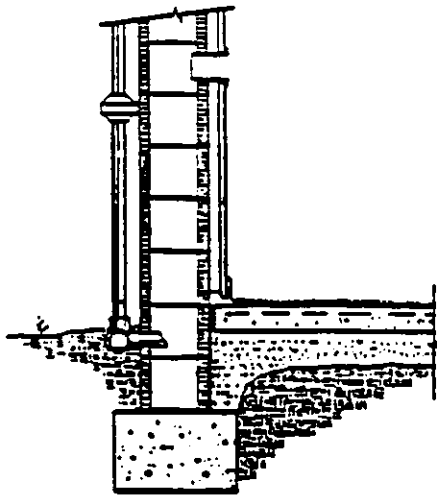
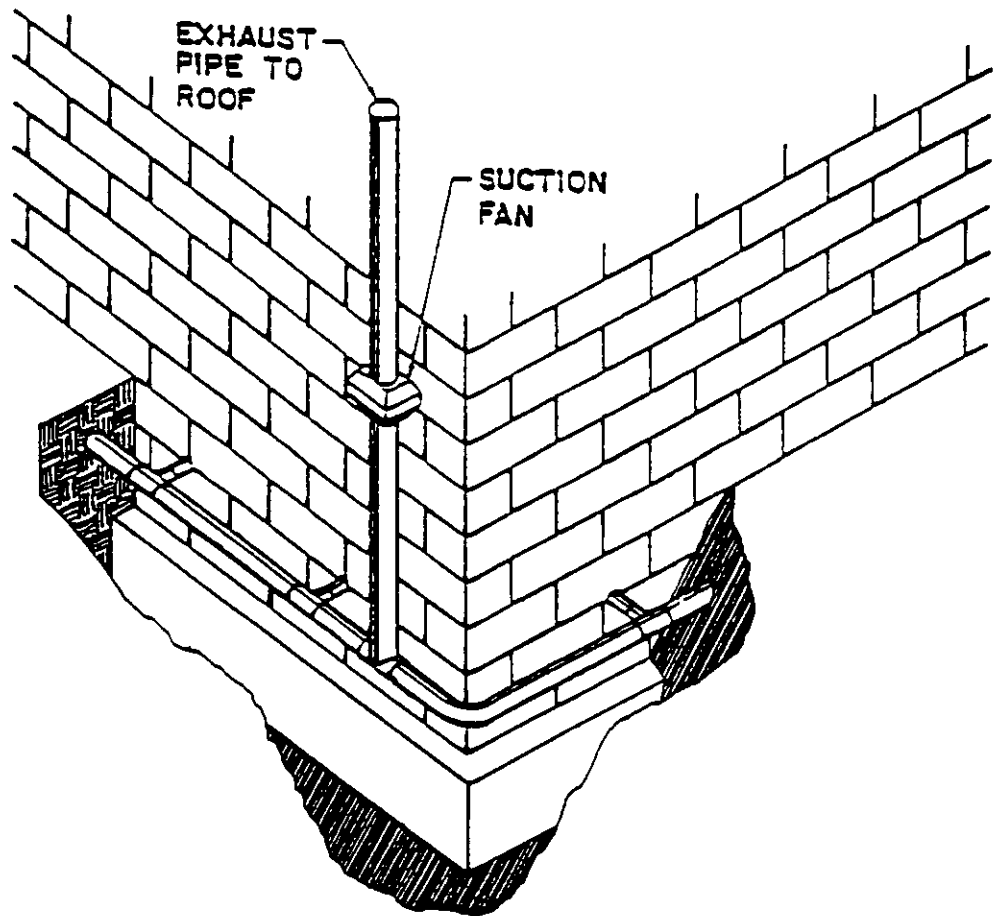
FIGURE 42

Since it was not determined if the slab was cast fully into the foundation wall, the block wall cavity was under suspicion. With over 20" of stemwall in contact with the sub-slab fill dirt, ample opportunity was present for the radon to enter the wall cavity. Negative pressure conditions, either naturally or mechanically induced, would result in the radon migrating from the wall cavity into the occupied space. The fireplace, clothes dryer and HVAC system were the mechanical systems capable of causing these negative pressure conditions.

If the Phase 1 activities did not adequately reduce the indoor radon levels, installation of the block wall depressurization system is recommended.

The installation of the block wall depressurization system would involve first conducting pressure tests to determine where vertical cells in the block had been poured with concrete thereby creating several isolated wall cavities. Once these separate wall cavities had been

identified a 4" diameter PVC pipe would be placed just below grade around the outside of the exterior wall. Following the installation of the 4" manifold, 2" PVC pipes would be tapped into the block wall cavity, below grade if possible, and connected to the manifold (Figure 42). After all wall cavities had been connected to the manifold, a 4" diameter PVC pipe would be run vertically to the underside of the soffit where a fan would be installed. The discharge from the fan could either be routed through the roof and terminated with a weather-proof flashing or turned horizontal just under the soffit and terminated at the edge of the fascia. A screen would be necessary at the end of the pipe to keep birds and other animals from nesting in this pipe. One concern about discharging active radon mitigation systems is that the closer the termination point is to the ground the greater the opportunity there is for re-entrainment. This condition occurs when the highly radon enriched discharge is drawn back into the house through windows, doors or other openings. If this discharge is in close proximity to outdoor areas that are frequently used, such as a patio or deck, elevated health risks can result.
