SURVEY DRAWINGS

ELIZABETH BISHOP HOUSE
HISTORIC STRUCTURES REPORT
624 WHITE STREET - KEY WEST FLORIDA
KEY WEST LITERARY SEMINAR

EXISTING STRUCTURAL CONDITIONS EVALUATION CRITERIA

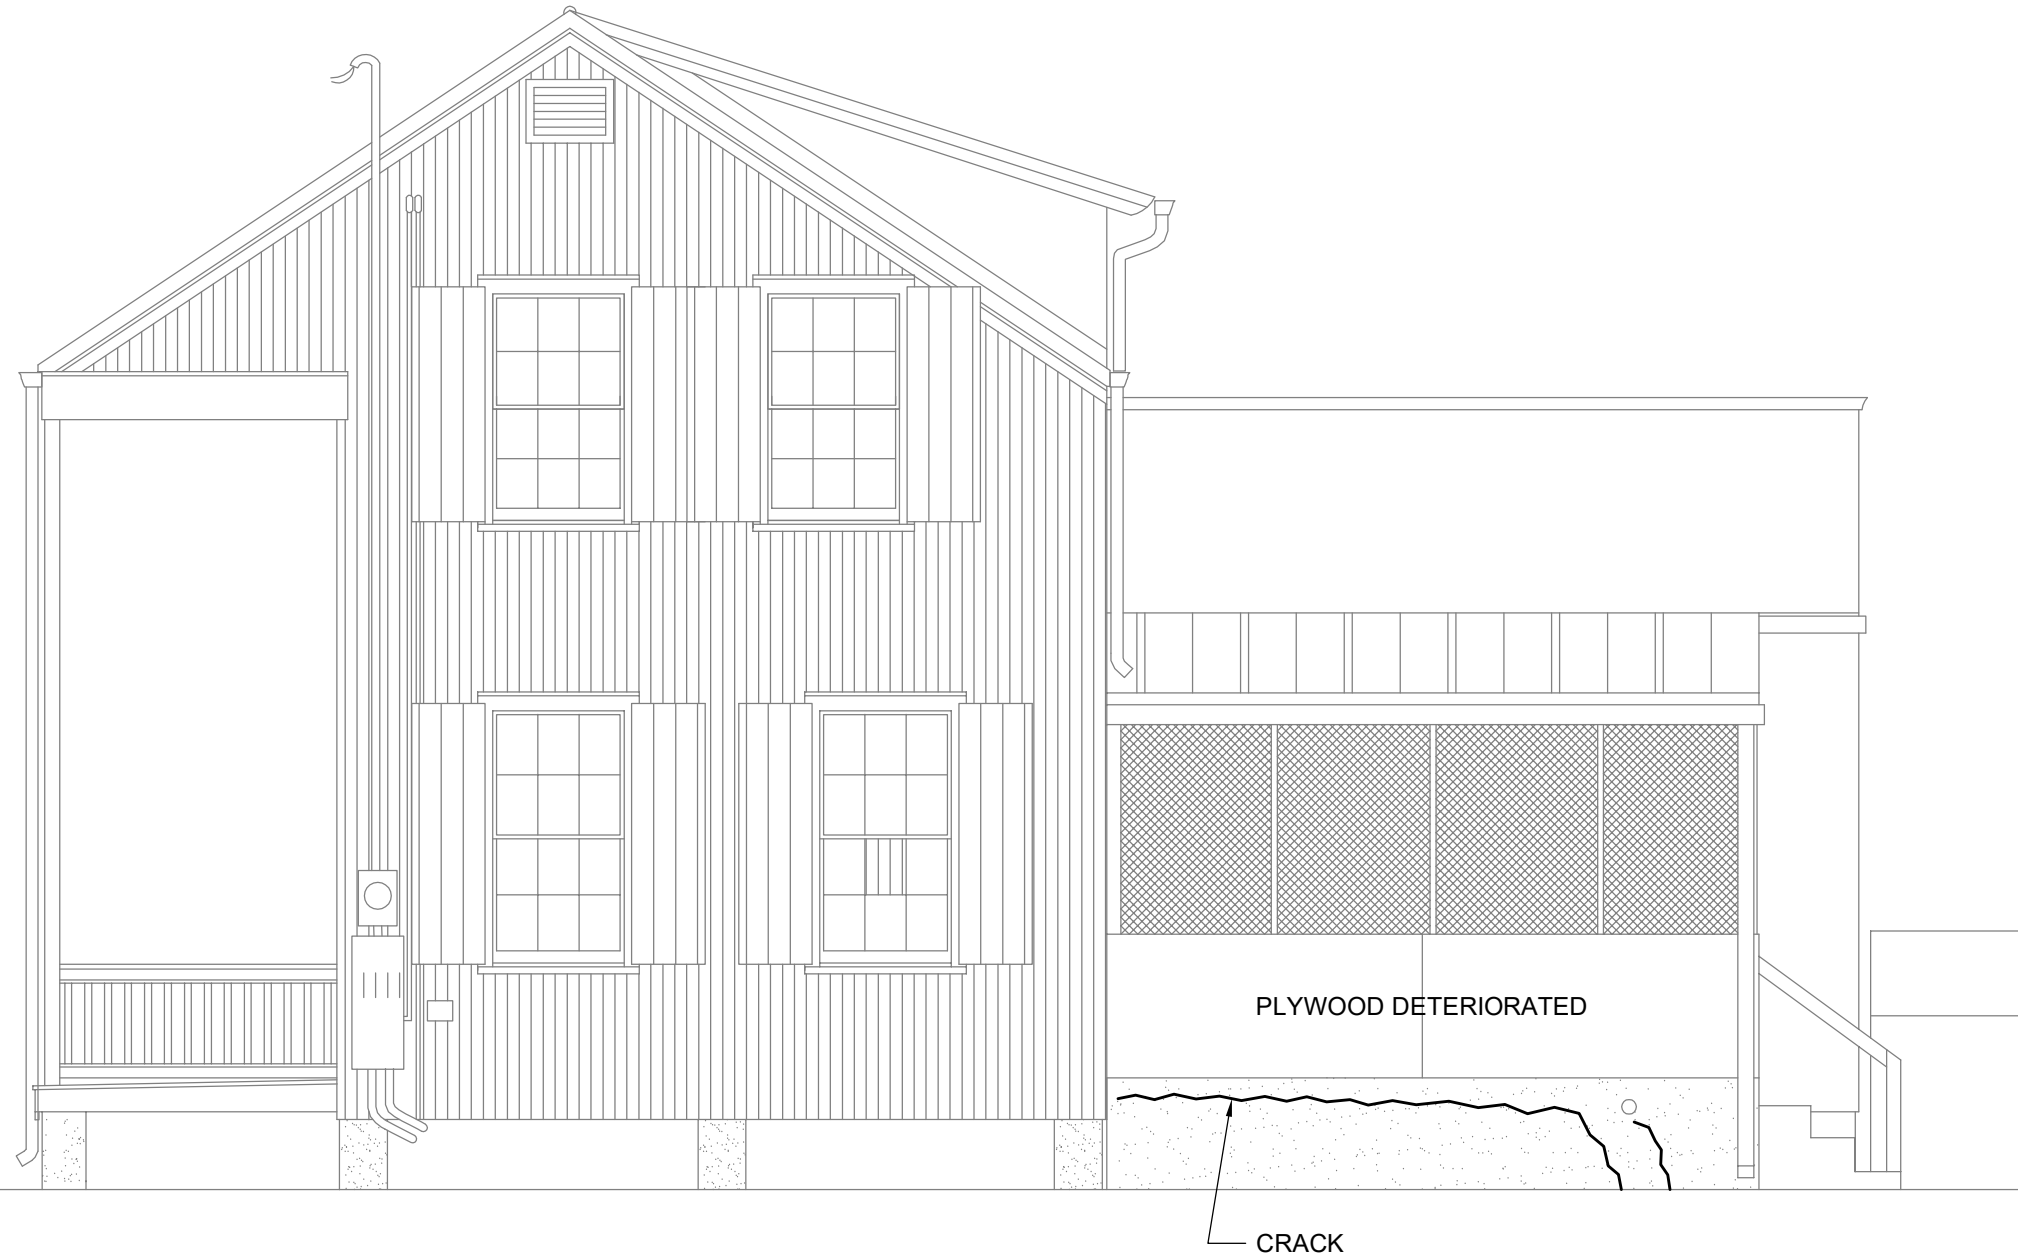
NORTH EXTERIOR ELEVATION

DETERIORATED SILL CRACK PLYWOOD DETERIORATED

DETERIORATED
SIDING

DAMAGED
WOOD SIDING

- 2. Exterior Siding Repair:** Repair deteriorated exterior siding as required to make the building watertight, taking care to match the existing dimension and species of the original vertical wood siding. Stagger the construction joints to blend the repair. Prior to commencing work, a written report of findings and proposed methods of repair should be submitted to the architects for review and modifications as required for compliance with accepted preservation standards.
