Final Report

Department of Community Affairs  
DCA Contract 03-RC-11-14-00-22-034

# Loss Relativities for FBC Wood Panel Shutters

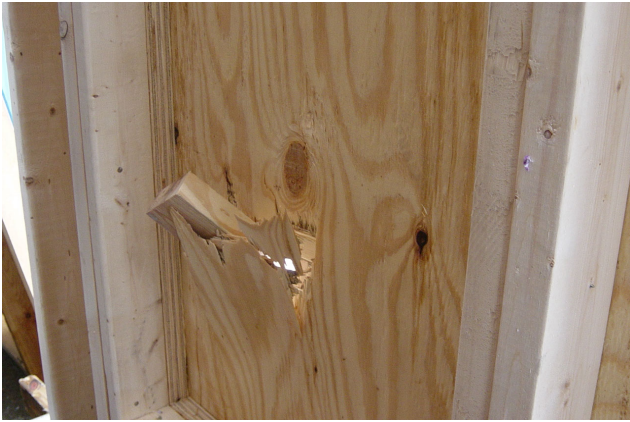
**Figure 2-1. Typical 4.5 lb. 2x4 Missile Impact on Plywood Panel**

Figures 2-1 through 2-4 illustrate typical 2x4 and clay tile missile impacts on the plywood and OSB specimen.

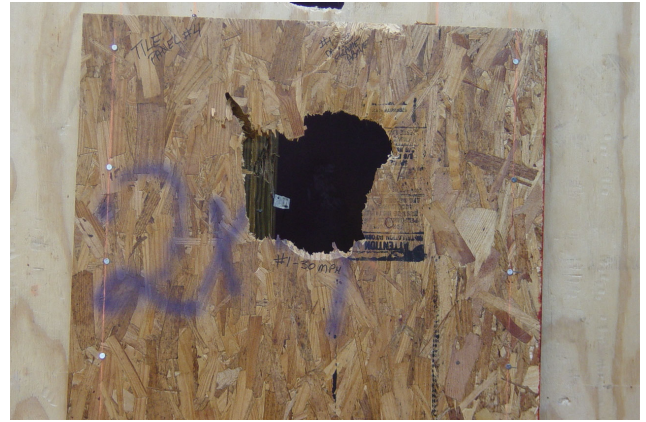
**Figure 2-4. Typical 6.6 lb. Clay Tile Impact on OSB Panel**

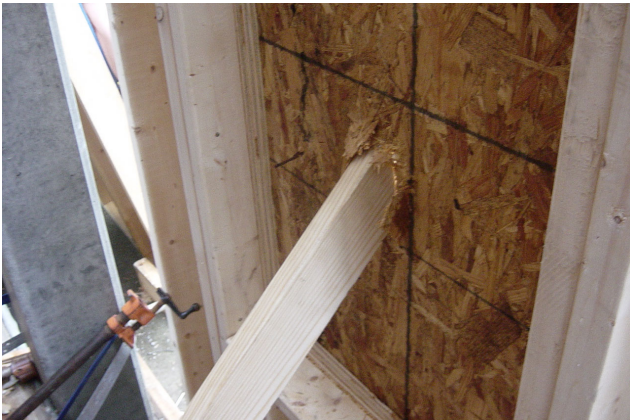
**Figure 2-2. Typical 4.5 lb. 2x4 Missile Impact on OSB Panel.**

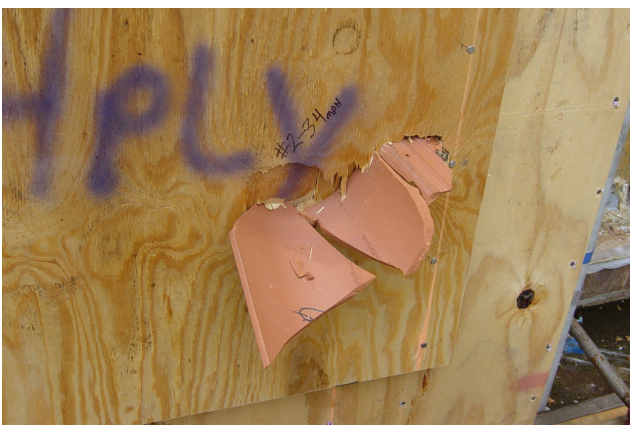
**Figure 2-3. Typical 6.6 lb. Clay Tile Impact on Plywood Panel**

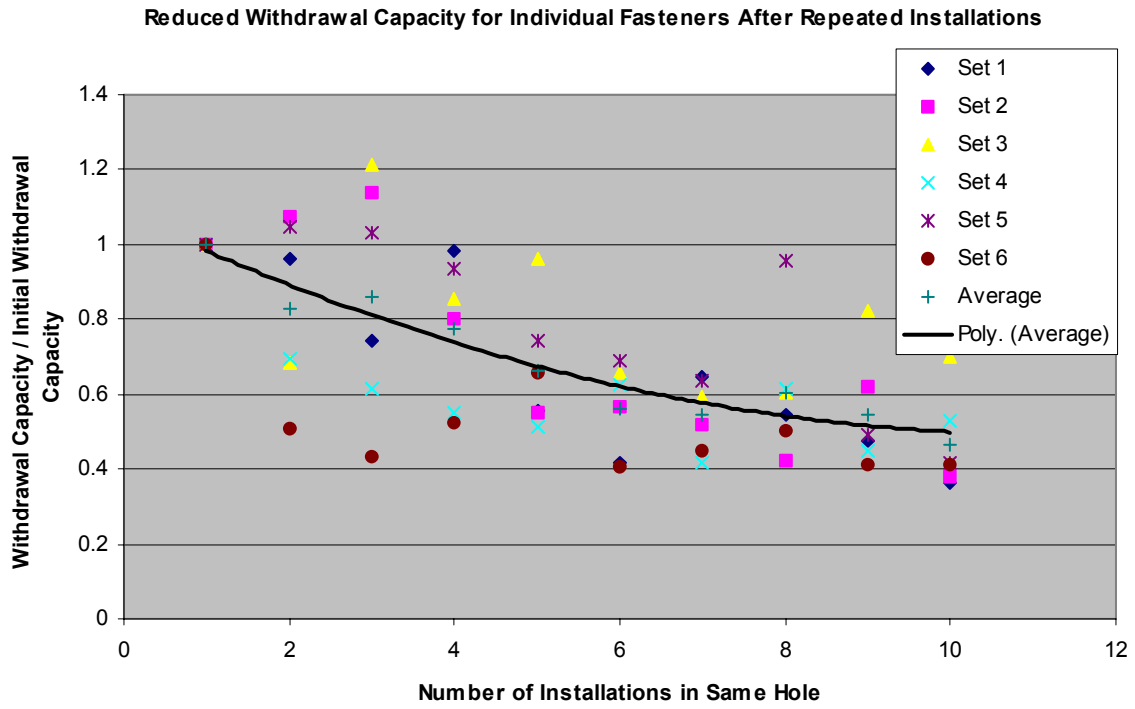
**Figure 2-6. Variation in Wood Frame Withdrawal Capacity for Repeated Installation of Fasteners**

measure the force required to remove the nail. A new nail was then re-installed in the same hole with the nail driven to the same depth and the force required to withdraw the new nail was measured. This was repeated ten times in the same hole before the process was started again. Results of these tests are reported in Appendix C and plotted in Figure 2-6.

Again, there is considerable scatter in the results from the repeated tests with some subsequent applications yielding higher withdrawal capacities than the initial installation. This may be due to slight differences in the nail diameters of an additional reflection of the large variability in measurements involving natural wood products. A trend line based on the average capacities obtained from the six sets of tests suggests that there is a general reduction in withdrawal capacity with repeated installation in the same hole and that the reduction may reach 50 percent after 10 repeated installations in the same hole.

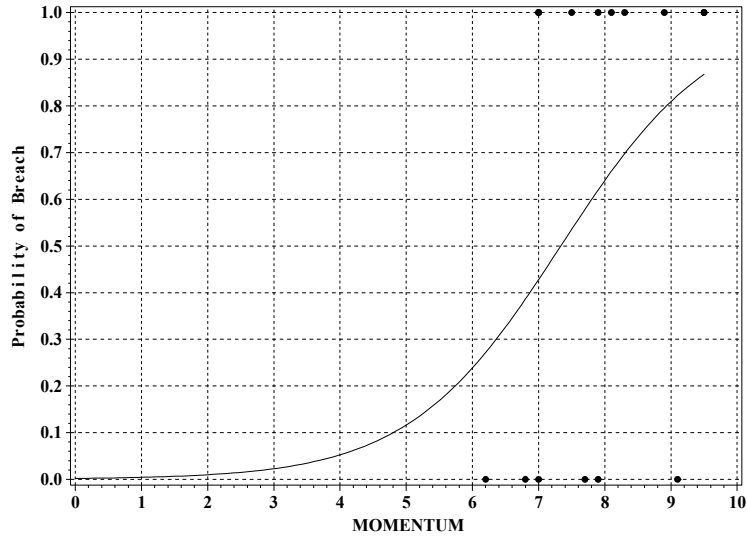
Material = Plywood Opening = Small Missile = 2x4 Location = Central

**Figure 3-7. Momentum Logistic Model for Plywood, 2x4 Missile, Central Impacts**

We extracted the data from Appendix A and analyzed it in various ways to develop wood panel perforation models. Some examples of the resulting logistic fits of the data for the 2x4 wood plank missile on large openings are given in Figure 3-5 through 3-8. The dots on the figures are the individual test results. Those tests with no breach of the panel (i.e., the missile bounced off the panel and did not stick in the panel or punch all the way through the panel) are plotted at the 0 probability position. Those tests that perforated the panel are plotted at the 1 probability position.

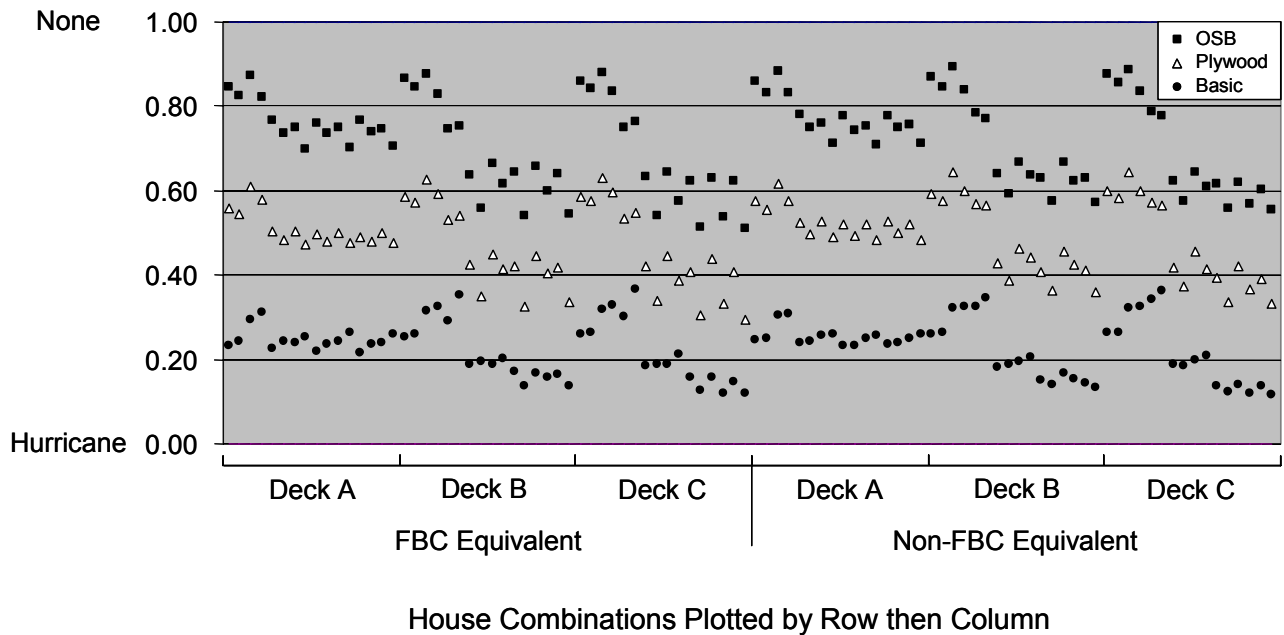
**Figure 3-9. Terrain B Loss Relativities (Normalized Within Cell Group) Ranging from None (1.0) to Hurricane (0.0)**

One of the simplifications we examined was to see if additional levels of shutters could be implemented as a separate constant factor adjustment to the Basic or Hurricane level that is already built into the tables. To determine if this simplification is possible, we produced the plots in Figures 3-9 and 3-10. These plots show normalized-within-cell-group relativities of the effect of opening protection, ranging from Hurricane (plotted at 0) and None (plotted at 1). We see that Basic Protection (175 ft-lb of energy impact resistance), Plywood, and OSB

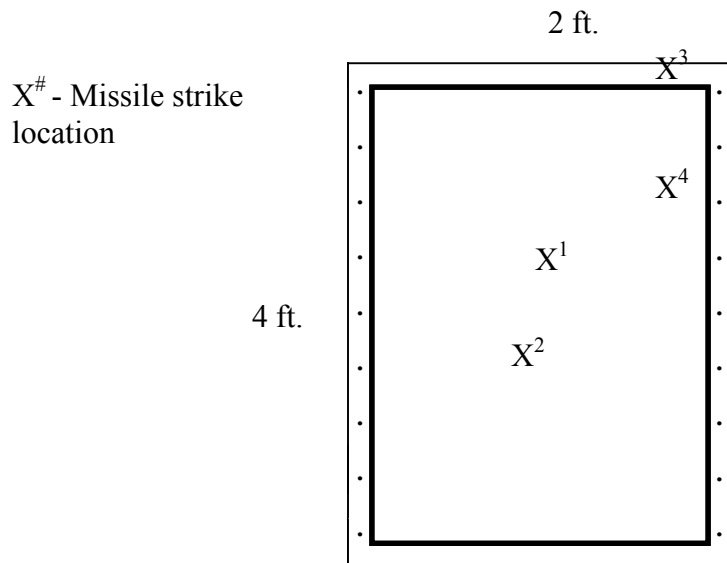
<b>Test Number:</b> Panel 10			
<b>Panel Type:</b> 15/32 Plywood – 4 Ply			
<b>Panel Layout:</b> 2' x 4' Opening Strong Axis in 4' direction	<b>Nailing Schedule and Location:</b> 12d common 6" along sides of the panel		
<b>Missile Impact:</b> <input type="checkbox"/> None <input type="checkbox"/> 2x4 <input checked="" type="checkbox"/> Clay Tile	<b>Pressure Test:</b> <input type="checkbox"/> None <input type="checkbox"/> Monotonic to Failure ___ psf failure <input type="checkbox"/> Cyclic _____ Design Wind Speed <input type="checkbox"/> _____ Number of Cycles to Failure		
<b>Results of Missile Tests:</b>			
<b>Impact #</b>	<b>Missile Weight</b>	<b>Missile Speed</b>	<b>Damage Observation</b>
1	6.68 lb	30 mph	Part of tile broke off in shutter – did not fully penetrate
2	6.67 lb	33 mph	Partial penetration
3	6.62 lb	27 mph	Hit too high
4	6.70 lb	34 mph	Tile punctured shutter and stuck in plywood (hit near edge)

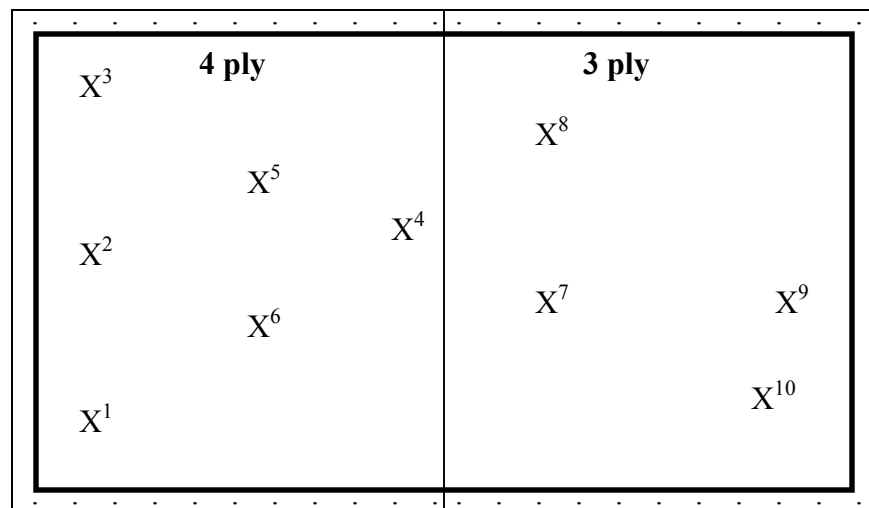
<b>Test Number:</b> Panels 28 and 29			
<b>Panel Type:</b> 15/32 Plywood; Two 3'-9" by 5'-6" panels; 4-ply on left and 3-ply on right			
<b>Panel Layout:</b> 5' x 7' Opening; Two panels with strong axis oriented in 5' direction (2 vertical panels)	<b>Nailing Schedule and Location:</b> 12d common 4" along top and bottom of the panel		
<b>Missile Impact:</b> <input type="checkbox"/> None <input checked="" type="checkbox"/> 2x4 <input type="checkbox"/> Clay Tile	<b>Pressure Test:</b> <input type="checkbox"/> None <input type="checkbox"/> Monotonic to Failure ___ psf failure <input type="checkbox"/> Cyclic _____ Design Wind Speed <input type="checkbox"/> _____ Number of Cycles to Failure		
<b>Results of Missile Tests:</b>			
<b>Impact #</b>	<b>Missile Weight</b>	<b>Missile Speed</b>	<b>Damage Observation</b>
1	4.54 lb	34 mph	Puncture of 4-ply panel
2	4.54 lb	32 mph	Punctured panel
3	4.54 lb	30 mph	Cracked surface and back plys of panel

4	4.54 lb	30 mph	Cracked panel
5	4.54 lb	34 mph	Penetrated panel
6	4.54 lb	34 mph	Penetrated panel
7	4.54 lb	33 mph	Indented panel, cracked interior ply
8	4.54 lb	37 mph	Cracked panel
9	4.54 lb	36 mph	Penetrated panel
10	4.54 lb	33 mph	Indented surfaced and cracked panel

X<sup>#</sup> - Missile strike location

5 ft.
