CONSTRUCTION TESTING CORPORATION

Report No: 04-009 LE FBC

Testing : Polycarbonate Hurricane Shutter Panels

Transparent Protection Systems, Inc.

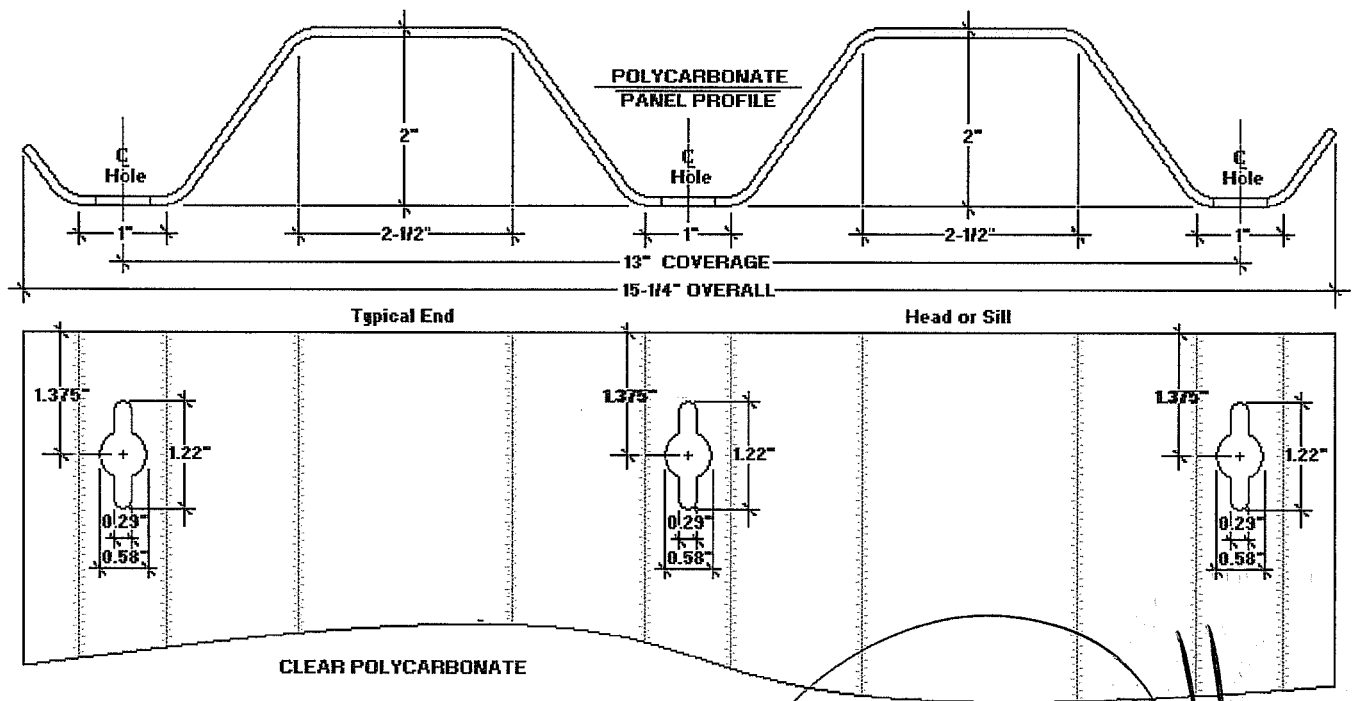
Description of Specimens: Specimens were nominal 1/10" polycarbonate Storm Panels (Mic'd thickness varied across section from 0.0905" to 0.1185"). These panels were extruded into a two ribbed 2" x 13" section with a nominal coverage of 13" per panel manufactured by Transparent Protection Systems, Inc. of West Palm Beach, Florida. These panels utilized the a double key hole punch pattern at each end of the panels as shown in the diagram below. Specimen were all three panels wide (41 1/4") and 103" long. Specimen were mounted in a variety of fastenings these are detailed on the following page. Specimen were installed without intermediate supports to the panel overlaps. Detailed descriptions of each specimen are included immediately preceding the relevant test data together with section drawings.

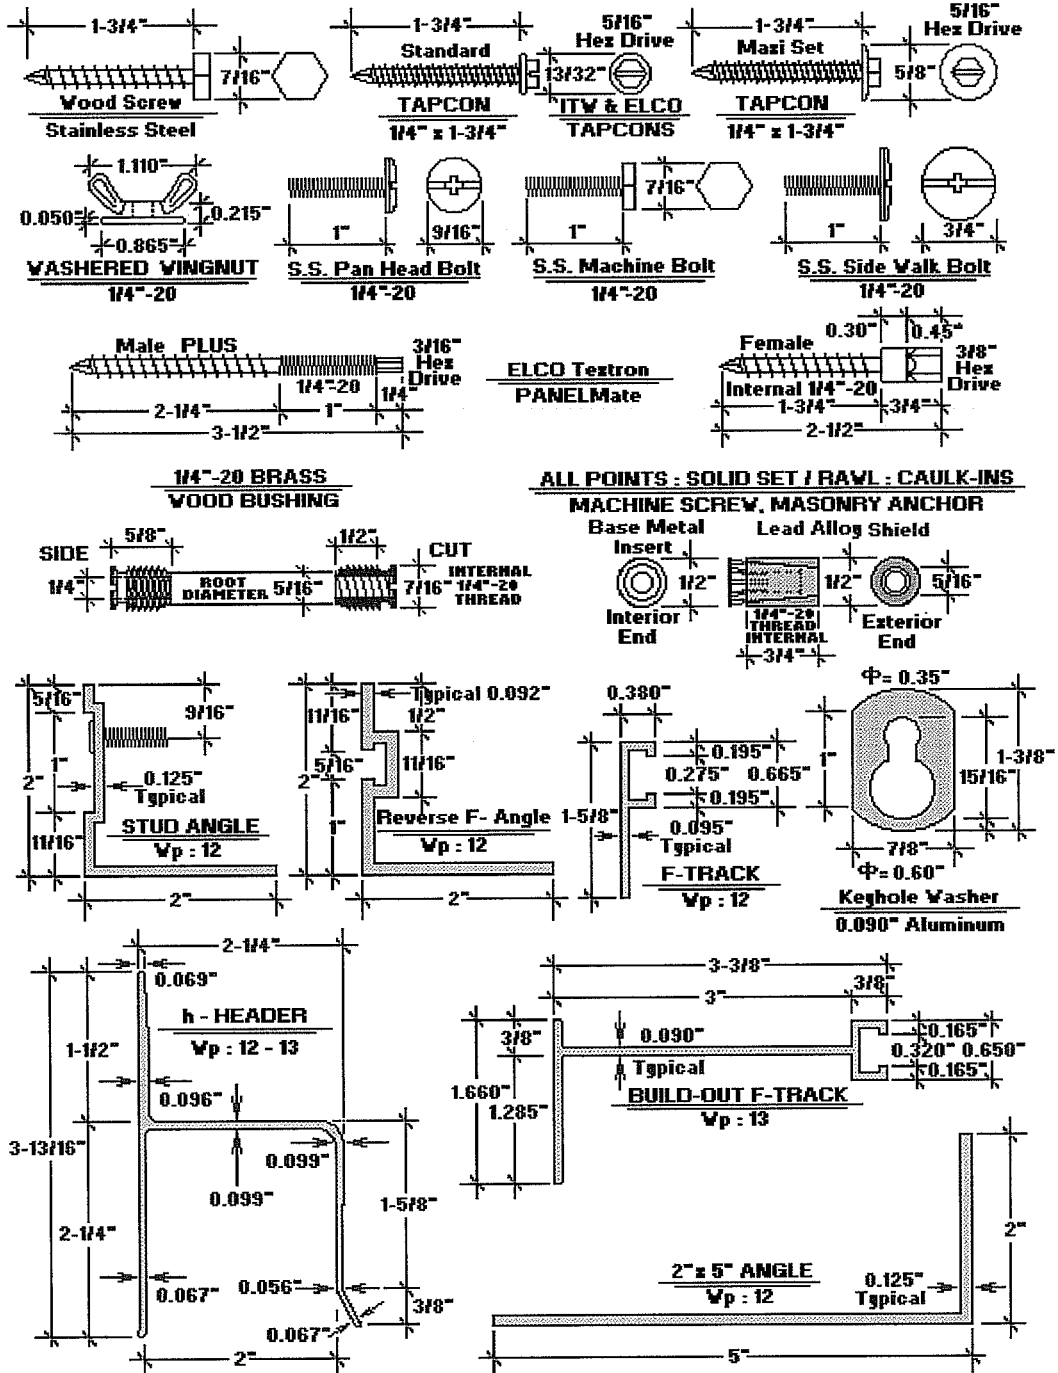
DETAILS: Test specimens were installed with the following fasteners and aluminum extrusion:

A "Webster" gauge was utilized to determine the material hardness of aluminum components. These readings are indicated (w: 13) for example where the gauge registered a 13 hardness taken off of a mill finish extrusion. Where gauge readings are taken off of a painted aluminum component, readings are indicated (Wp: 11.5) for example. Where a number of similar aluminum components were sampled and a range of readings were found these are shown as (w: 11.5-13) or as (Wp:10-12) for example.

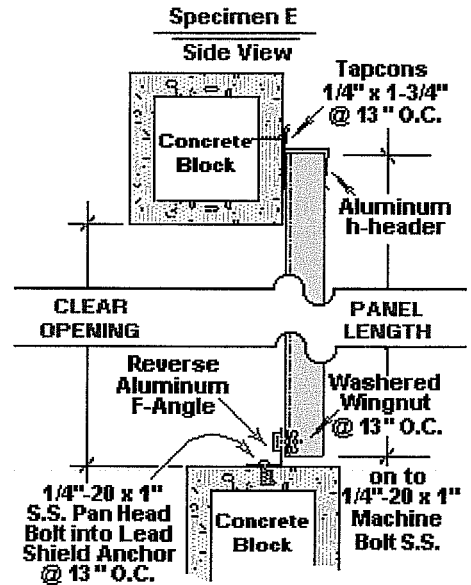
Specimen E : Wall / Floor, Mount : 103" Panels : 99" C.O. Impacts & Cyclic Wind Loading

Head: Panels were mounted into an aluminum h-header extrusion. This extrusion was secured to a concrete block beam at 13" on center with ITW Maxi Set 1/4" x 1-3/4" Tapcon masonry screws. **Sill:** Panels were mounted at 13" on center with washered wing nuts onto stainless steel, 1/4"-20 x 1" machine bolts trapped into an aluminum reverse f-track. This reverse f-angle was secured to a concrete block beam at 13" on center with stainless steel, 1/4"-20 x 1" pan head bolts (9/16" head and combination slot & Phillips drive) into All Point, Solid Set, machine bolt, masonry anchors.

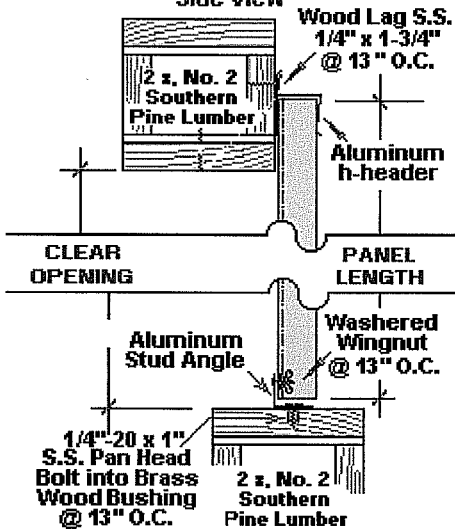
Side View

Specimen F : Build Out / Floor, Mount : 103" Panels : 99" C.O. Impacts & Cyclic Wind Loading

Head: Panels were mounted into an aluminum h-header extrusion. This extrusion was secured to a No: 2 Southern Pine lumber beam at 13 on center with S.S. 1/4" x 1-3/4" wood lags. **Sill:** Panels were mounted at 13" on center with washered wing nuts onto a studded aluminum angle. This angle was secured at 13" on center with stainless steel 1/4"-20 x 1" pan head bolts (9/16" head and combination slot & phillips drive) into All Points, brass wood bushings secured into a No: 2 Southern Pine lumber beam.

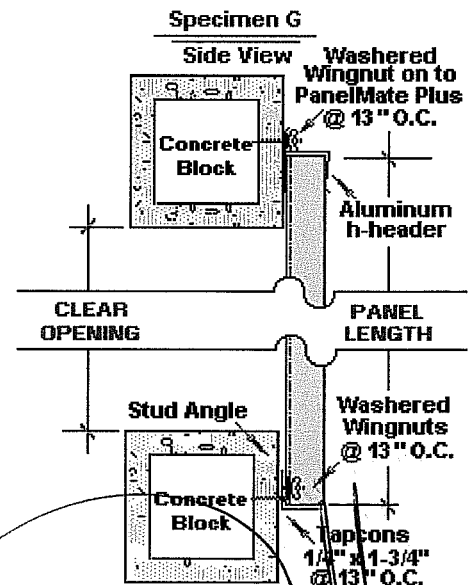
Specimen G : Wall Mount : 103" Panels : 96" C.O. Impacts & Cyclic Wind Loading

Head: Panels were mounted into an aluminum h-header extrusion. This extrusion was secured to a concrete block beam at 13" on center with washered wing nuts onto ELCO PanelMate, Male, masonry anchors. **Sill:** Panels were mounted at 13" on center with washered wing nuts onto a studded aluminum angle. This angle was secured at 13" on center with standard 1/4" x 1-3/4" ELCO Tapcon masonry screws.

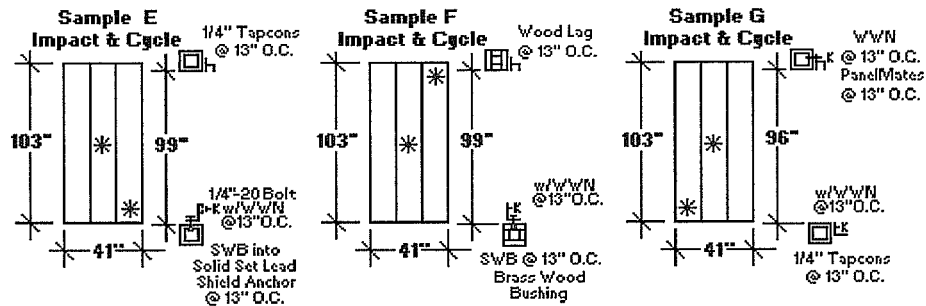
The specimens, **E, F & G**, as previously described, were impacted (as shown in the diagram above) with a 9.02 lb, 96" long, S4S, 2x4, of No. 2 Southern Pine lumber, in locations as directed by the client consulting engineer.

IMPACTS : Specimens E, F & G were impacted in accordance with FBC 2001 TAS 201-94. None failed as a result of large missile impacts.

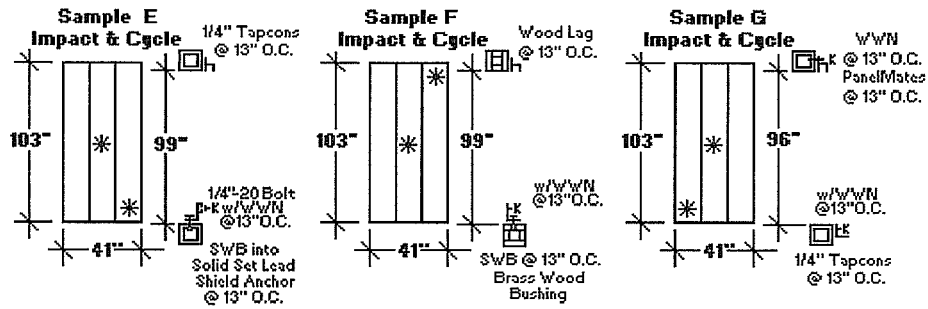
Following impacts, specimens E, F & G were cyclic wind loaded as directed by the **FBC 2001, TAS 203-94, CRITERIA FOR TESTING PRODUCTS SUBJECT TO CYCLIC WIND PRESSURE LOADING**, in accordance with **Table 1625.4 : Fatigue Loading Sequence**, located in chapter 16, **FBC 2001**. In general, numerous static air pressure cycles are applied to the specimen at varying load levels based upon the positive and negative design load levels. Polyethylene film (2 mil) and tape were used to seal air leakage during loads and were used in a manner that did not influence the results. A detailed account of the cyclic wind loads applied and resulting deflections at the centerline of the specimen's primary span follows:

CYCLIC WIND LOADS : Specimens E, F & G were subjected to cyclic wind loads in accordance with FBC 2001 TAS 203-94. All specimen successfully completed the cyclic wind loads to verified a **Design Load of +/- 17.33 PSF.**

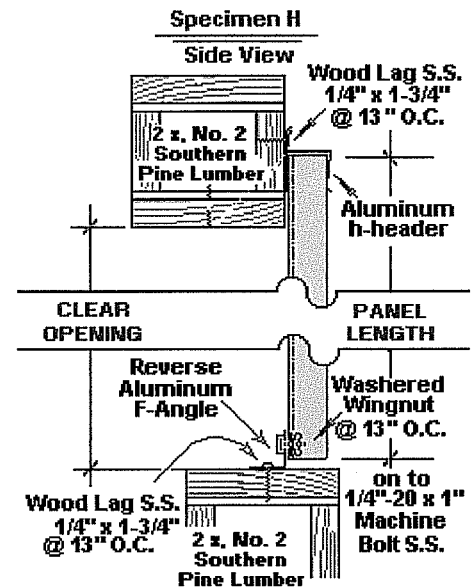
Specimen H1 : Wall / Floor, Mount : 103" Panels : 99" C.O. : -Wind

Specimen H4 : Wall / Floor, Mount : 93" Panels : 89" C.O. : -Wind

Head: Panels were mounted into an aluminum h-header extrusion. This extrusion was secured to a No: 2 Southern Pine lumber beam at 13" on center with S.S. 1/4" x 1-3/4" wood lags. **Sill:** Panels were mounted at 13" on center with washered wing nuts onto stainless steel, 1/4"-20 x 1" machine bolts trapped into an aluminum reverse f-track. This reverse f-angle was secured to a No: 2 Southern Pine lumber beam at 13" on center with S.S. 1/4" x 1-3/4" wood lags.

Static Wind Loading / Manner of Testing: In accordance with FBC 2001, TAS 202-94, **CRITERIA FOR TESTING IMPACT & NON IMPACT RESISTANT BUILDING ENVELOPE COMPONENTS USING UNIFORM STATIC AIR PRESSURE :** Loads were applied to the specimen (30 second duration) at levels specified by the client's Consulting Engineer. Polyethylene film (2 mil) and tape were used to seal air leakage during loads these were used in a manner that did not influence the results. Gauges were mounted along the centerline of the specimen's primary span to record deflections. Deflection readings follow:

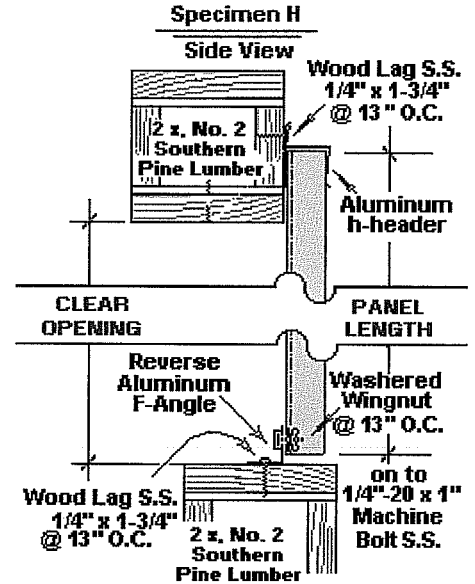
Specimen H2 : Wall / Floor, Mount : 84" Panels : 80" C.O. : -Wind
Specimen H5 : Wall / Floor, Mount : 72" Panels : 68" C.O. : -Wind

Head: Panels were mounted into an aluminum h-header extrusion. This extrusion was secured to a No: 2 Southern Pine lumber beam at 13" on center with S.S. 1/4" x 1-3/4" wood lags. **Sill:** Panels were mounted at 13" on center with washered wing nuts onto stainless steel, 1/4"-20 x 1" machine bolts trapped into an aluminum reverse f-track. This reverse f-angle was secured to a No: 2 Southern Pine lumber beam at 13" on center with S.S. 1/4" x 1-3/4" wood lags.

Static Wind Loading / Manner of Testing: In accordance with FBC 2001, TAS 202-94, **CRITERIA FOR TESTING IMPACT & NON IMPACT RESISTANT BUILDING ENVELOPE COMPONENTS USING UNIFORM STATIC AIR PRESSURE :** Loads were applied to the specimen (30 second duration) at levels specified by the client's Consulting Engineer. Polyethylene film (2 mil) and tape were used to seal air leakage during loads these were used in a manner that did not influence the results. Gauges were mounted along the centerline of the specimen's primary span to record deflections. Deflection readings follow:

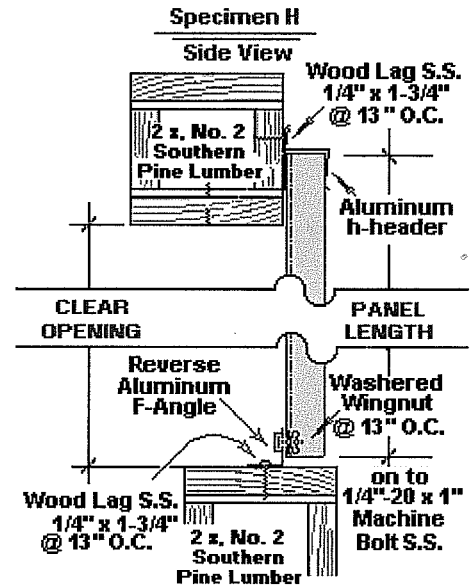
Specimen H3 : Wall / Floor, Mount : 60" Panels : 54" C.O. : -Wind

Specimen H3 : Wall / Floor, Mount : 48" Panels : 44" C.O. : -Wind

Head: Panels were mounted into an aluminum h-header extrusion. This extrusion was secured to a No: 2 Southern Pine lumber beam at 13" on center with S.S. 1/4" x 1-3/4" wood lags. **Sill:** Panels were mounted at 13" on center with washered wingnuts onto stainless steel, 1/4"-20 x 1" machine bolts trapped into an aluminum reverse f-track. This reverse f-angle was secured to a No: 2 Southern Pine lumber beam at 13" on center with S.S. 1/4" x 1-3/4" wood lags.

Static Wind Loading / Manner of Testing: In accordance with FBC 2001, TAS 202-94, **CRITERIA FOR TESTING IMPACT & NON IMPACT RESISTANT BUILDING ENVELOPE COMPONENTS USING UNIFORM STATIC AIR PRESSURE :** Loads were applied to the specimen (30 second duration) at levels specified by the client's Consulting Engineer. Polyethylene film (2 mil) and tape were used to seal air leakage during loads these were used in a manner that did not influence the results. Gauges were mounted along the centerline of the specimen's primary span to record deflections. Deflection readings follow:
