# Tracking Chart – Roofing TAC

This proposal will require a sealed roof deck consistent with the IBHS Fortified Bronze designation.

## Hurricane Demonstration Testing

### Insights on Wind-Driven Water Entry

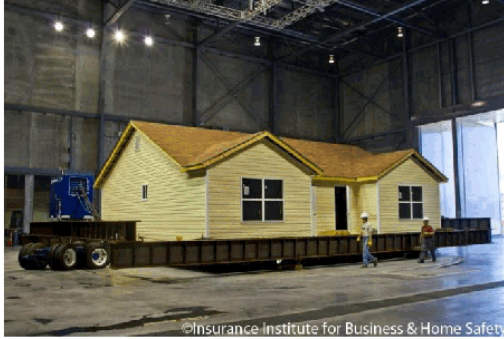
Figure 1-Test duplex moving into the large test chamber at the IBHS Research Center.

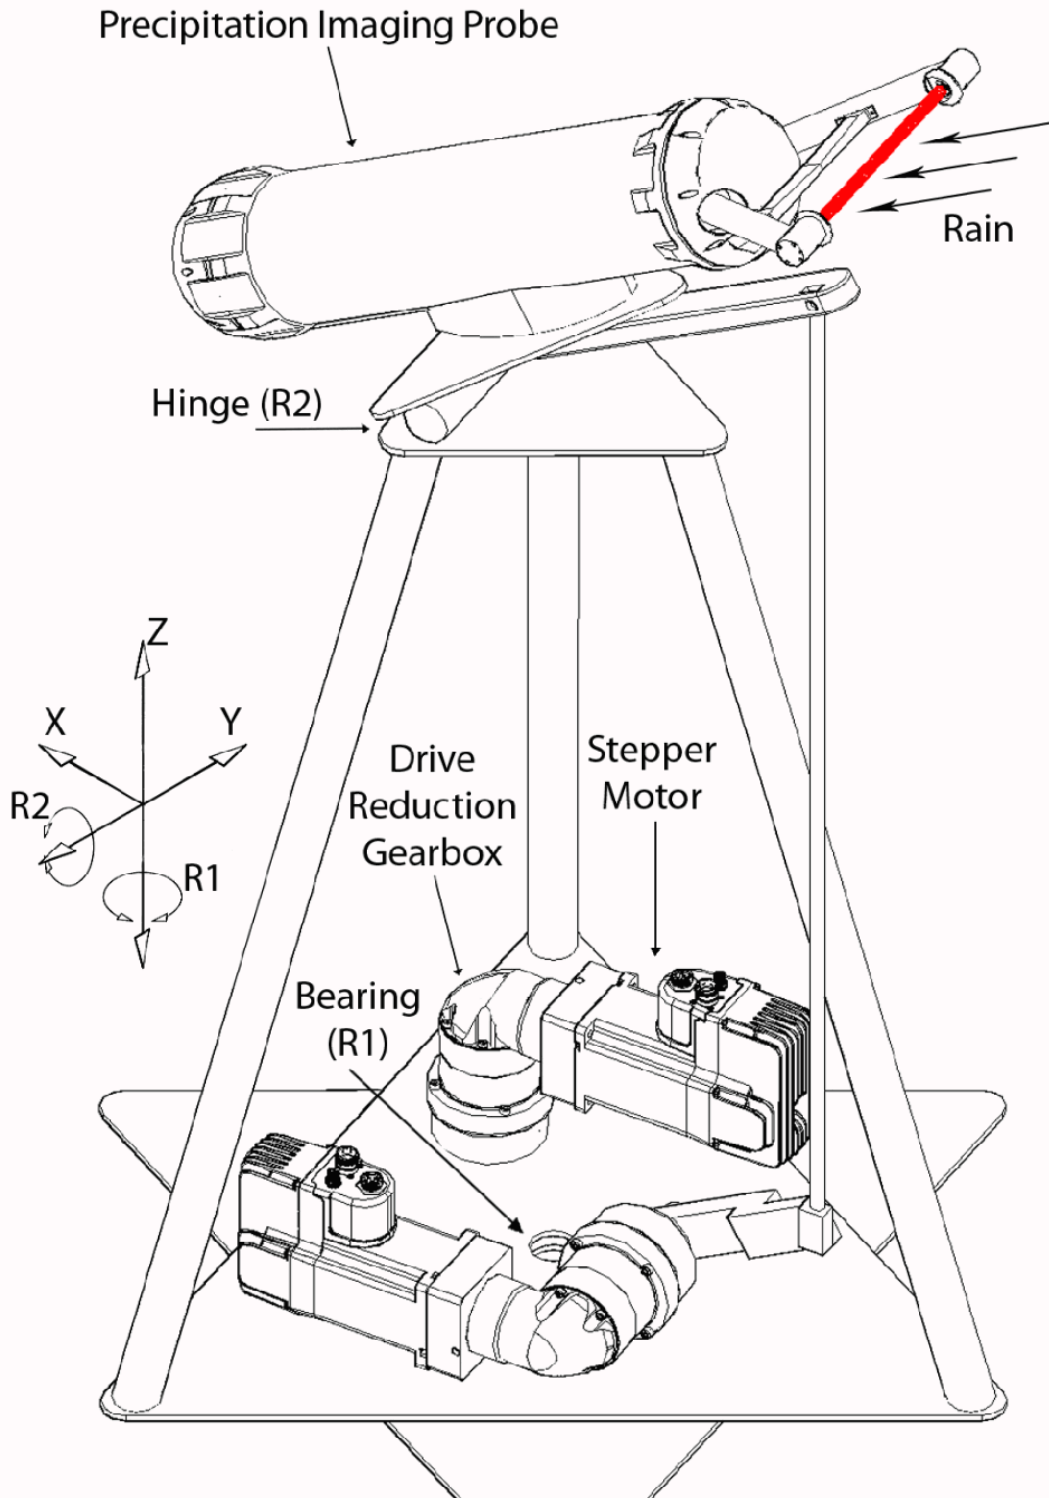
Figure 2 - Precipitation Imaging Probe (PIP) style disdrometer mounted on Florida Coastal Monitoring Program (FCMP) portable weather station for Hurricane Ike data collection by University of Florida.

Planning and research leading to the development of wind-driven rain capabilities at the IBHS Research Center have been ongoing for several years. IBHS provided support to the University of Florida (UF) to assist with deployment of a research disdrometer (an instrument that quantifies droplet size and rain fall rates, shown in Figure 2 on page 3) in Hurricane Ike.

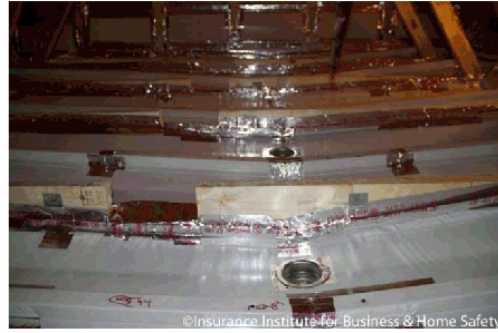
Figure 3 - Photograph of water collection channels between ceiling trusses in duplex.

When the duplex was completed, including installation of wall board and ceiling drywall, drainage panels and tracks (DrySpace™) were installed to create water collection channels between the ceiling trusses, as shown in Figure 3. These channels were outfitted with drains and pipes that allowed collected water to be captured in plastic containers arranged throughout the interior (non-attic) space in the two halves of the duplex. The drainage system was installed in a modular system that allowed the collection of water in ceiling areas roughly 10 feet long by 2 feet wide. The trusses ran from front to back of the house and the 22½ inch space between the trusses was divided into three sections, each about 10 feet long. Each drainage channel directed water to a separate numbered plastic container. Typical drain and collection locations are shown in Figure 4, Figure 5, and Figure 6 (shown on page 6). Tests were typically conducted for a 20-minute period, during which a constant wind speed was maintained and rainfall rate was set to produce 8 inches per hour on the test building (i.e., horizontally driven rain). At the completion of each test, water in the buckets was measured and quantity was recorded.

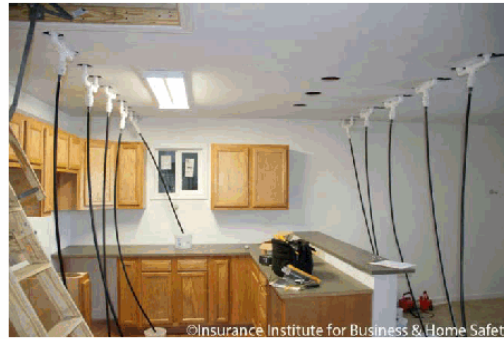
Figure 4 - Photograph of water collection drains to collection buckets in the duplex.

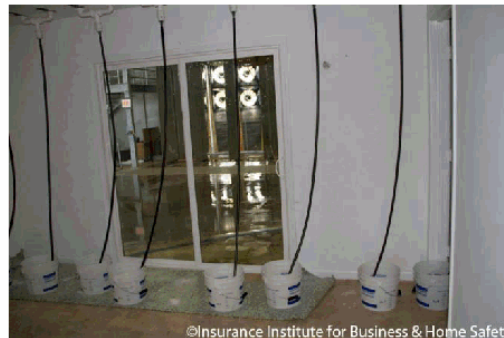
Figure 5 - Photograph of water collection drains to collection buckets in the duplex.

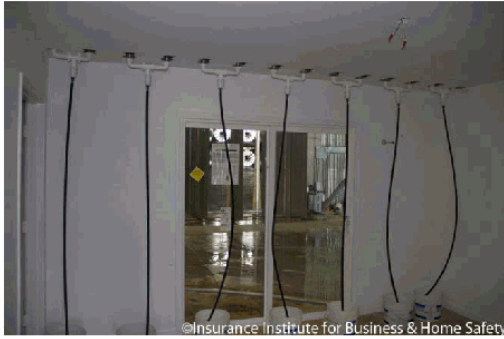
Figure 6 - Photograph of water collection drains to collection buckets in the duplex.

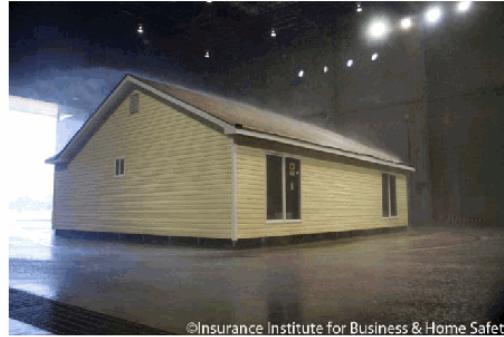
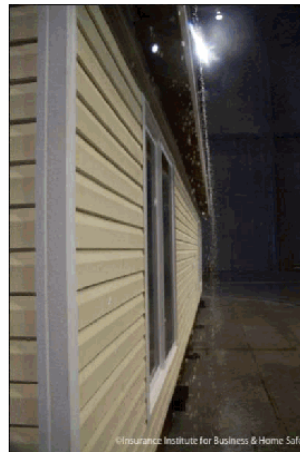
Figure 7 - Photographs of the water entry quantification testing for the open soffit case with the wall facing the wind flow: top) whole duplex; and bottom) close-up of the open soffit area.

A series of quantitative tests was conducted during the time available before the scheduled hurricane demonstration. The first test sequence involved measuring water entry rates when the soffit cover was missing along the entire length of the back eave of the duplex. The opening of approximately 8.5 sq. ft. under the eave of the roof where wind and wind-driven rain could enter the attic caused by the missing soffit is typical of the observed loss of the soffit cover in strong winds. Tests were conducted for wind speeds of 30 mph, 50 mph and 70 mph, during which the wall with the open soffit faced the wind flow, as shown in Figure 7. A quartering wind test (i.e., the wall with the open soffit was oriented at 45 degrees off perpendicular to the wind direction) was also conducted with a 50 mph wind speed.

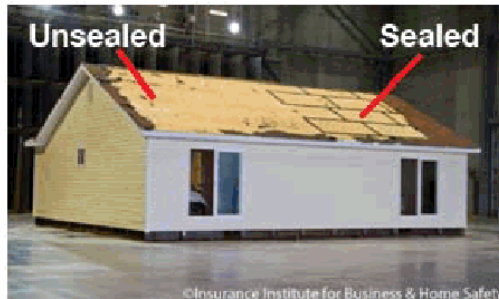
Figure 8 - Photograph of the back of the duplex after shingle and underlayment removal, illustrating the sealed roof deck (on the right) and the un-sealed roof deck (on the left).

to remove roof cover from the back roof surface to expose the sealed and un-sealed roof decks above the same eave where soffit water entry testing was conducted. Removal of roof cover from the front and back surfaces exposed the gap at the top of the primary ridge, so it was fitted with a Florida Building Code High Velocity Hurricane Zone approved ridge vent.

The final sequence of quantification testing included wind speeds of 50 mph with the back of the duplex facing the wind flow. This configuration put the exposed sealed and un-sealed roof decks, shown in Figure 8, perpendicular to the wind-driven rain to allow a relative comparison in the amount of water entry in the attic for each half of the roof.

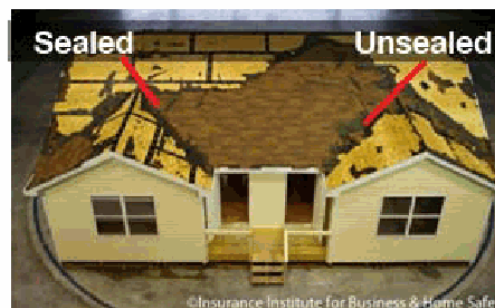
Figure 9 - Photograph of the front of the duplex after shingle and underlayment removal using high winds, illustrating the sealed roof deck (on the left) and the un-sealed roof deck (on the right).

wind-driven rain events modeled after Hurricane Dolly. These tests gave IBHS the opportunity to illustrate the consequences of water entry into attic spaces with compelling photos and video. Figure 10 shows photographs taken on the un-sealed roof deck side of the duplex during the demonstration testing, while Figure 11 (shown on page 9) shows a similar view on the sealed roof deck side.

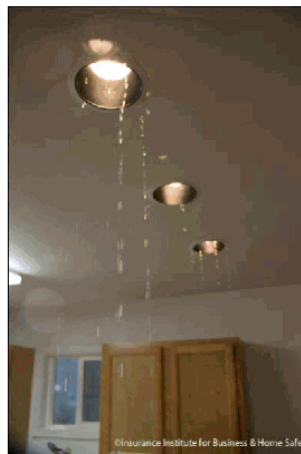
Figure 10 - Photograph of the water entry during the demonstration event on the un-sealed roof deck side of the duplex: close up of the recessed lighting in the kitchen.

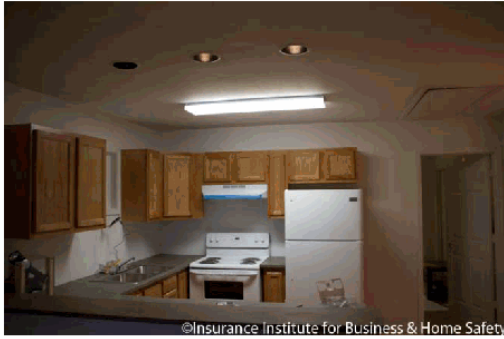
Figure 11 - Photograph of the kitchen during the demonstration event on the sealed roof deck side of the duplex.

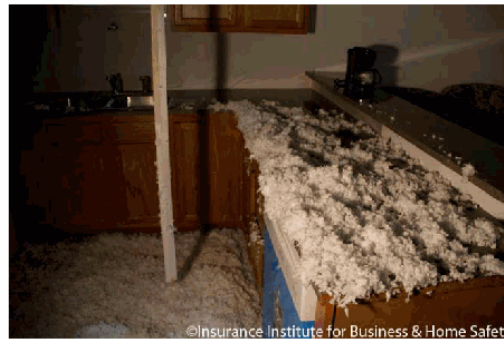
Figure 13 - Photograph of fallen portions of collapsed ceiling in the kitchen on the un-sealed roof deck side of the duplex.

The amount of water streaming into the living space during the demonstration in the un-sealed roof deck side of the duplex, and the level of damage ultimately experienced on this half of the duplex, is typical of the level of water entry reported during real-world events. Within 45 minutes of the conclusion of testing, the kitchen ceiling in the un-sealed side of the duplex collapsed, as shown in Figure 12 and Figure 13. Shortly thereafter, the living room area ceiling also collapsed, as shown in Figure 14.

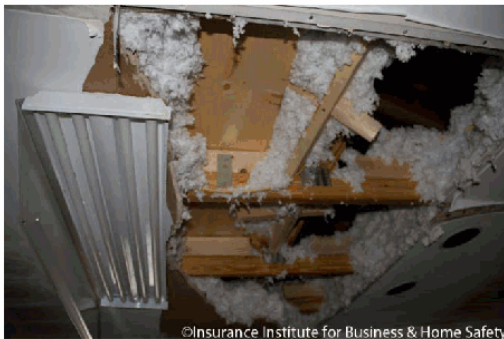
Figure 12 - Photograph of collapsed ceiling in the kitchen on the un-sealed roof deck side of the duplex.

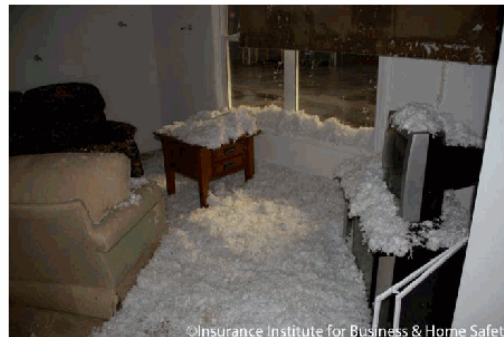
Figure 14 - Photograph of fallen portions of collapsed ceiling in the living room on the un-sealed roof deck side of the duplex.
