GLASSCRAFT DOOR COMPANY TEST REPORT

STRUCTURAL TESTING ON
HARDWOOD GLAZED DOUBLE /SINGLE TDL DOORS

H4307.01-801-44

Hardwood Glazed Double TDL Doors

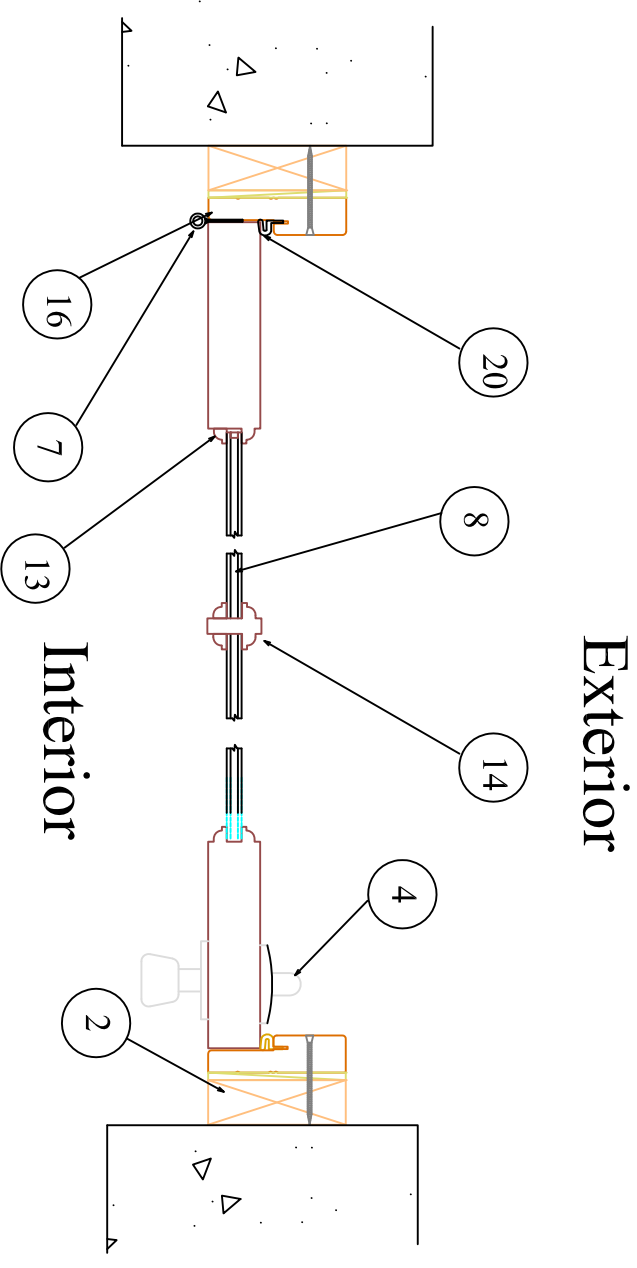
Horizontal Cross Section

Exterior

Interior
