PERFORMANCE TEST REPORT

GLASSCRAFT DOOR COMPANY

SERIES/MODEL: Portobello and Estancia

PRODUCT TYPE: 42" x 96" Single Outswing Hardwood Door

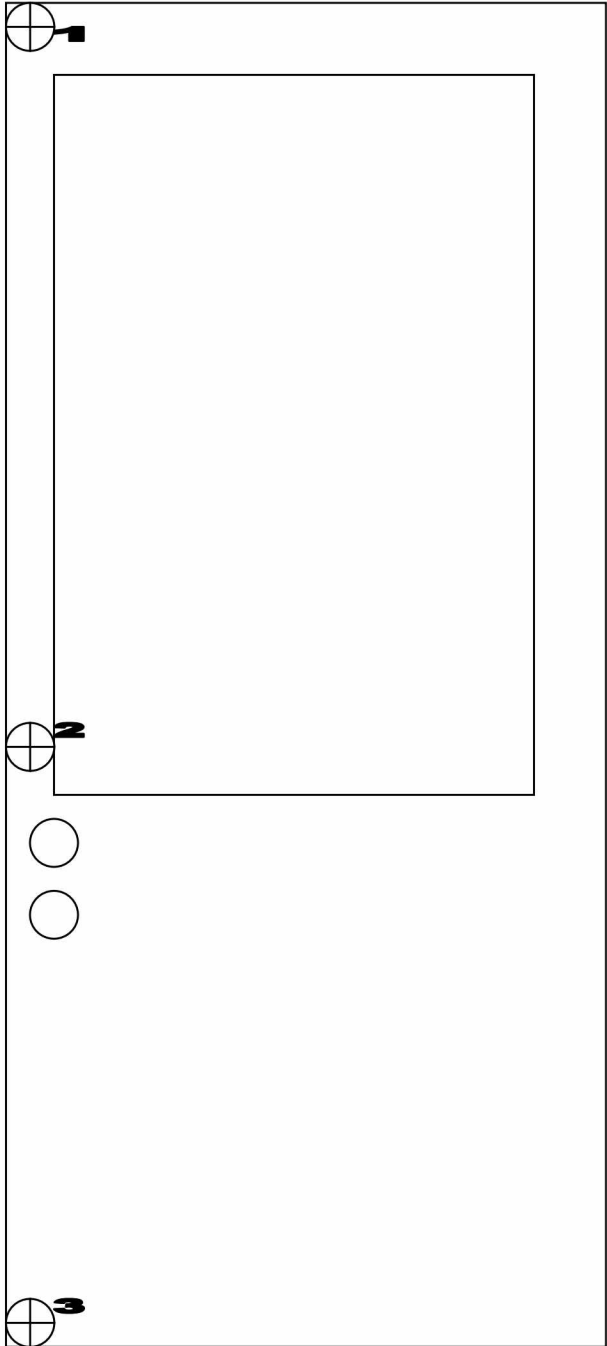
**Indicator locations**

<u>Title of Test</u>	<u>Results</u>		
	<u>Indicator Reading (inch)</u>		
	<u>1</u>	<u>2</u>	<u>3</u>
Uniform Load Deflection per ASTM E 330 (Deflections were taken on the door) (Load held for 25 seconds)			
47.2 psf (positive)	0.12	0.13	0.17
51.4 psf (negative)	0.14	0.24	0.16
	<u>Indicator Reading (inch)</u>		
	<u>1</u>	<u>2</u>	<u>3</u>
Uniform Load Structural per ASTM E 330 (Permanent sets were taken on the door) (Load held for 10 seconds)			
70.8 psf (positive)	0.03	0.03	0.05
77.1 psf (negative)	0.05	0.12	0.10

Note: See Architectural Testing Sketch #1 for indicator locations.

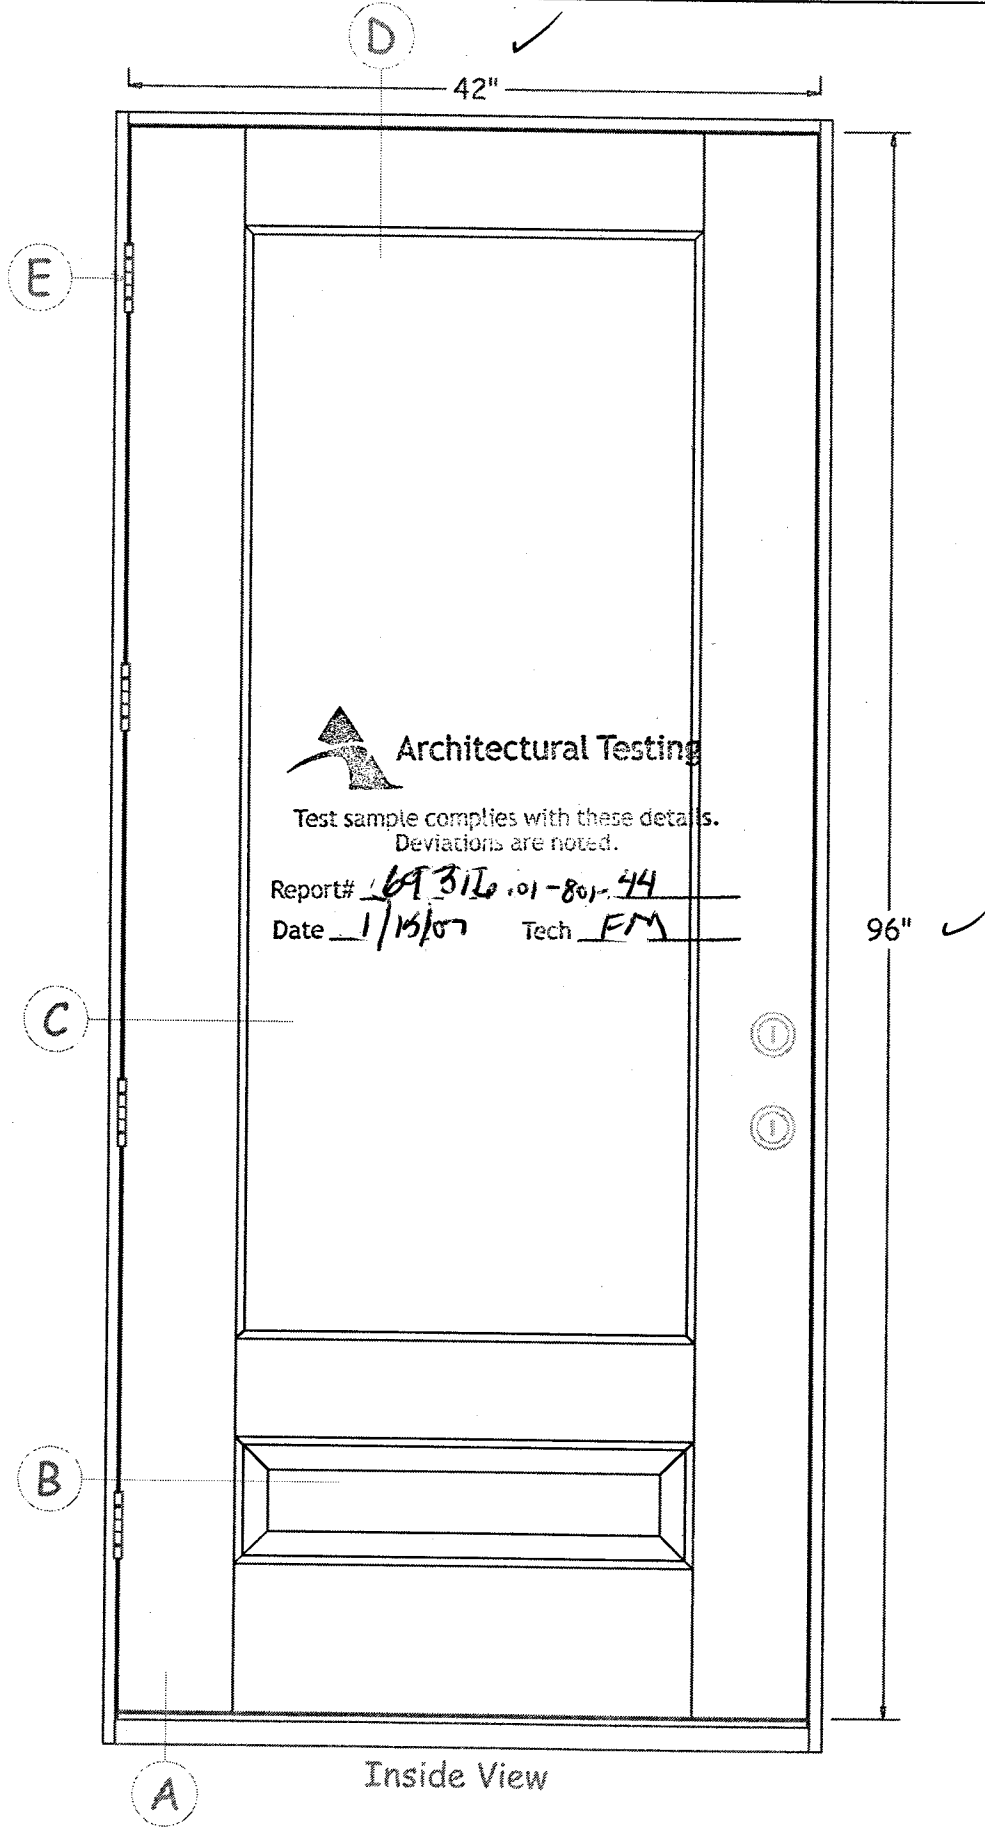
Inside View

(D)

(E)

(C)

(B)

(A)

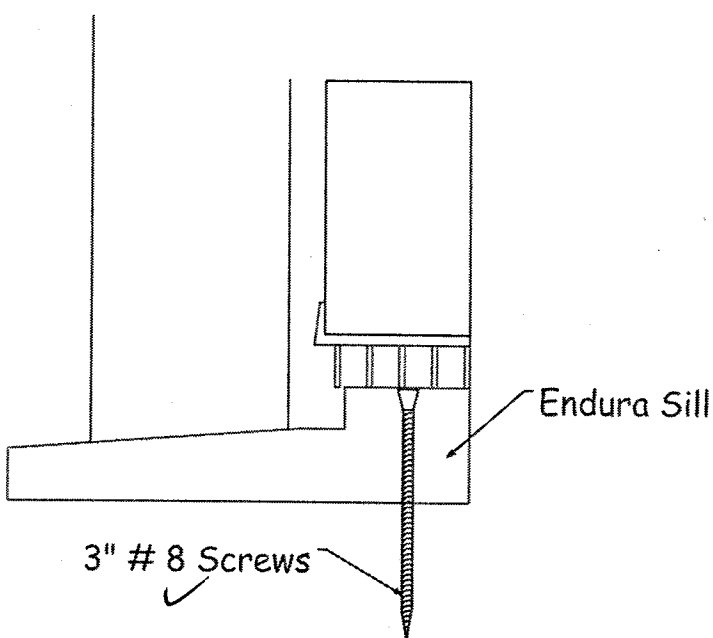
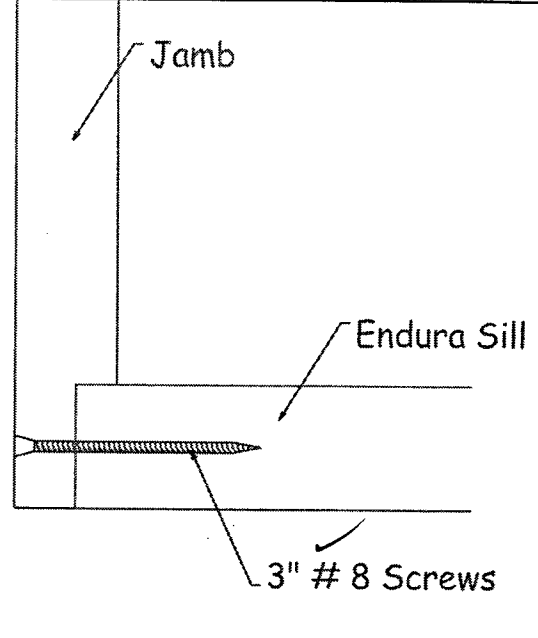
A Threshold In Swing

Section View

Inside View

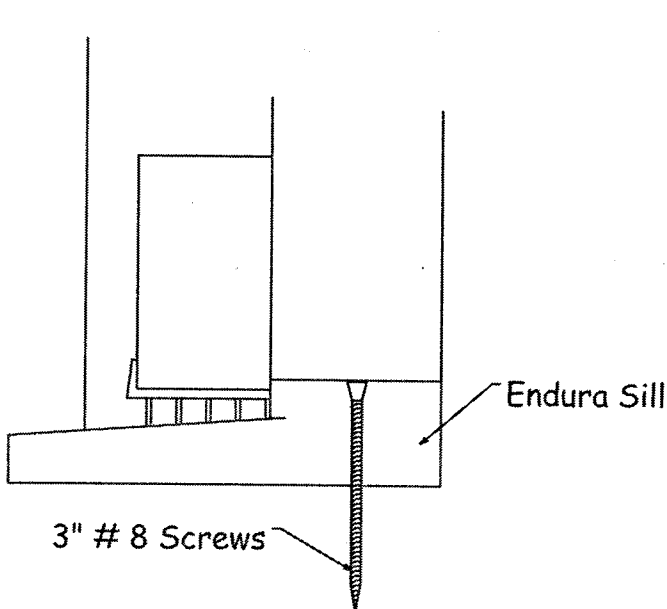
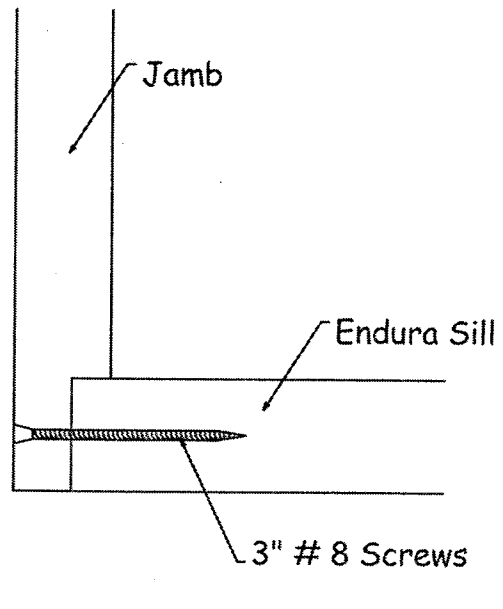
A Threshold Out Swing

Section View

Inside View

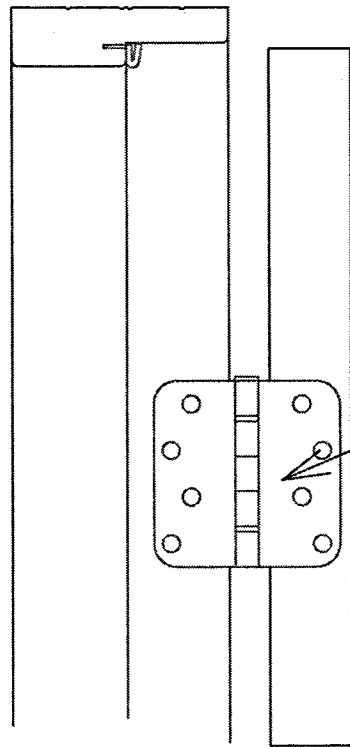
Door Hinge

Penrond 4"x4"
5/8" Radius
Hinge

Hardware: One Schlage F-300 Series single-point lockset 36" from bottom of the leaf and one Schlage deadbolt located 41-5/8" from the bottom of the leaf. Four 4" butt type hinges were fastened to the leaf with four #8 x 3" screws each. Each hinge was secured to the jamb with two #8 x 3" screws and two #8 x 1" flat head screws. The hinges were located at 7", 32-1/4", 57-1/2" and 82-3/4" from the top of the jamb. Surface bolts were attached to the top and bottom of the leaf with four #10 x 1" flat head machine screws with a 1-1/2" long blind nut. Strike plates for the surface bolts were attached to the head with two #8 x 3" screws and to the threshold with two #10 x 3" sheet metal screws.
