PERFORMANCE TEST REPORT

GLASSCRAFT DOOR COMPANY

**PRODUCT TYPE: 6' x 8' Double Outswing Hardwood TDL Door
with Half Circle TDL Transom**

Report No.: 81838.01-801-44

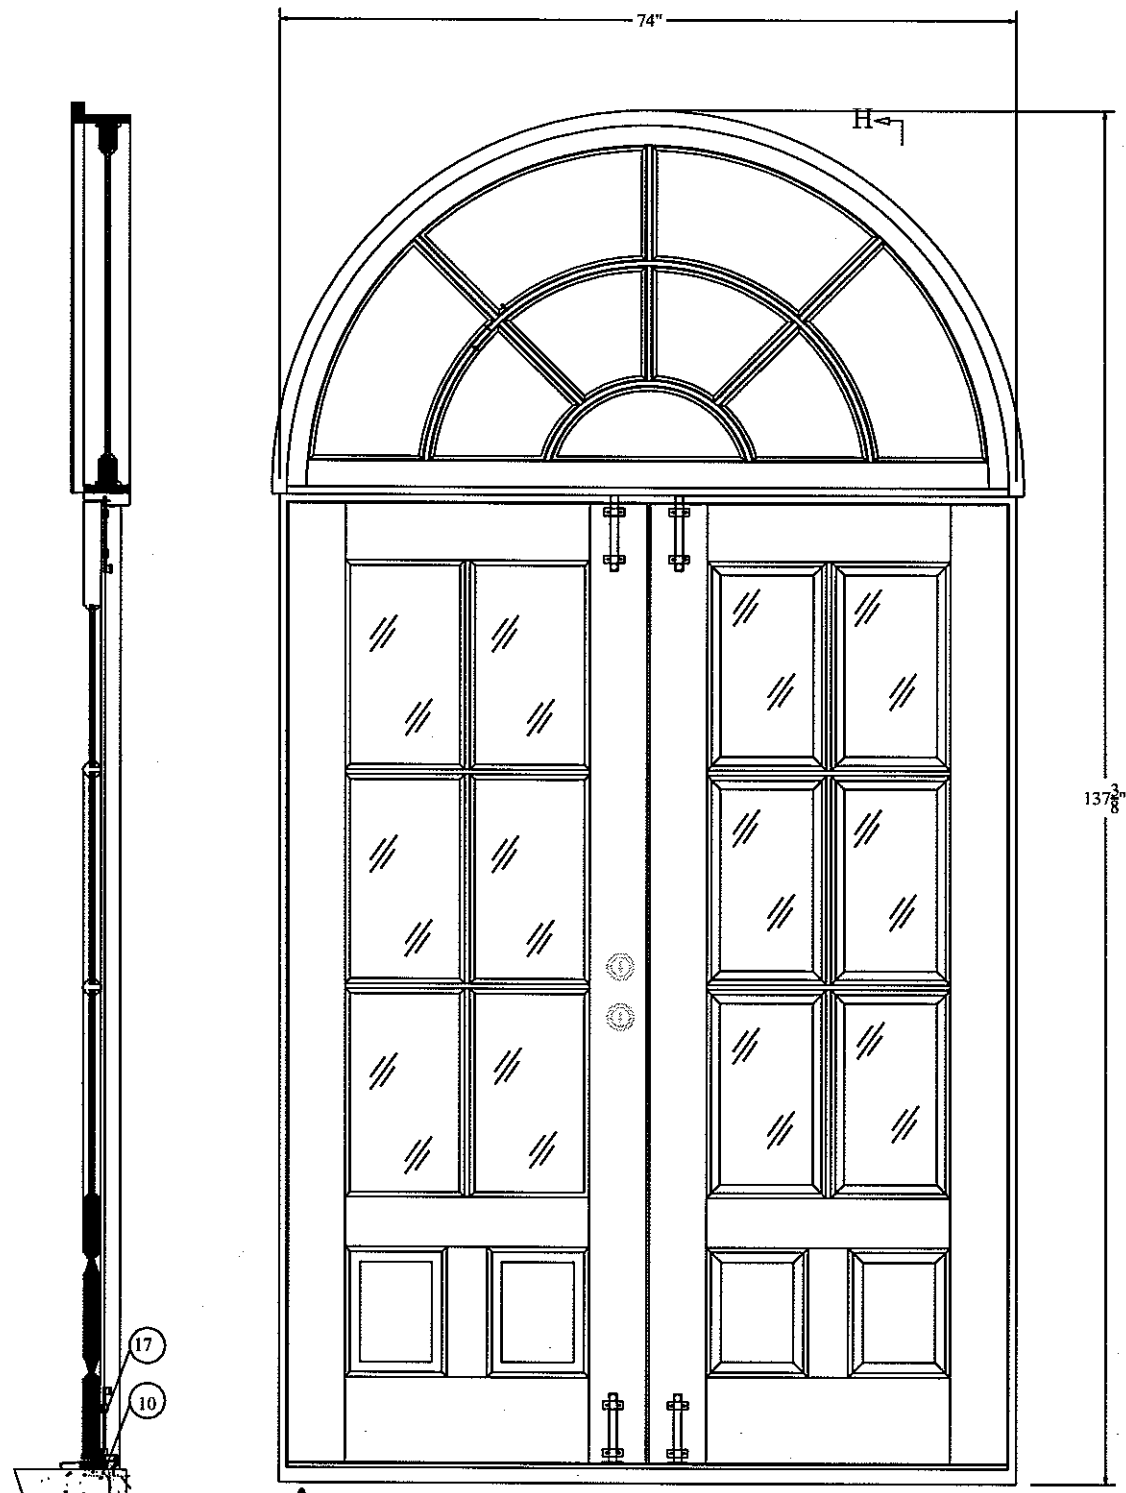
Section
Glass*Craft

Hardwood Double Glass Doors/Transom

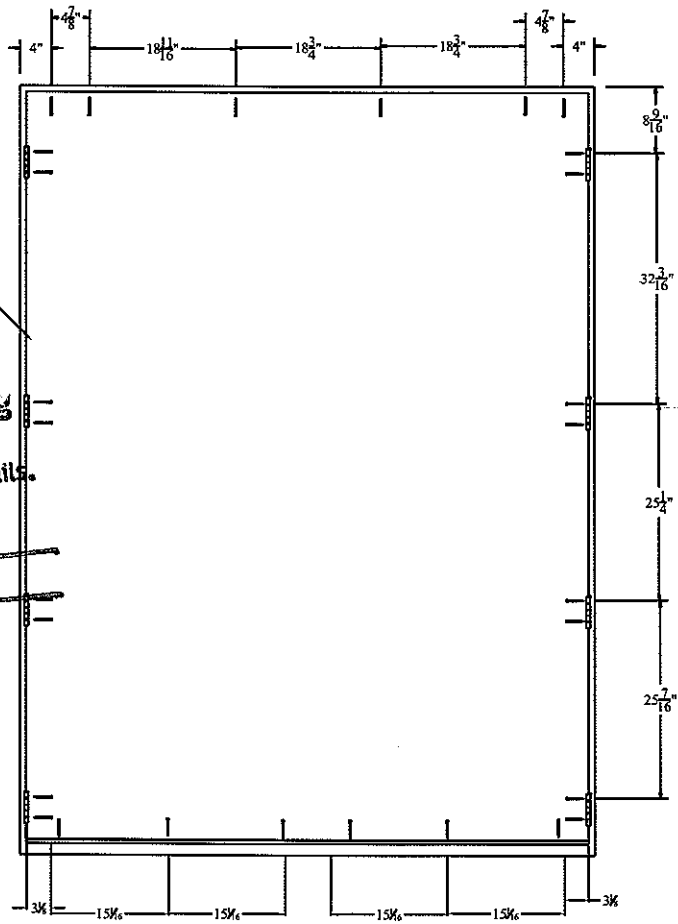
ANCHORING DIMENSION

Hardwood Double Glazed Doors/Transom

Installation: The jambs were secured to a #2 Yellow Pine 2x12 test buck with two #8 x 3" screws at each hinge (16 total). The unit was secured through the jambs with #8 x 3" screws located 2" from the bottom of each jamb and on 12" centers thereafter.

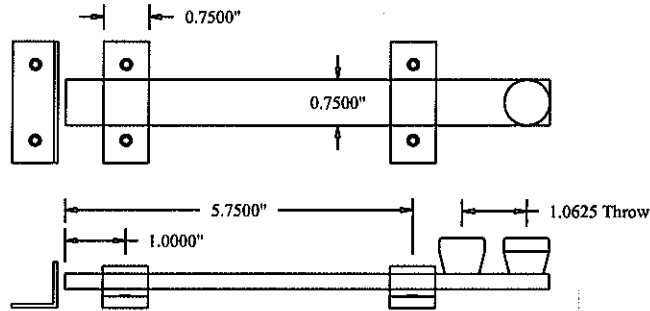
L Strike

Mortise Strike

Hardware: One Schlage F-300 Series single-point lockset 36" on center from bottom of the leaf and a Schlage deadbolt located 41-5/8" on center from the bottom of the leaf. Two metal strike plates located in the astragal secured with two #8 x 2-1/2" flat head screws. Four 4" butt type hinges fastened to each leaf with four #8 x 3" screws. Each hinge was secured to the jamb with two #8 x 3" screws and two #8 x 1" flat head screws. The hinges were located at 9-1/8", 34-1/2", 59-1/2" and 84-3/4" on center from the top of the jamb. Surface bolts were attached to the top and bottom of each leaf with four #10 x 1" flat head machine screws with a 1-1/2" long blind nut. Strike plates for the surface bolts were attached to the head jamb with two #10 x 2" screws and to the threshold with two #10 x 3" sheet metal screws.

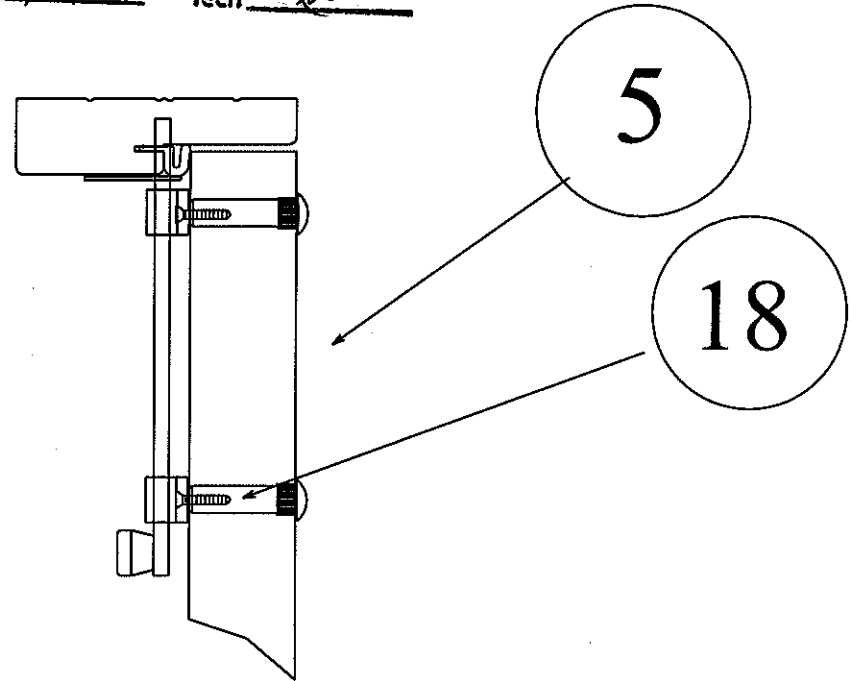
(F)

Rockwood 580 Surface Bolt

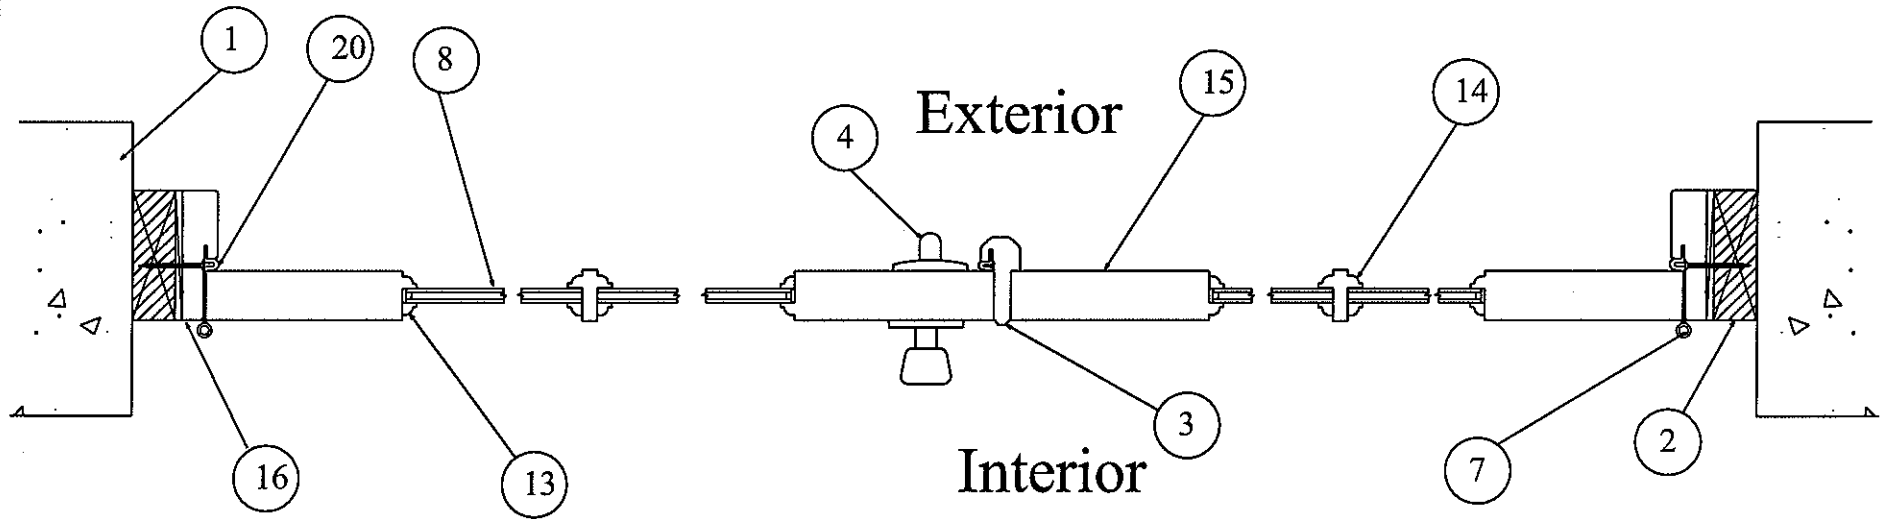
Horizontal Cross Section

Hardwood Double Glazed Doors

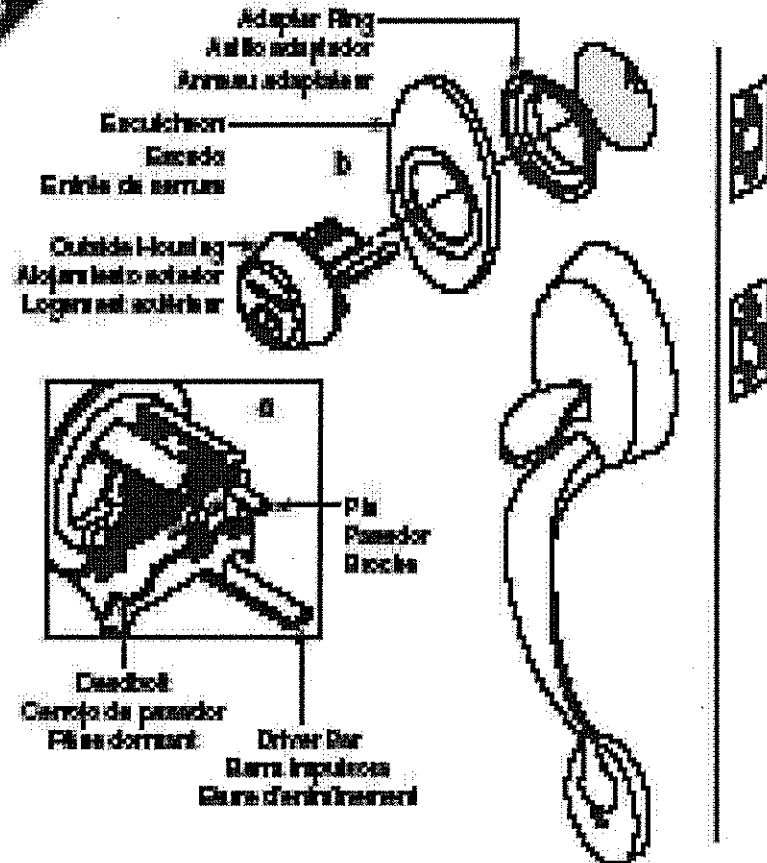
Install Outside Housing

NOTE: Do not install adapter ring if using 1 1/2" (38 mm) hole.

- FOR Faso/Faso:** Ensure pin is positioned to slide through correct backset slot in deadbolt.
- Insert housing through escutcheon and adapter ring and into door. Driver bar should slide under deadbolt.

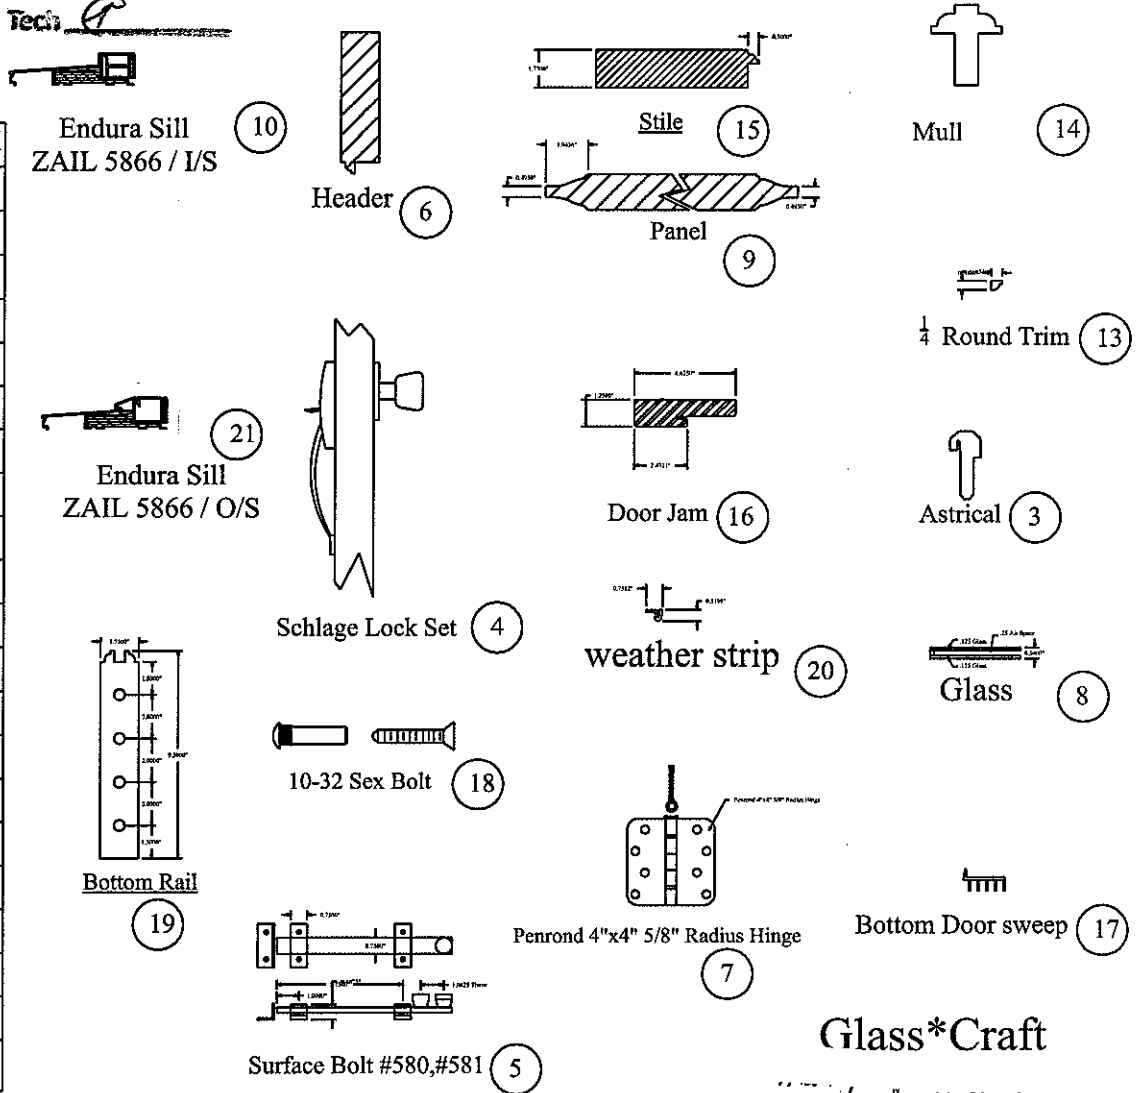
List of Material

Item #	Discription	Material
1	Masonry	CONC.
2	2x Buck	Wood
3	Astrical	Wood
4	Schlage lock Set	Metal
5	Rockwood Serface Bolts #580	Metal
6	Top Header	Wood
7	Penrond 4"x4" 5/8" Radius Hinge	Metal
8	Glass	Glass
9	Panel	Wood
10	Endura Sill ZAIL 5866 / I/S	Alum.
11	3" #9 Wood screw	Metal
12	#9x1" PFH Wood Screw	Metal
13	1/4 Round Trim	Wood
14	Mull	Wood
15	Stile	Wood
16	Door Jam	Wood
17	Bottom Door sweep	Rubber
18	10-32 Sex Bolt	Metal
19	Bottom Rail	Wood
20	weather strip	Foam
21	Endura Sill ZAIL 5866 / O/S	Alum.

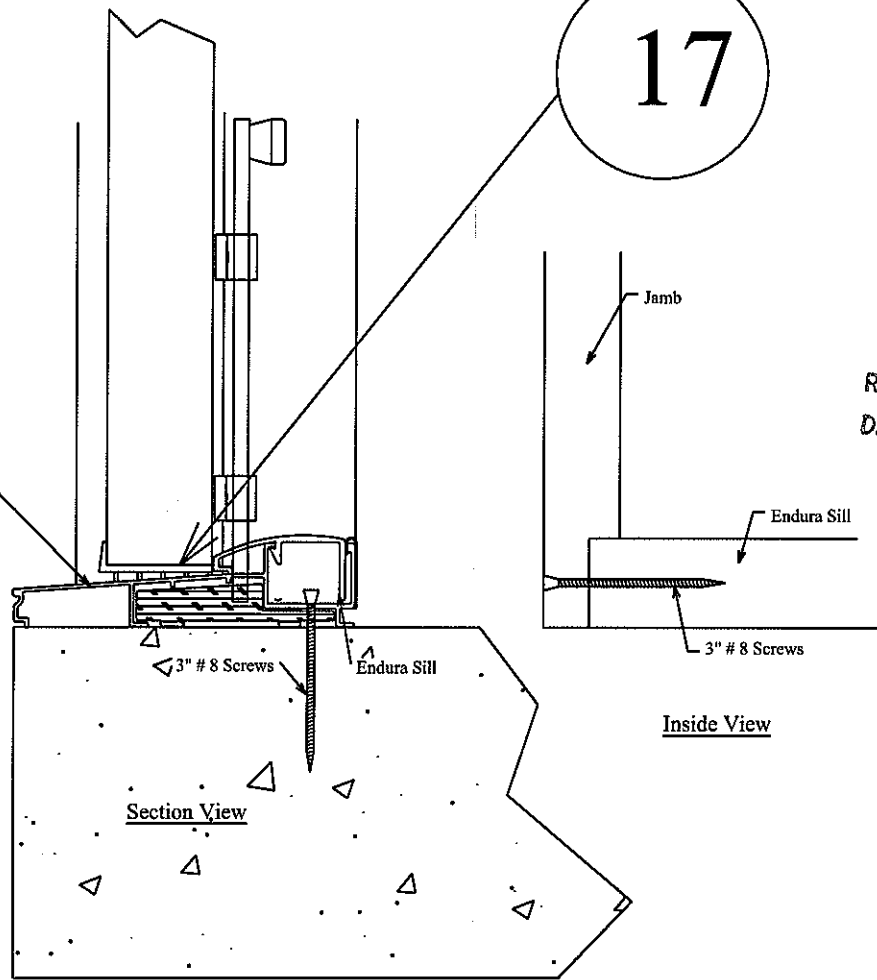
(A) Threshold Out Swing

Endura Sill
ZAIL 5866 / O/S

Frame Construction: The door frame was constructed of 4-5/8" by 1-1/4" hardwood head and jambs, a 3-1/4" by 1-3/8" hardwood T-astagal and included an adjustable extruded aluminum and composite threshold. The head and jambs were kerfed to accept the weatherstripping. The corners were coped and butted and secured with two #8 x 1-1/2" and five #8 x 3" screws at the threshold; and four #8 x 1-1/2" and two #8 x 3" screws at the head. The astragal was attached to the inactive panel with sixteen 2" x 0.040" x 0.050" rectangular shank 0.050" x 0.080" head brad nails located 1" from each end and on 8" spacing.

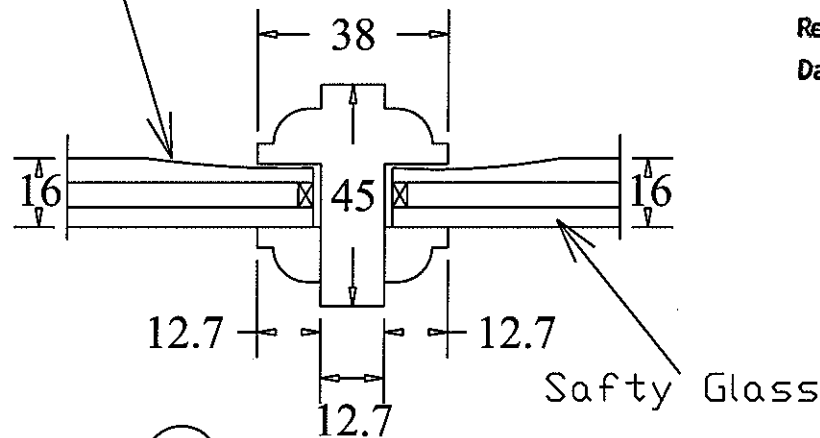
(C) CROSS SECTION

Beveled Safety Glass
