**PERFORMANCE TEST REPORT**

**GLASSCRAFT DOOR COMPANY**

**SERIES/MODEL: Buffalo Forge Steel Doors/Round Top Double**

**PRODUCT TYPE: In-swing Round Top Double Door LH-4-5/8**

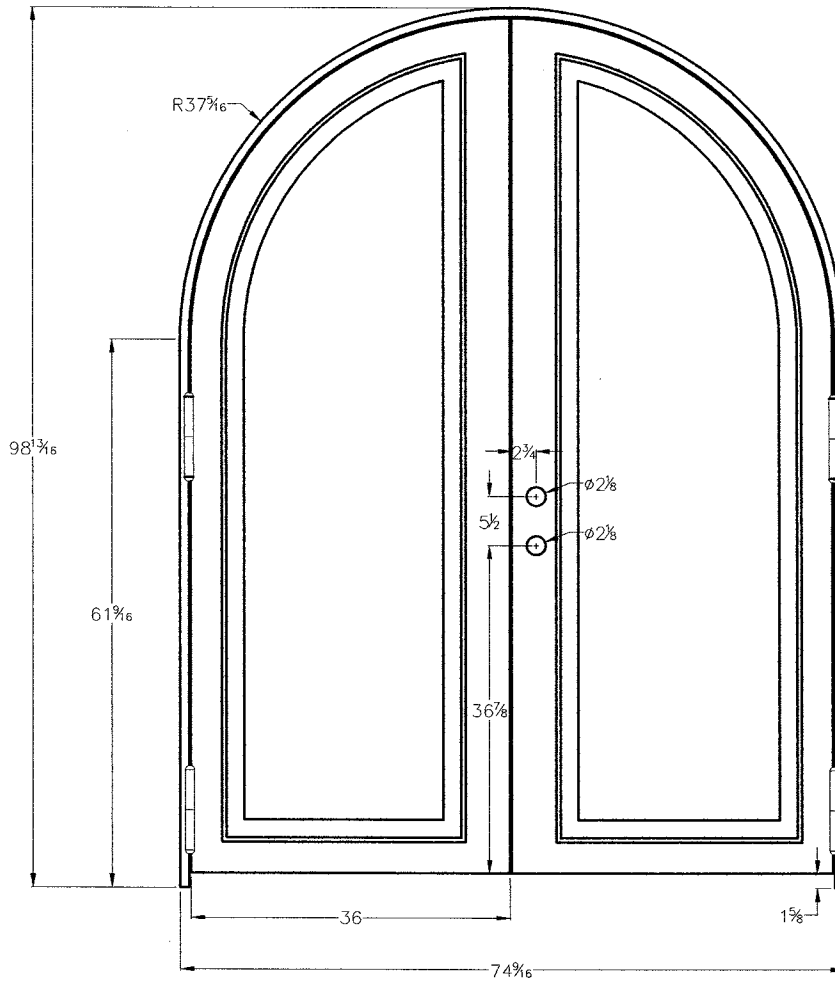
Double door  
Full arch top

- 1. Door Hardware/ Schlege F-series handle set with Dead Bolt F358ply620
- 2. Z-series sill (Endura
- 3. 98" Compression w/strip bronze

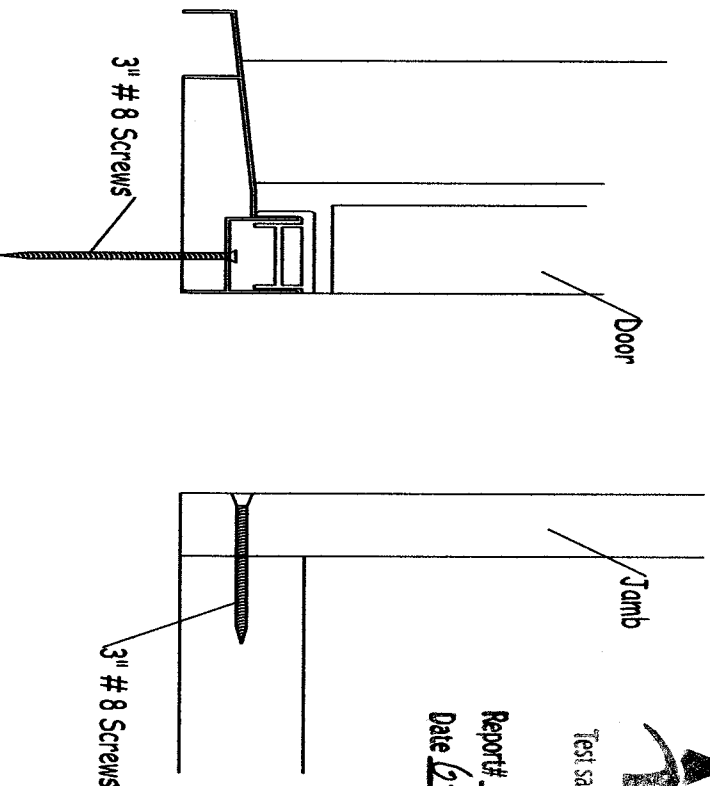
# Door Jam Cross Section

End Section View

Front View

Threshold In Swing

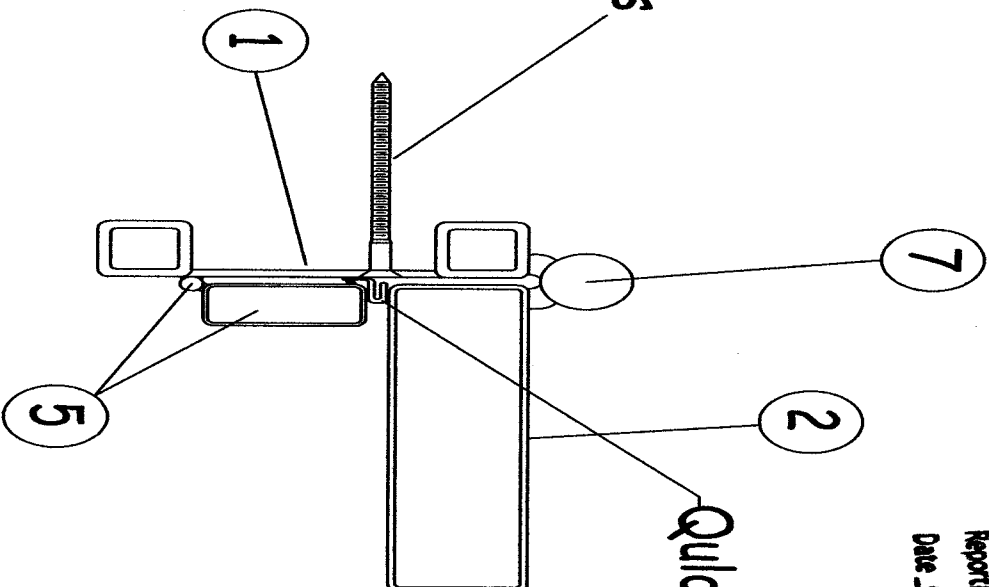
3" # 14 F/H Screws

- 1 Jamb
- 2 Stile
- 3 Glass
- 4 Forge
- 5 Door stop
- 6 Astragal
- 7 Prodeco hinge
- 8 Glass frame hinge
- 9 Forge frame
- 10 Fixed glass stop
- 11 Screwed glass stop

**Frame Construction:** The door frame section was constructed of 4-5/8" thick steel jambs, and included an adjustable extruded aluminum threshold. The aluminum threshold was secured to the jambs with three #8 x 3" screws at each end.

**Installation:** The jambs were secured to a #2 Yellow Pine test buck with #14 x 3" screws 9" from each corner and 16" on center thereafter.

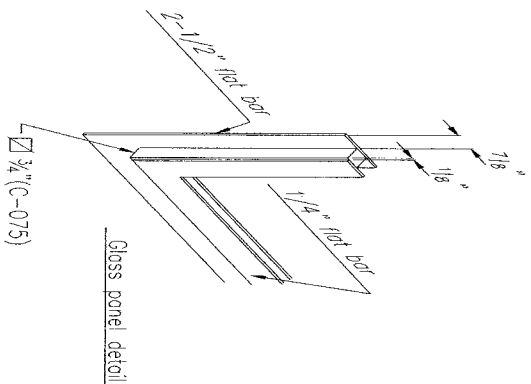
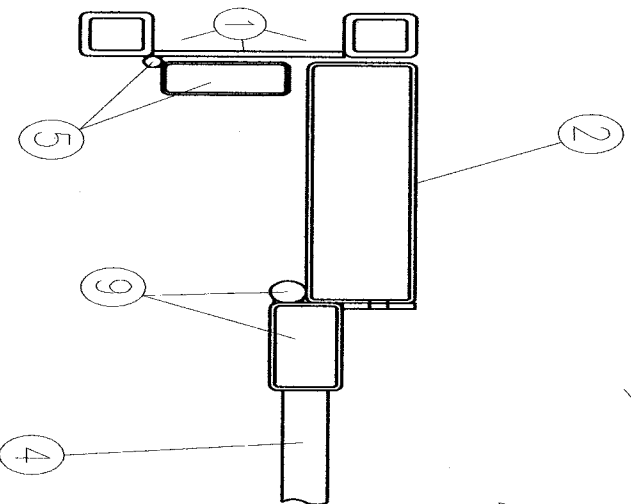
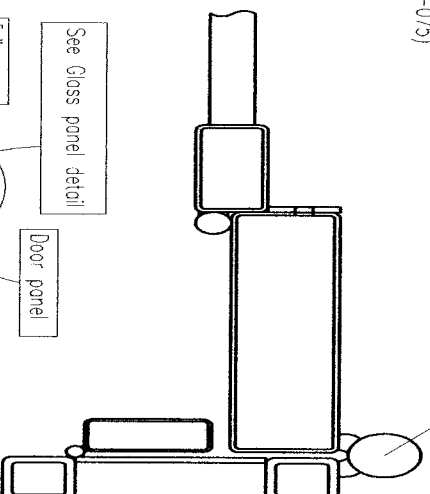
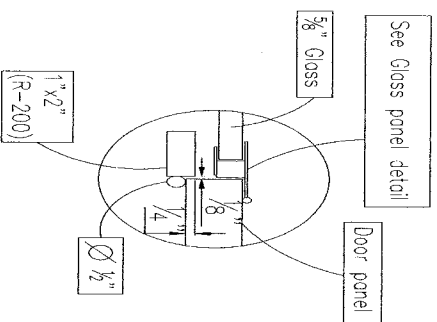
# Single door Cross Section

- 1 Lamb
- 2 Stile
- 3 Glass
- 4 Forge
- 5 Door stop
- 6 Astragal
- 7 Prodeco hinge
- 8 Glass frame hinge
- 9 Forge frame
- 10 Fixed glass stop
- 11 Screwed glass stop

**Leaf Construction:** The door leaf was constructed from steel with a foam core. A glass frame was secured to the door leaf with three barrel hinges and three sweep latches. Sweep latch keepers were welded to the door leaf. A decorative iron grille was secured at the exterior of the unit.

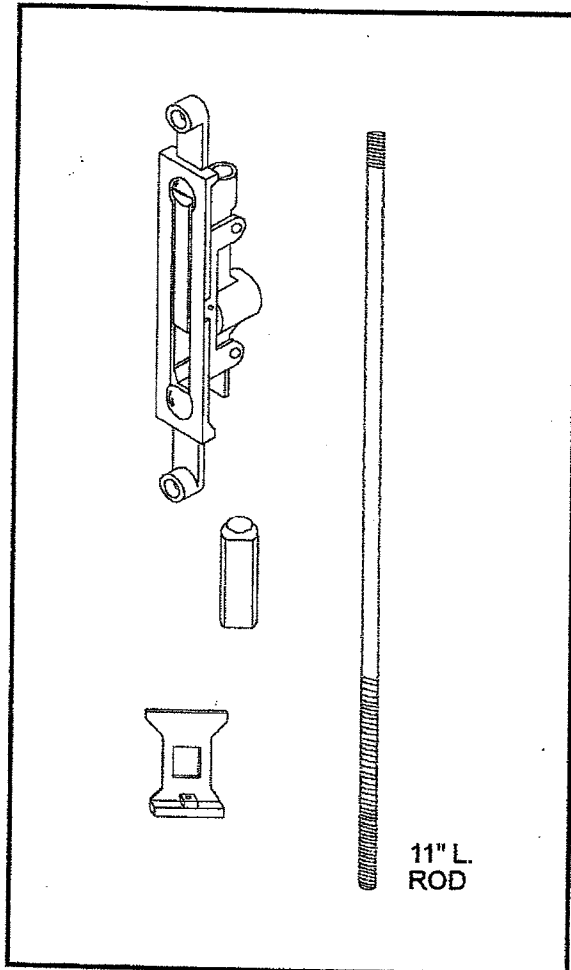
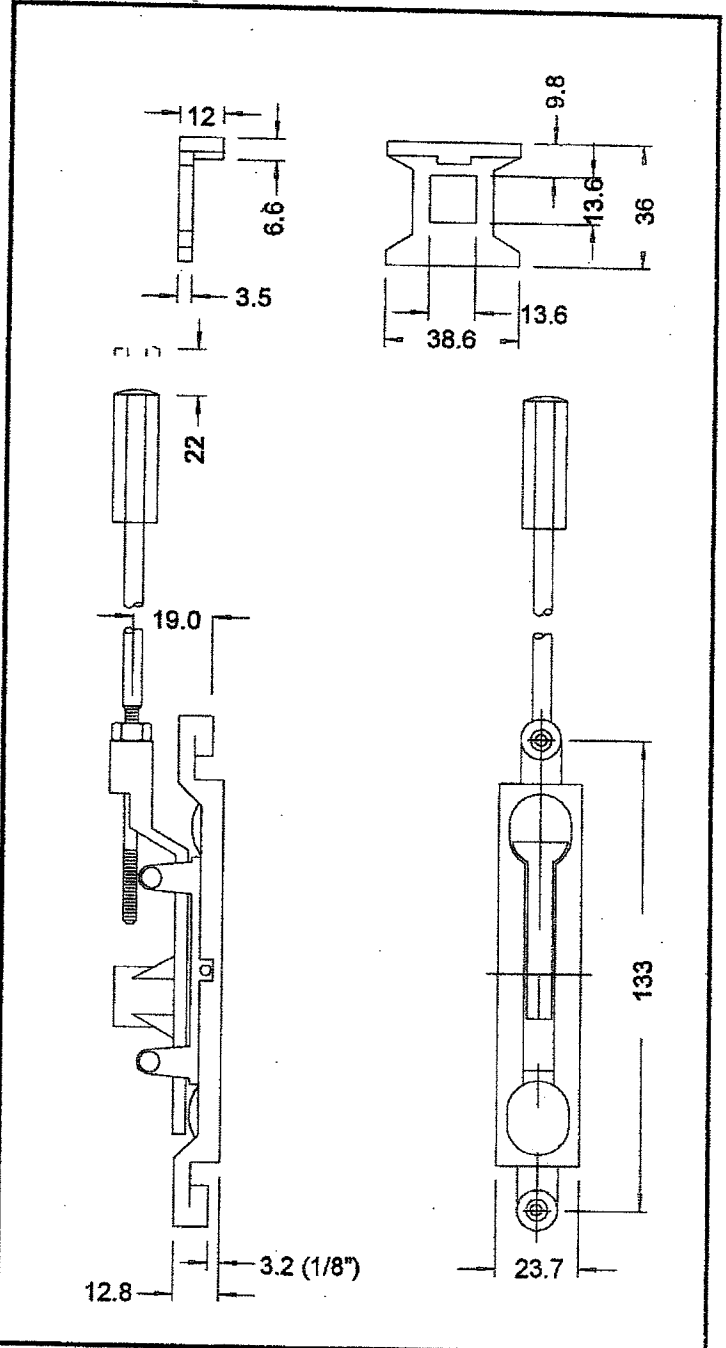
# Z/C FLUSH BOLT

**Product code: FB1**  
**Zinc alloy flush bolt with**  
**11" rod.**

- \*Positive "U" joint actuator with 7/8" throw
- \*1/8" offset with 3/4" backset.
- \*5/8" adjustment on rod length.
- \*Round brass tip
- \*Finish option:  
AL: Baked satin aluminum.  
DU: Baked duronodic.  
BK: Baked black.
