PERFORMANCE TEST REPORT

GLASSCRAFT DOOR COMPANY

**PRODUCT TYPE: 6' x 8' Double Outswing Hardwood Door
with Half Circle Transom**

Report No.: 64138.01-801-44

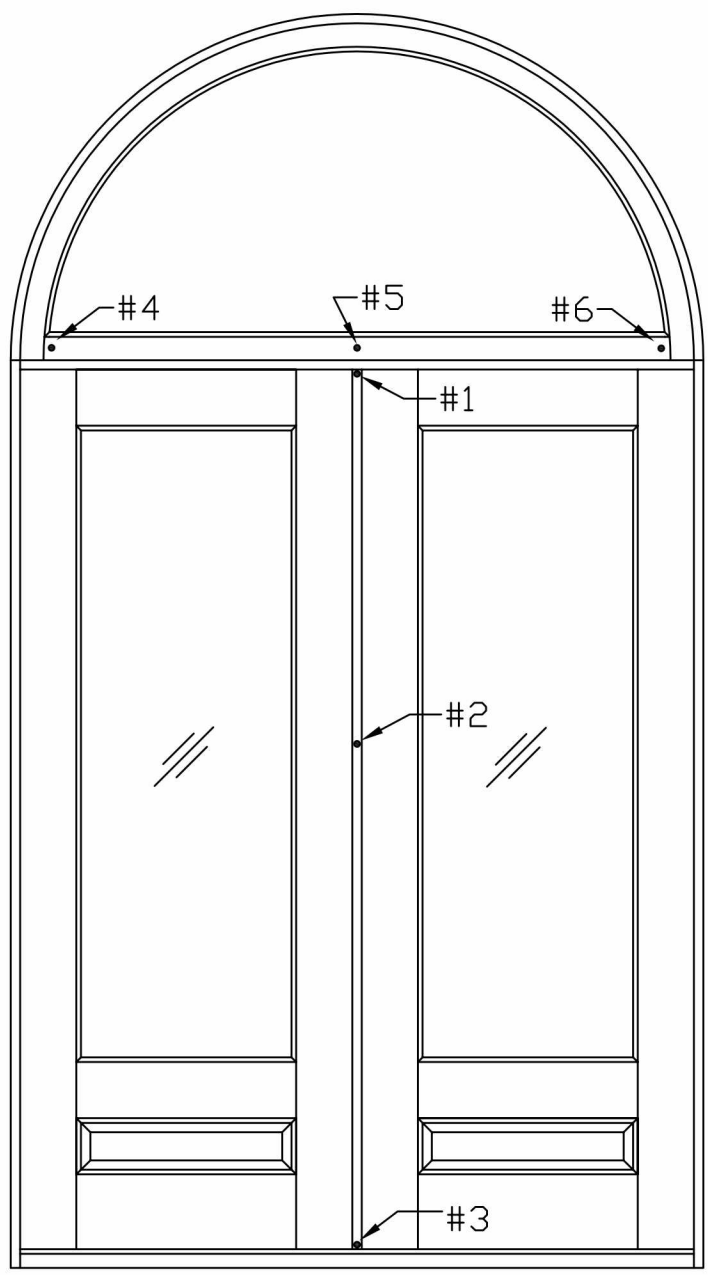
DRAWING SKETCH #1

Note: See Architectural Testing Sketch #1 for indicator locations.

Uniform Load Deflection per ASTM E 330 (Deflections were taken on the astragal)	<u>Indicator Number</u>			Net
	1	2	3	
36.2 psf (positive) (load held for 30 seconds)	0.02"	0.05"	<0.01"	0.04"
45.7 psf (negative) (load held for 27 seconds)	0.67"	1.08"	0.25"	0.62"

Uniform Load Deflection per ASTM E 330 (Deflections were taken on the transom sill)	<u>Indicator Number</u>			Net
	4	5	6	
36.2 psf (positive) (load held for 30 seconds)	0.20"	0.30"	0.22"	0.09"
45.7 psf (negative) (load held for 27 seconds)	0.34"	0.41"	0.37"	0.06"

Uniform Load Structural per ASTM E 330 (Permanent sets were taken on the astragal)	<u>Indicator Number</u>			Net
	1	2	3	
54.3 psf (positive) (load held for 10 seconds)	<0.01"	<0.01"	<0.01"	<0.01"
68.6 psf (negative) (load held for 10 seconds)	0.13"	0.02"	0.09"	0.09"

Uniform Load Structural per ASTM E 330 (Permanent sets were taken on the transom sill)	<u>Indicator Number</u>			Net
	4	5	6	
54.3 psf (positive) (load held for 10 seconds)	0.02"	0.02"	0.02"	<0.01"
68.6 psf (negative) (load held for 10 seconds)	0.05"	0.03"	0.08"	0.04"

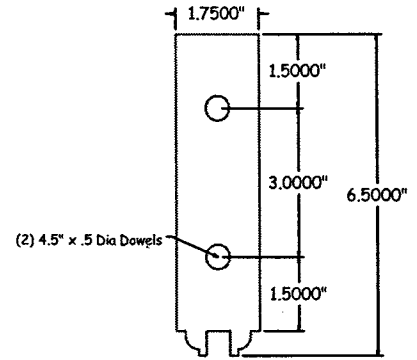
Top Rail

Leaf Construction: The door leaf was constructed of 1-3/4" thick hardwood and utilized a glued cove and bead joint, reinforced with 1/2" diameter by 4-1/2" long wood dowels. Two dowels were located at the top and middle rail to stile joint, and four dowels were located at the bottom rail to stile joint.

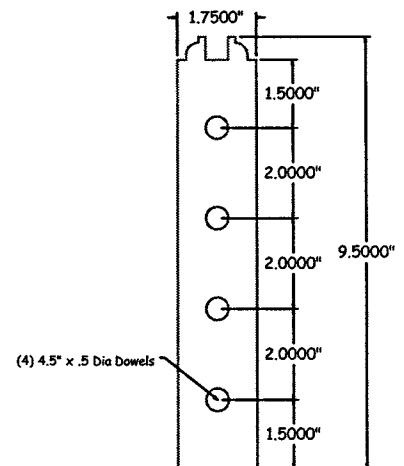
Bottom Rail

Weatherstripping: One five finger vinyl sweep at the bottom of the door leaf. One row of custom shaped foam-filled vinyl weatherstrip at the head and jambs.

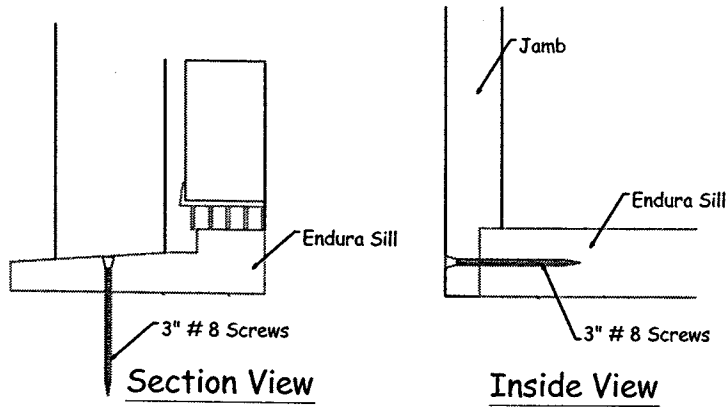
A Threshold

Frame Construction: The door frame was constructed of 4-5/8" by 1-1/4" hardwood head and jambs, a 3-1/4" x 1-3/8" hardwood T-astragal and included an adjustable extruded aluminum and composite threshold. The head and jambs were kerfed to accept the weatherstripping. The corners were coped and butted and secured with two #8 x 1-1/2" and five #8 x 3" screws at the threshold; and four #8 x 1-1/2" and two #8 x 3" screws at the head. The astragal was attached to the inactive panel with twelve #8 x 3" screws located 7" from each end and on 8" spacing.

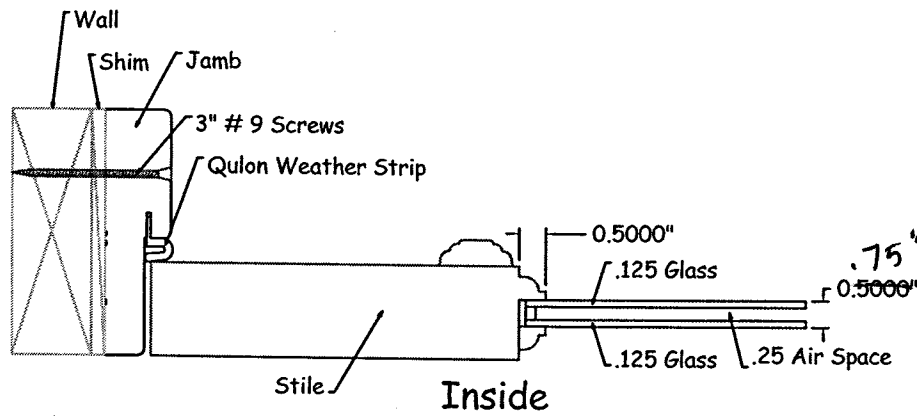
C Glass

Glazing Type: Sealed insulating glass comprised of one sheet of 1/8" thick tempered glass at the exterior and one sheet of 1/8" thick tempered decorative textured glass at the interior. The sheets were separated by a 1/2" aluminum spacer system providing a 3/4" overall thickness.

Glazing Details: Interior glazed with double-sided butyl tape and a wood glazing bead secured by 1" x 0.040" x 0.050" rectangular shank 0.050" x 0.080" head brad nails (18 gauge brad nail) 1" from each corner and on 6" spacing thereafter.

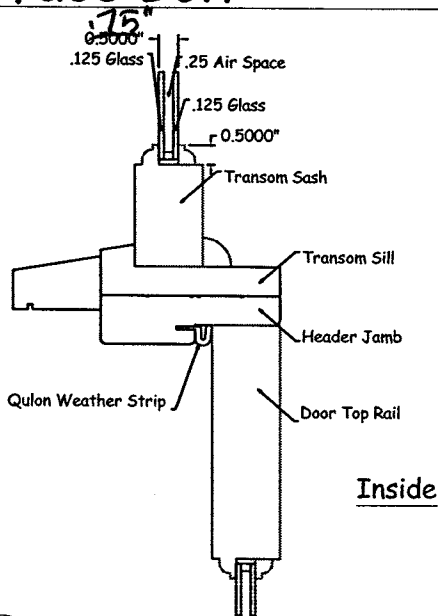
F Header-Sill

Frame Construction: The frame was constructed of 4-1/2" by 3/4" hardwood. The corners were secured with two #8 x 3" wood screws.

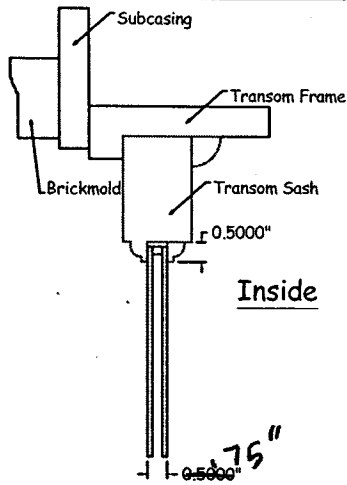
G Transom Head

Panel Construction: The panel was constructed of 1-3/4" thick laminated hardwood and utilized a glued cove and bead joint. Two #8 x 3" screws were located at each stile to rail joint. The panel was secured to the transom frame with seven #8 x 3" screws 3" from each corner and on 18" spacing around the arch and three #8 x 3" screws 3" from each corner and in the center across the sill and with 1/2" quarter round trim fastened by 1-1/4" x 0.040" x 0.050" rectangular shank 0.050" x 0.080" head brad nails (18 gauge brad nail) 1" from each corner and on 6" spacing. The transom was attached to the head jamb of the door with six #8 x 1-1/2" screws one 3" from each corner of the head/sill and on 13" spacing across the head/sill.

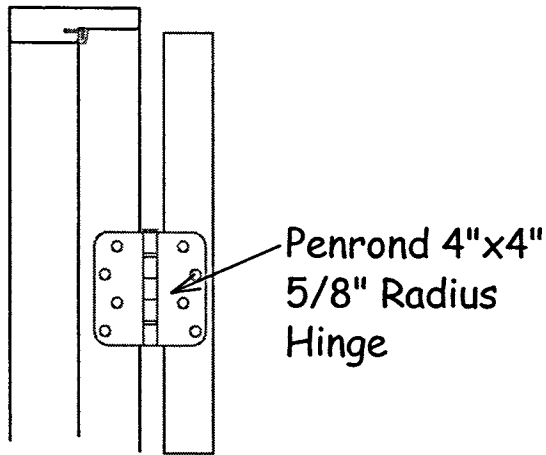
H Door Hinge

Hardware: One Schlage F-300 Series single-point lockset 36" on center from bottom of the leaf and a Schlage deadbolt located 41-5/8" on center from the bottom of the leaf. Two metal strike plates located in the astragal secured with two #8 x 2-1/2" flat head screws. Four 4" butt type hinges fastened to each leaf with four #8 x 3" screws. Each hinge was secured to the jamb with two #8 x 3" screws and two #8 x 1" flat head screws. The hinges were located at 9-1/8", 34-1/2", 59-1/2" and 84-3/4" on center from the top of the jamb. Surface bolts were attached to the top and bottom of each leaf with four #10 x 1" flat head machine screws with a 1-1/2" long blind nut. Strike plates for the surface bolts were attached to the head jamb with two #8 x 3" screws and to the threshold with two #10 x 3" sheet metal screws.
