PERFORMANCE TEST REPORT

GLASSCRAFT DOOR COMPANY

SERIES/MODEL: Portobello and Estancia

Report No.: 69316.01-801-44

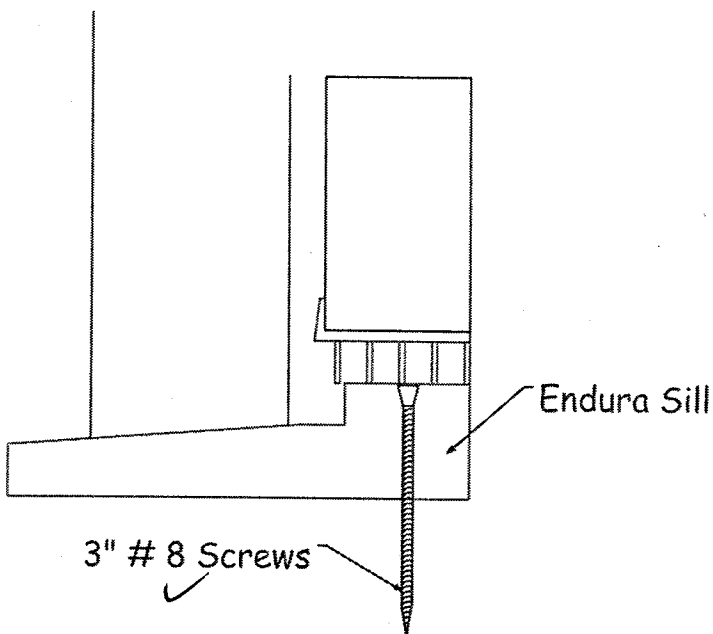
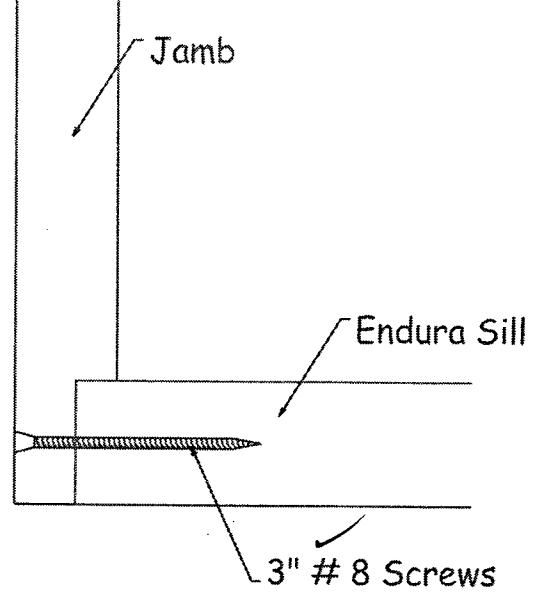
A Threshold In Swing

Section View

Inside View

Frame Construction: The doorframe was constructed of 4-5/8" by 1-1/4" hardwood head and jambs, and included an adjustable extruded aluminum and composite threshold. The head and jambs were kerfed to accept the weatherstripping. The corners were coped and butted and secured with two #8 x 1-1/2" screws and five #8 x 3" screws at the threshold; and four #8 x 1-1/2" screws and two #8 x 3" screws at the head.

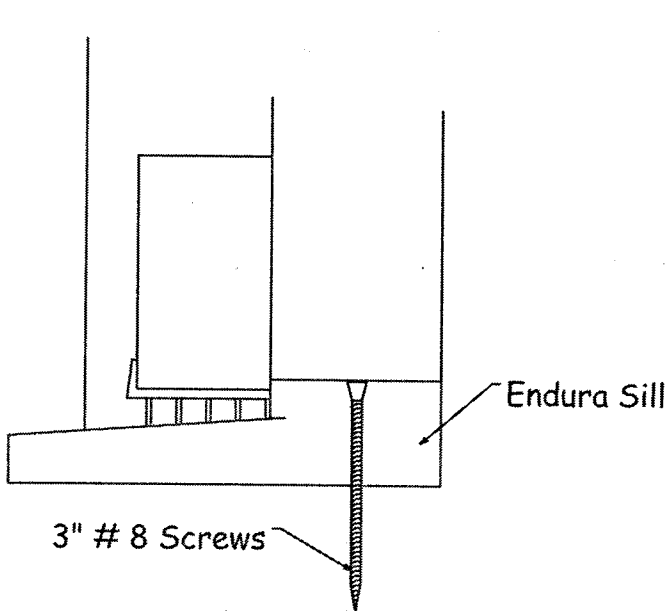
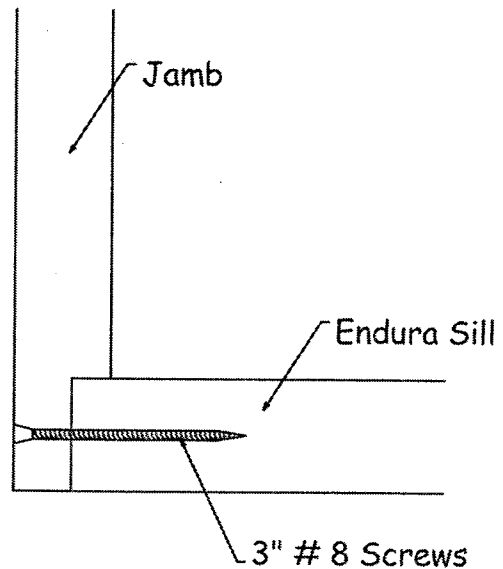
A Threshold Out Swing

Section View

Inside View
