Laboratory Test Report

Product Name(s): 24ga. 16" Steel - Board and Batten Wall Panels

Project No.: 2651T0007A

Test Methods: TAS 202 (ASTM E330) & TAS 203 & ASTM A370 (Tensile)

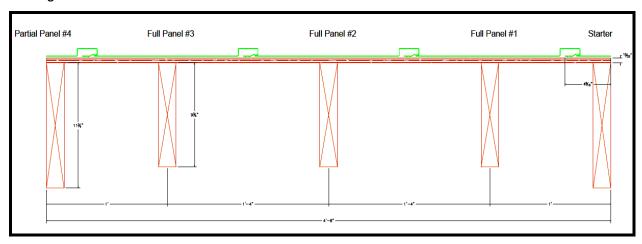
Framing Details

The test assemblies were constructed on 56" wide by 96" tall walls, fabricated from nominal 2x12 SYP perimeter framing members with 2x6 SYP wooden intermediate framing members spaced 16" O.C. (See Appendix A for details) The framing was sheathed with nominal 15/32" plywood and attached with 8D nails; 6" O.C. around the perimeter and in the field. Three (3) 2" diameter holes were fabricated in each stud cavity through the sheathing to permit pressurization to the back side of the cladding panels. Polyethylene film and tape was applied between the back of the panels and the plywood sheathing prevent excess air leakage during negative loading. (Film was cut for positive loads.)

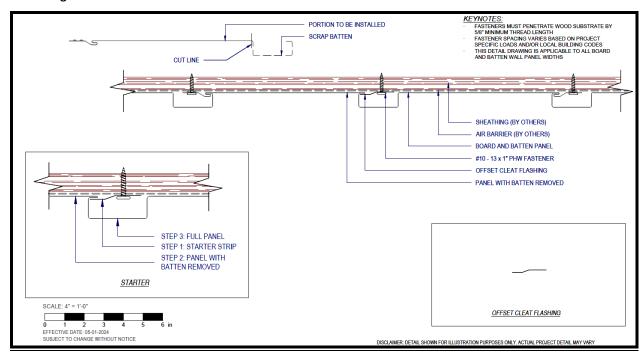
Anchoring Details

Each assembly was contructed with three full (3) panels, one (1) starter strip (cut from a panel), and one (1) fabricated panel. A 96" length of starter strip was attached to the vertical edge of the assembly with each adjacent panel slid into the corresponding interlock. The starter strip and each panel was attached into the sheathing only with fourteen (14) \pm 10-13 x 1" GP Concealor screws spaced approximately 6-1/2" O.C. into each nail flange slot.

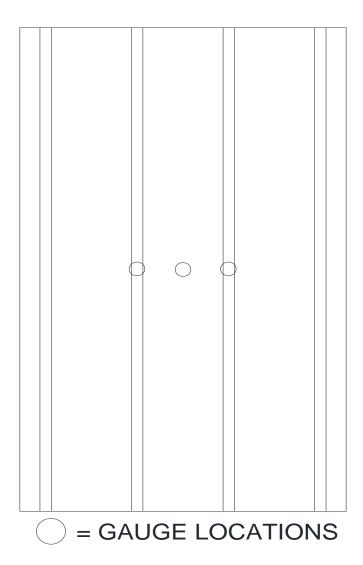
Deflection / Permanent Set Measurement

- Deflection and permanent set were captured on the midspan of the center panel, the unsupported span measured 16". See sketch (Assembly 1) in Appendix A for gauge measurement locations.
- Upon completion of testing the specimen met the requirements outlined in the Florida Building Code section 1626.2.8.

- 1. Loads were held for 30 seconds.
- 2. Tape and polyethylene film were utilized to seal the specimen for excessive air leakage, and in the PRI-CMT witness's opinion did not influence the test results
- 3. Deflection and permanent set were captured on the midspan of the center panel, the unsupported span measured 16". See Appendix A Sketches for gauge measurement locations.
- 4. Upon completion of testing the specimen did not have indication of deterioration or incipient failure, such as cracking, fastener loosening, local yielding exceeding 10% over maximum deflection, or loss of adhesive bond.

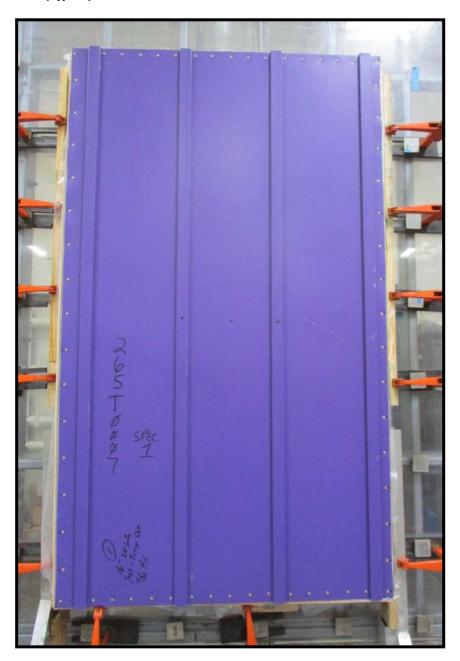
Assembly Prior to Test (Typical)

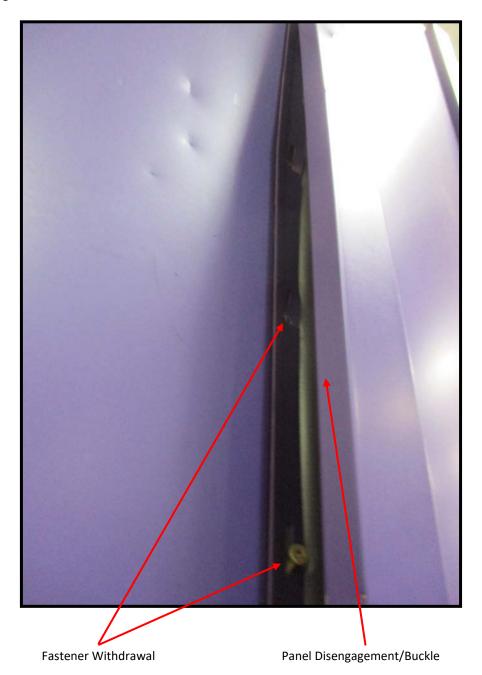
Typical Failure

- 1. Incremental Pressure Differential loading was specified by the client. Negative pressure only.
- 2. Failure due to anchor withdrawal resulting in panel disengagement/buckle. See Appendix A Photographs.
