PERFORMANCE TEST REPORT

SERIES/MODEL: Buffalo Forge Steel Doors/ Double with Transom
PRODUCT TYPE: LH-A In-swing Double Door with Half-Round Transom

Report No.: 72619.01-801-44

ASTM E 330-02, Test Method for Structural Performance of Exterior Windows, Curtain Walls and Doors by Uniform Static Air Pressure Difference

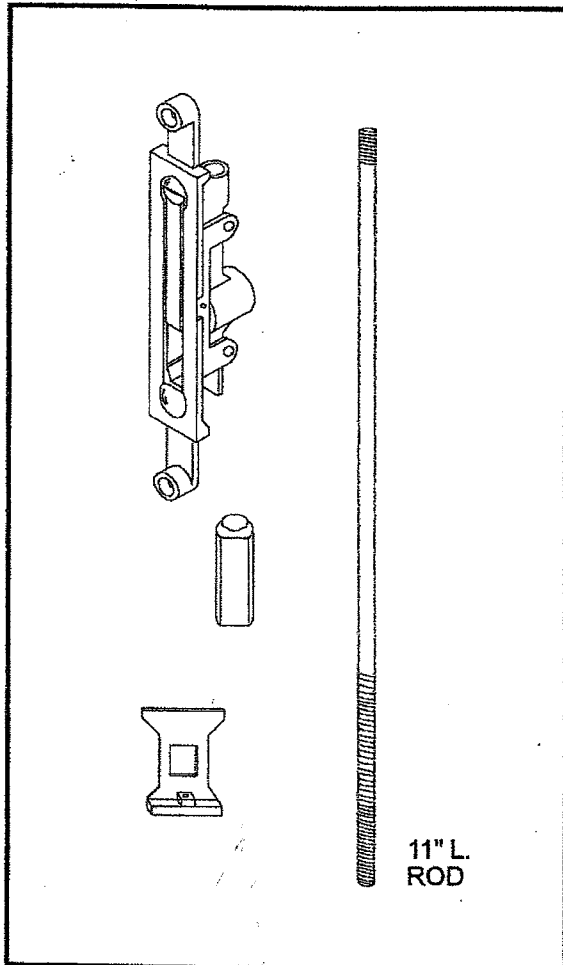
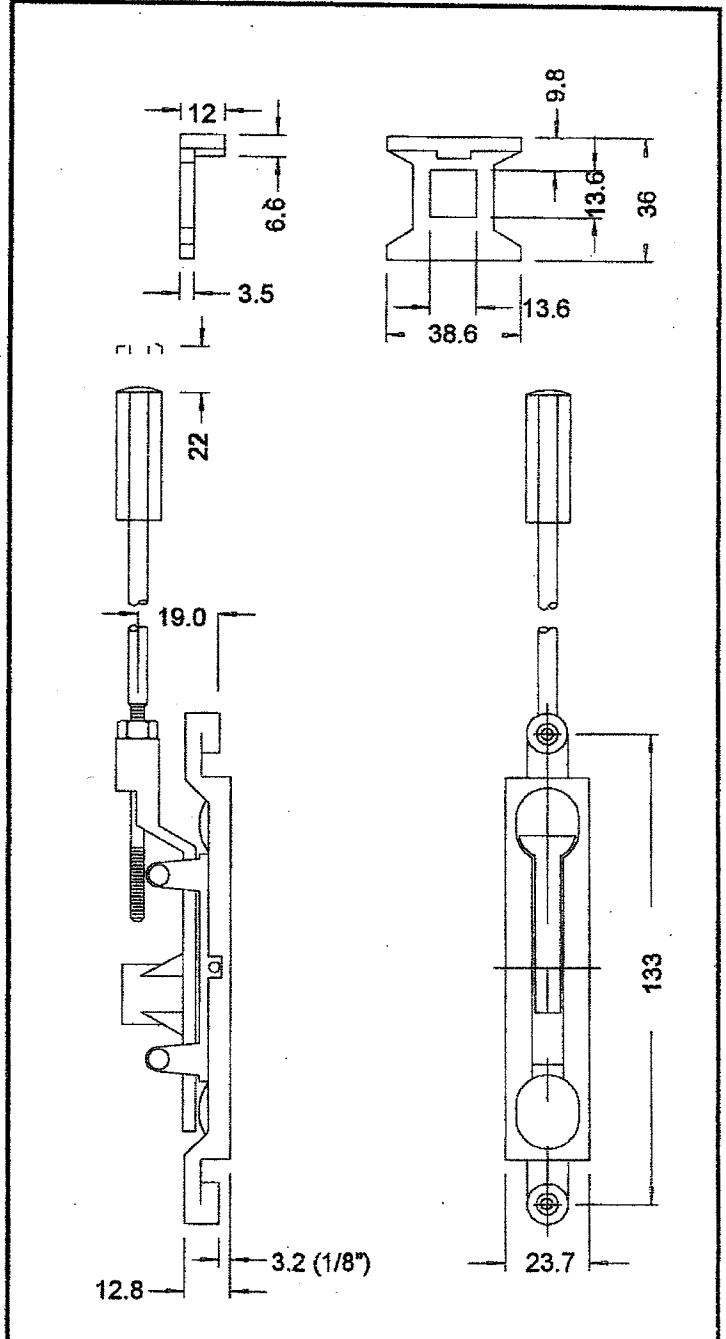
Z/C FLUSH BOLT

Product code: FB1
Zinc alloy flush bolt with
11" rod.

*Positive "U" joint actuator with 7/8" throw

*1/8" offset with 3/4" backset.

*5/8" adjustment on rod length.

*Round brass tip
